# Overflow tests on Belgian levees

# Continuous Overflow tests on Belgian levees

1.0 - 20221115

Depreiter, D., Vercruyse, J., Verelst, K., Zomer, W., Koelewijn, A., Tsimopoulou, V., Peeters, P.

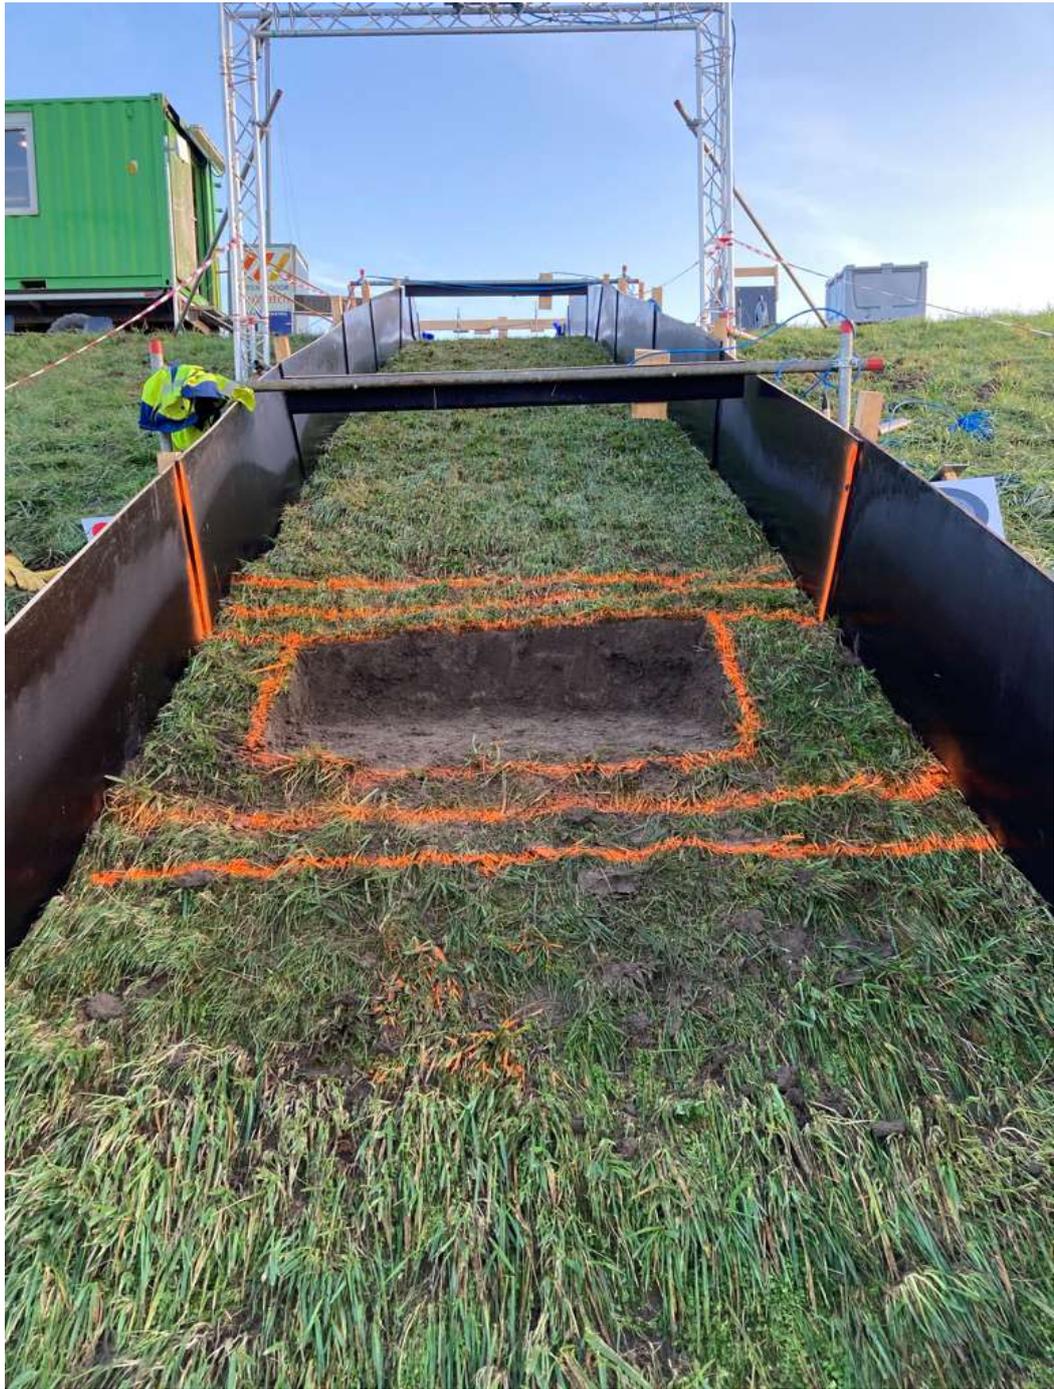
At the end of the day, the options to deliberately increase the damage by excavating a small cliff manually on the 7<sup>th</sup> of November 2020 were discussed. A cliff (width 135 cm, cliff height 30 cm, step length 90 cm) was to be excavated halfway the slope in the middle of the test section.

Figure 15 - Excavated cliff, dimension: 130 cm - 90 cm - 30 cm

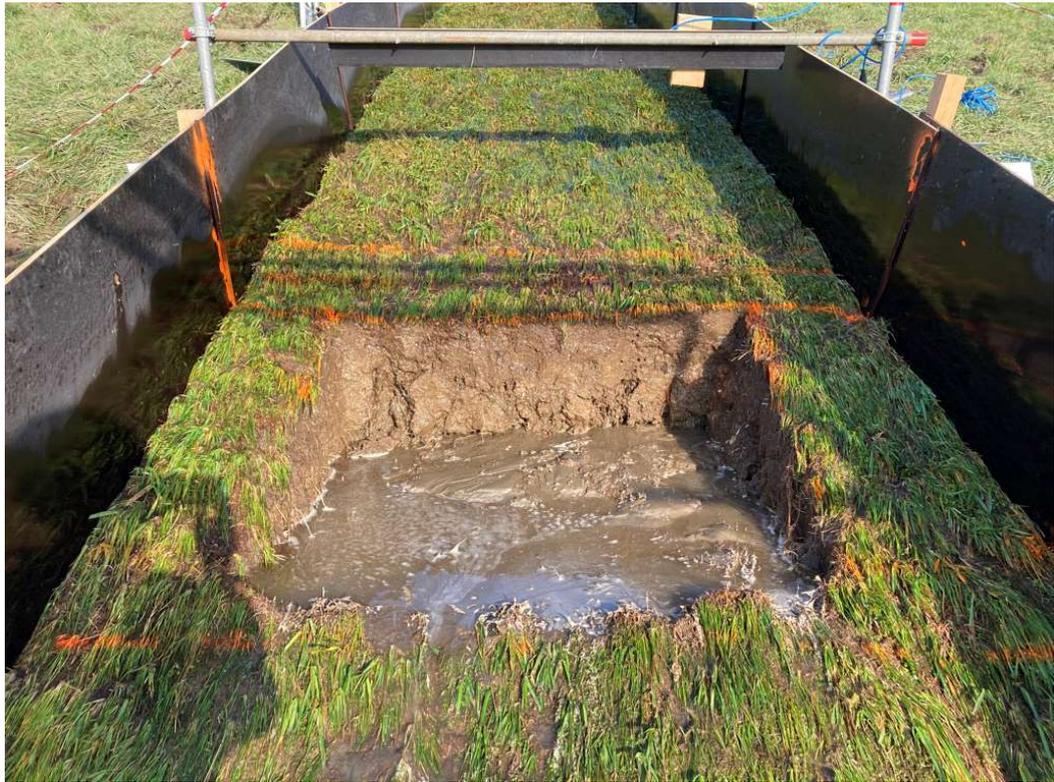
After the third run of 1 hour (totaling in 4 hours of overflow after the step was dug), damage was increasing, but not to that extent that failure was deemed imminent. It was therefore decided to increase the depth of the cliff by 10 cm to a depth of 40 cm. On a few small spots the cover layer of sandy-clay was dug away completely and a few cm<sup>2</sup> sandy core became visible. Roots of grass and herbs proved to extend beyond depth of 40 cm. Sand underneath the cover layer was a kind of silty sand. Note that the maximum volume of damage that was allowed was 1 m<sup>3</sup> of eroded soil.

Figure 16 - Excavated cliff, dimension: 130 cm - 90 cm - 40 cm

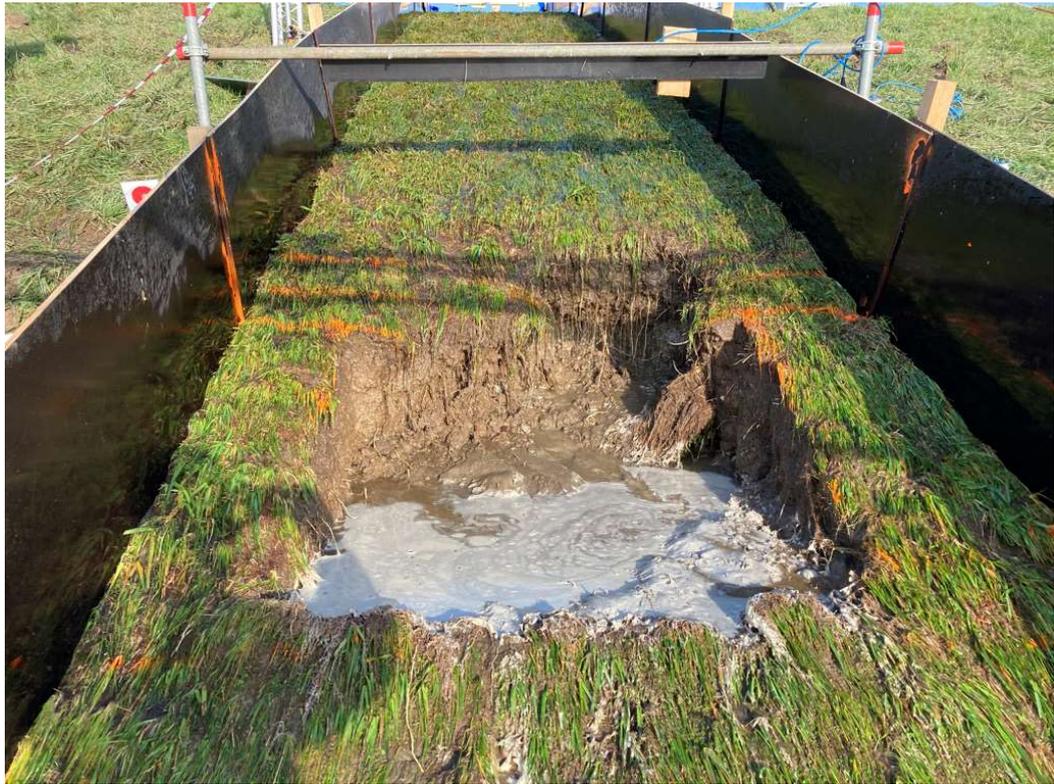
It was expected that damage would increase rapidly so runs of 15 minutes were decided upon with continuous presence of the experiment team executing visual inspections continuously. After the first 15 minutes erosion increased significantly. A second run was started planned for 10 minutes, again with prudent and in combination with on spot visual inspection. After 6:30 minutes the color of the water suddenly changed from white to brownish and the pumps were stopped immediately (around 7:00 minutes effectively). Damage increased very significantly in these few minutes and the experiment was stopped.

Figure 17 - Increasing damage to the top of the excavated cliff. Sand eroded from underneath the top layer causing this layer to crack and be flushed away.

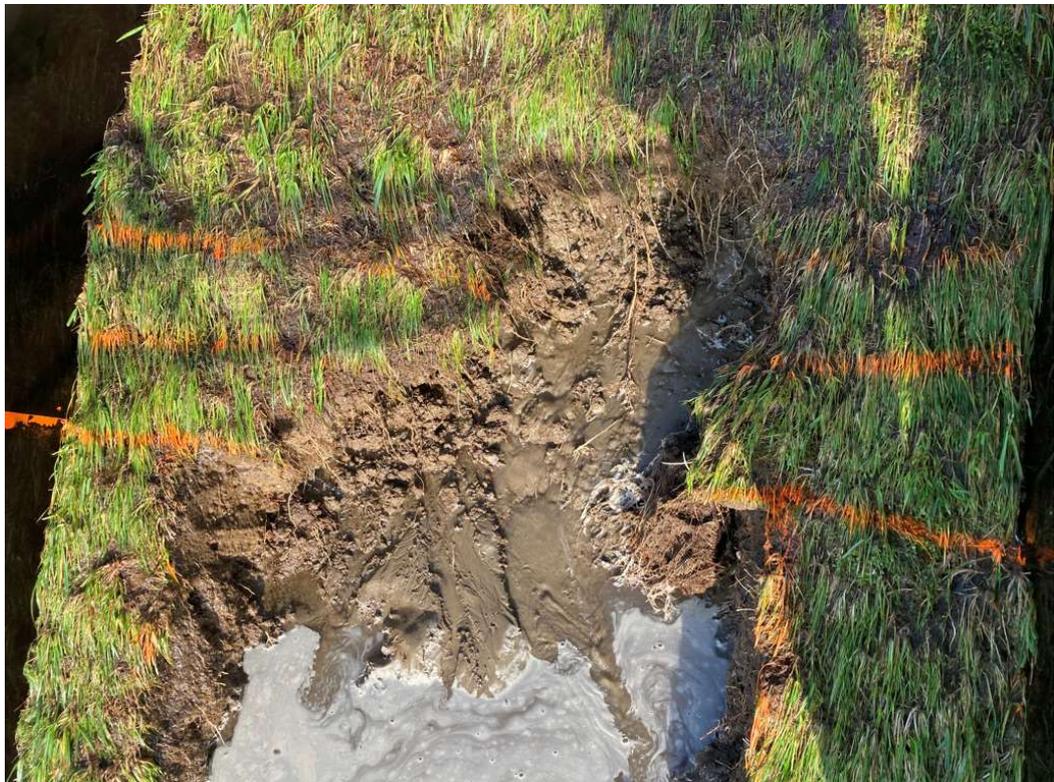
Figure 18 - Close up from the damage on the top side of the excavated cliff.

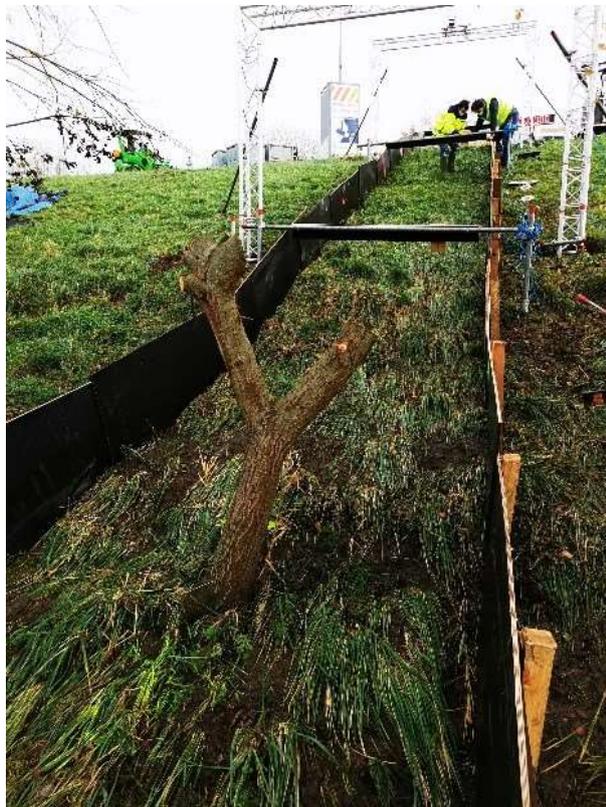
The test section is 2 m wide, sided by wooden boarding. On the upper part of the slope, there are no visible anomalies. Close to the toe, a small 'cliff-like structure' is present, which is believed to be due to grazing and sleeping sheep here. It is a damaged spot on the lower part of the slope. Near the toe, a small tree is present in the middle of the section.

Figure 28 - Tree at the toe of the levee.

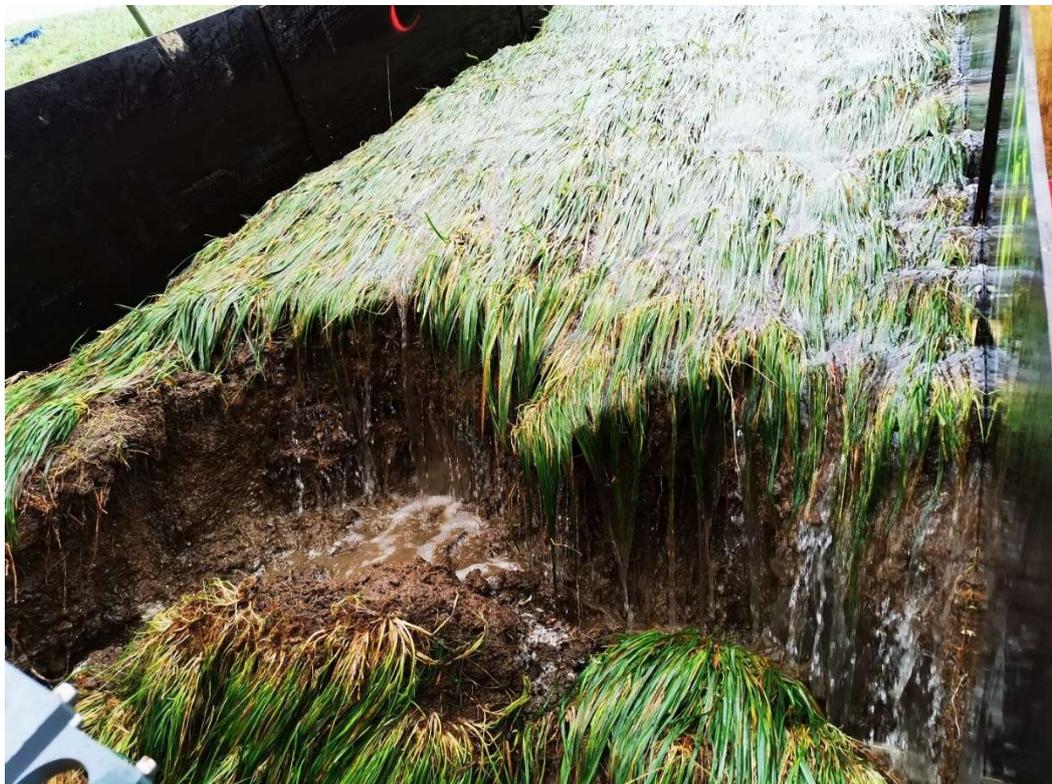
At 11:58, the test resumed for the last time, until 12:05. The total pumping time was only 67 minutes before final damage. The field hypothesis was that sand eroded from under the cover layer (i.e. sand from the levee core is transported, even partially outside the test section) created a mass deficit and destabilized the cover layer (undermining), leading to failure (sudden collapse).

Figure 31 - Initial cover layer collapse.

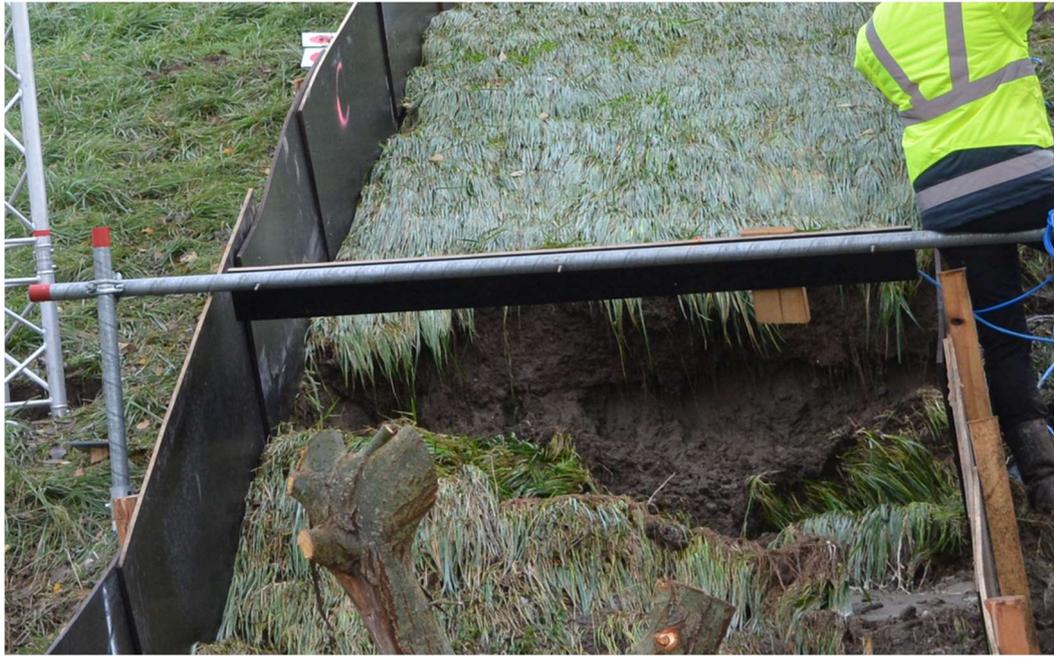
After the initial collapse, it was observed how the sand core under the cover layer had a fluidized aspect, mobilized and led to a further collapse of the cover layer. After the sand core was sufficiently drained, this collapse process stopped. In this manner, the cliff wall travelled back- and upwards for about 2 meters after the initial collapse.

Figure 32 - View on the undercut cover layer.

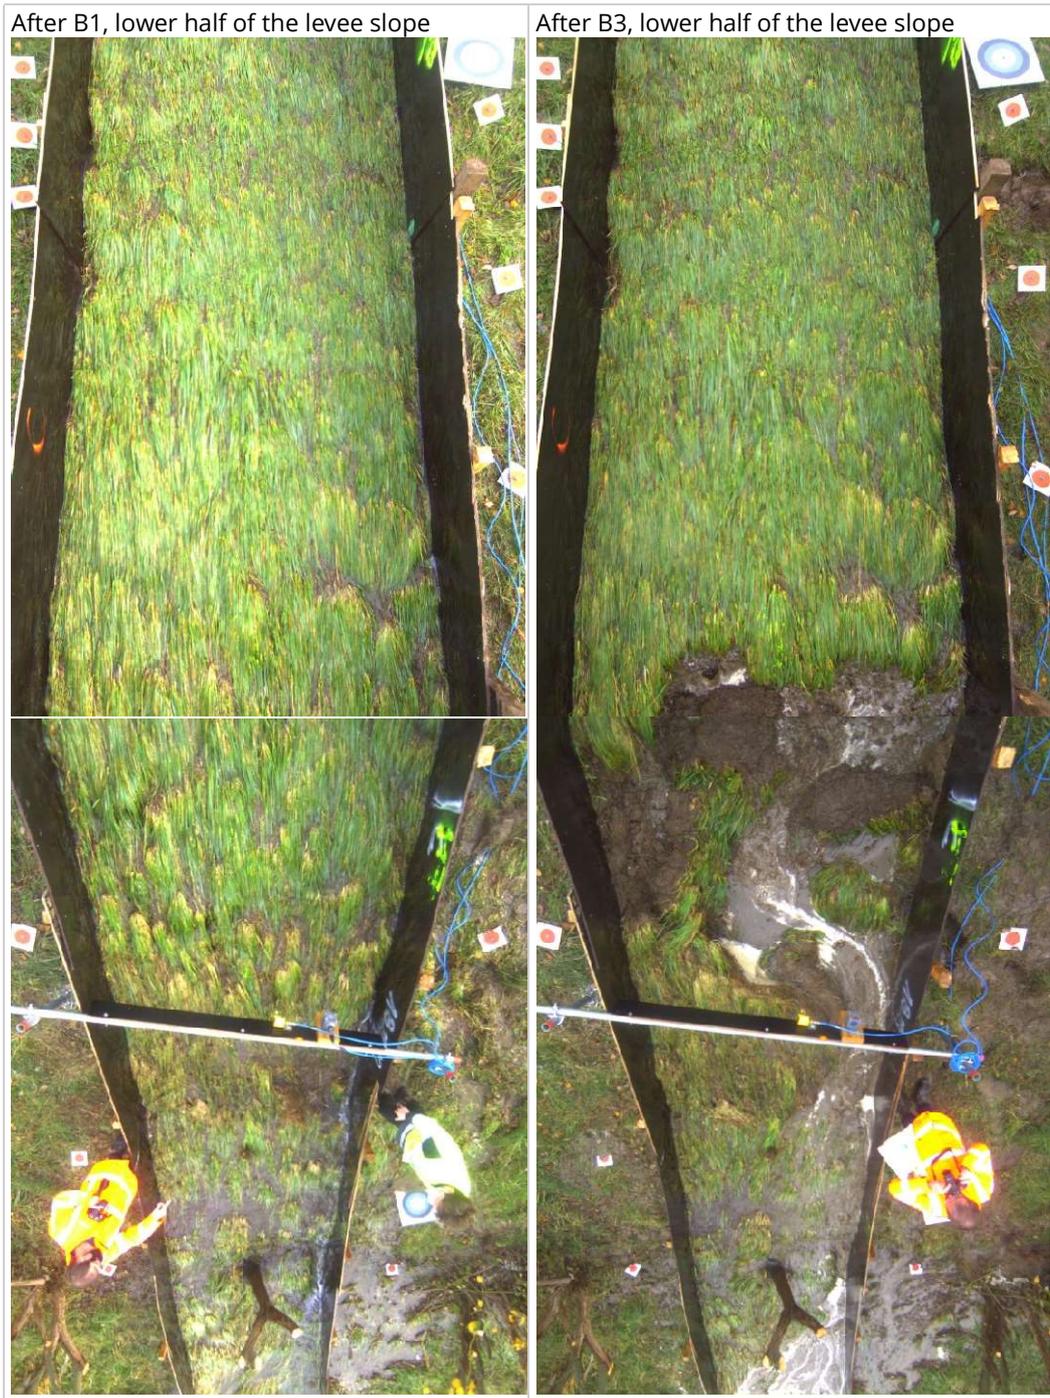
Figure 33 -Levee state near the toe before (left) and after (right) collapse of the levee cover layer. The upper part of the images is lookup upwards towards the crest of the levee, and the lower part is looking towards the toe (with the tree in view).

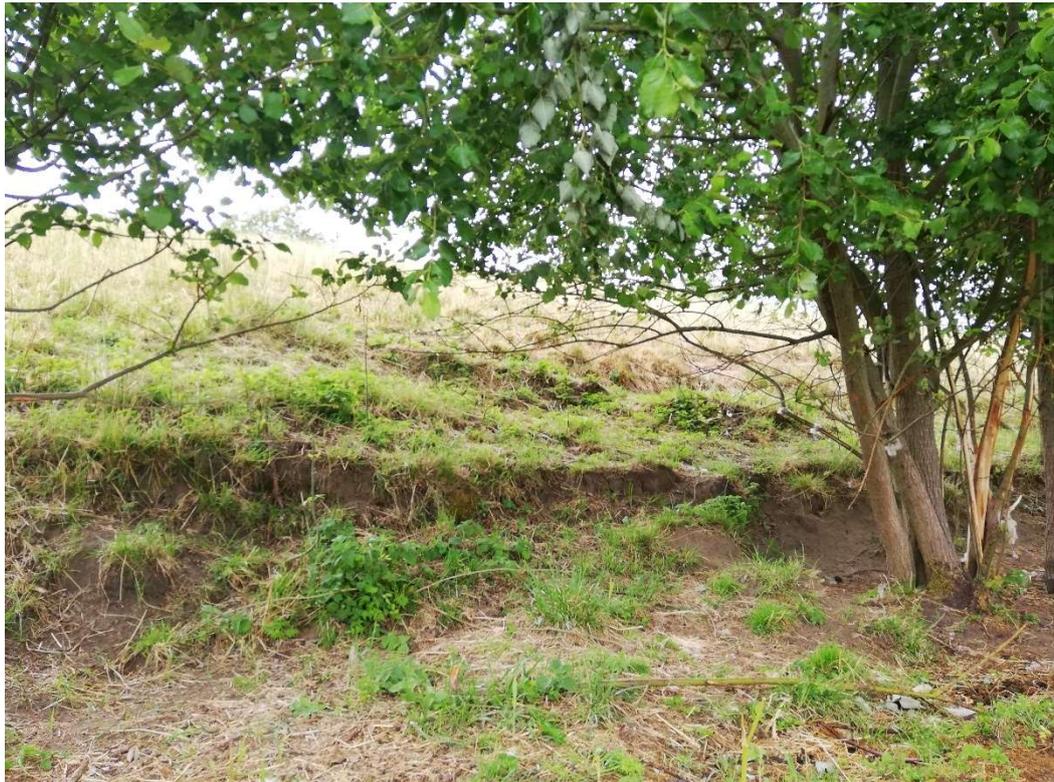
The levee slope is characterized by a local, steep cliff of more than 1 meter high near the levee toe (Figure 39). This cliff probably originates from grazing and sleeping of animals (sheep).

Figure 39 - Slope damage at the toe transition due to cattle activity in an area with trees.

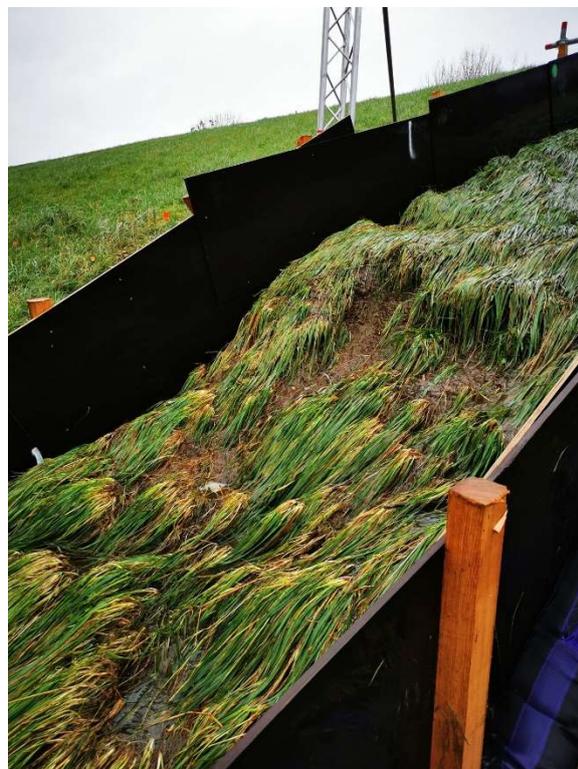
Figure 40 - Slope damage in the test section.

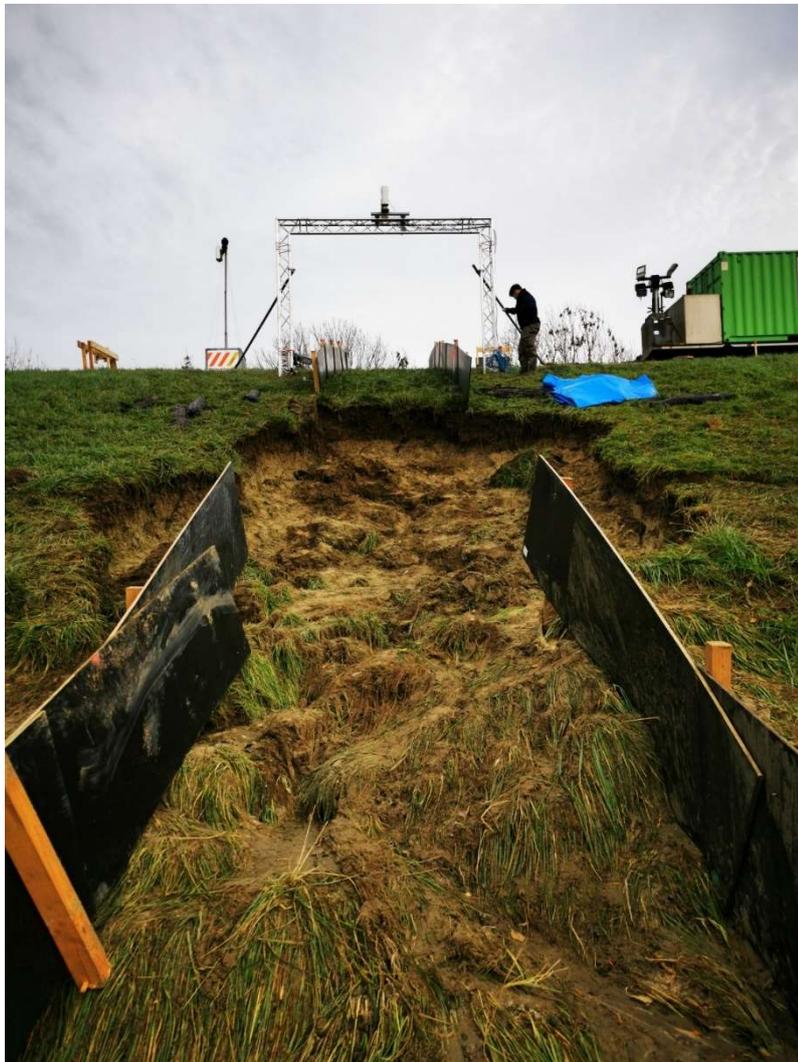
Figure 41 - End state of the B-05 test during cleanup.

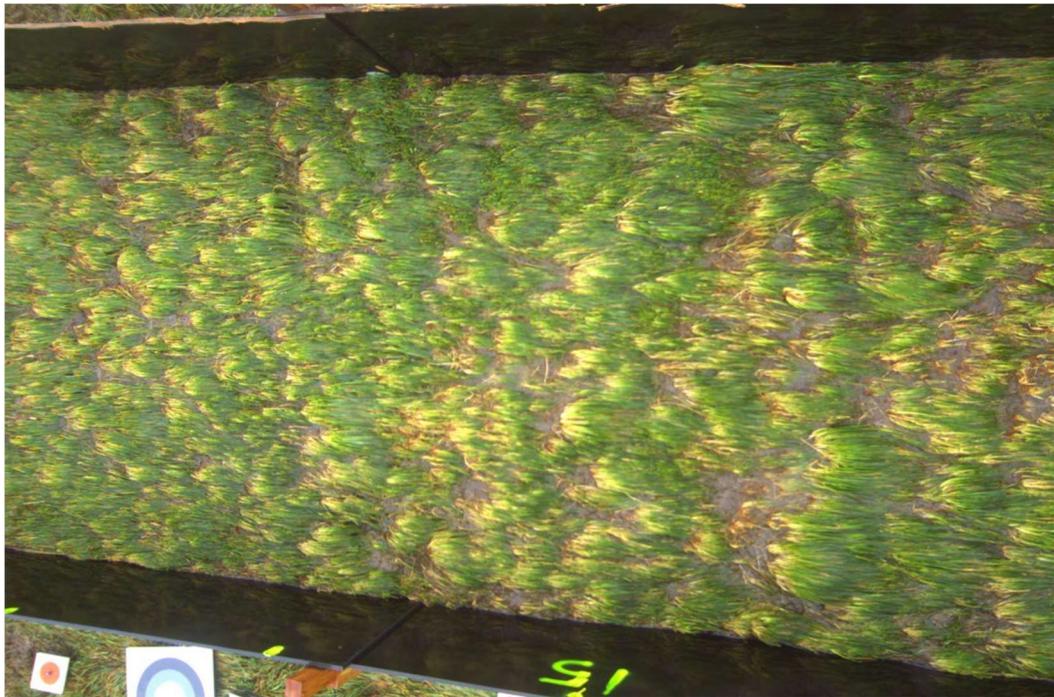
Figure 58 - Vegetation state after 22 hours of overflow on B-OF08.

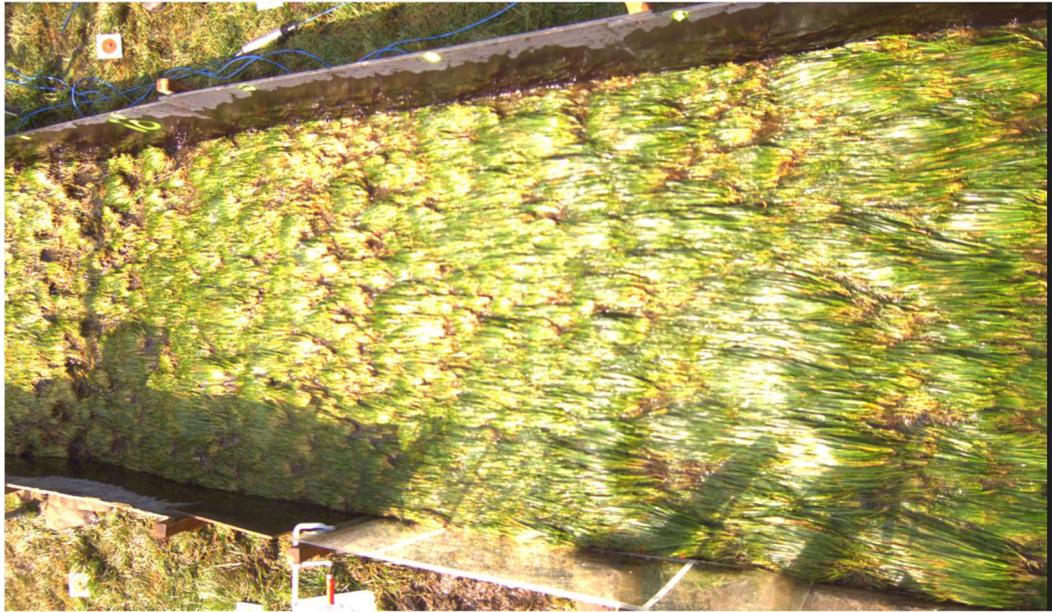
Figure 59 - Vegetation state on the lower slope and at the toe transition after 22 hours of overflow.

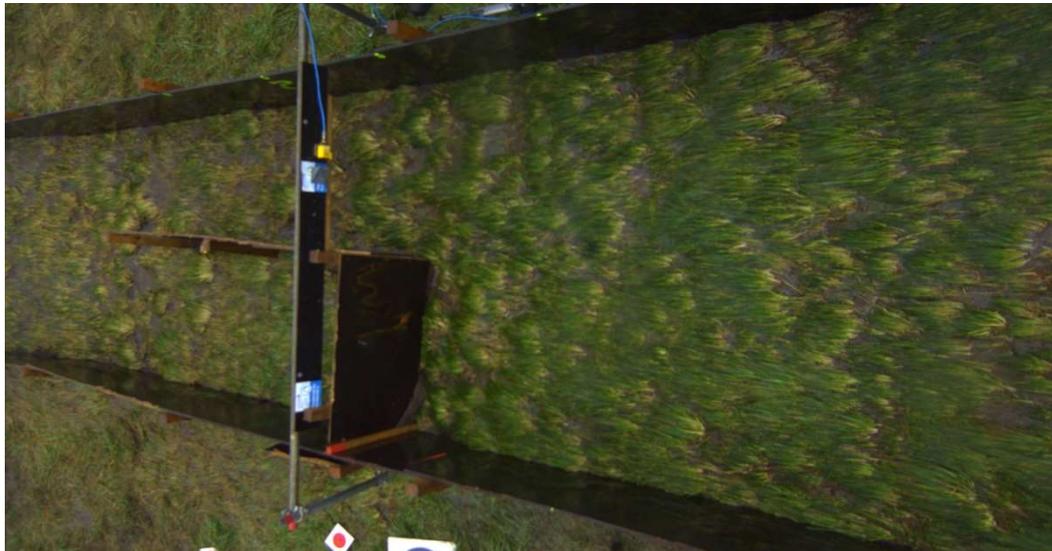
Figure 60 - End state of the obstructed area near the toe, after 24 hours of overflow.

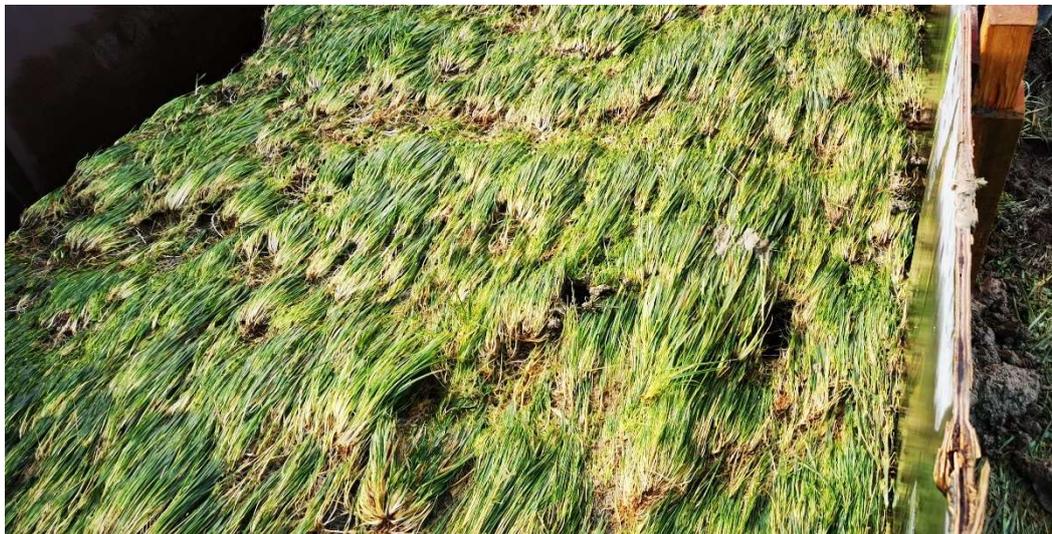
Figure 65 - View of the state of the levee cover after 13 hours of overflow at  $700 \text{ l.s}^{-1}$ .

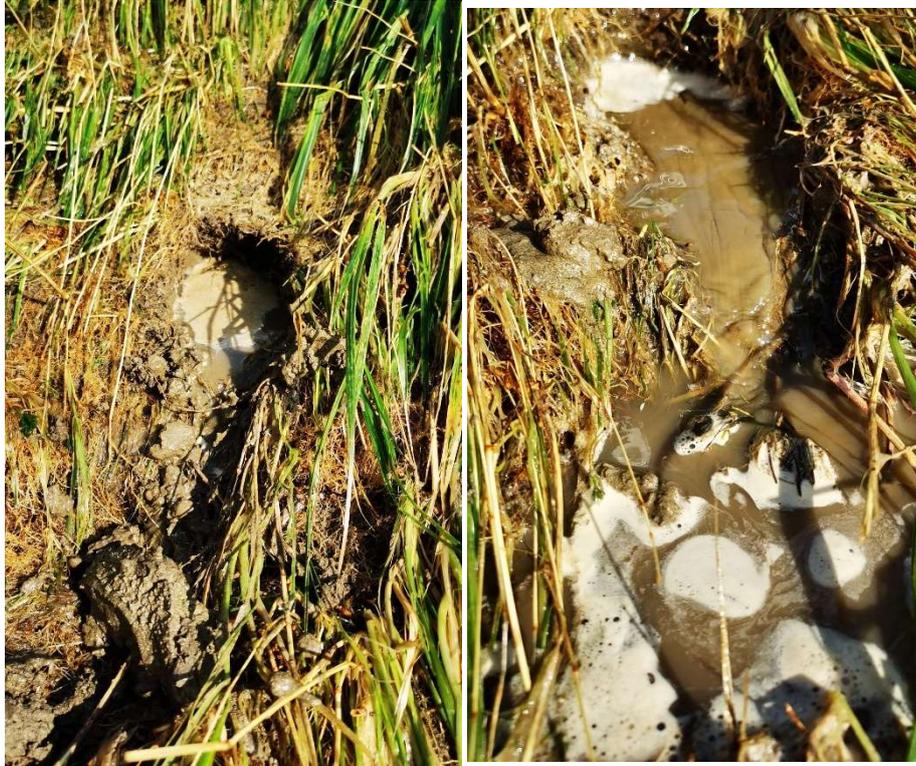
Figure 66 - Drillhole at the toe (left: initial state, block B10; right; modest outflow of water and some sediment at the end of an overflow block, block 11).

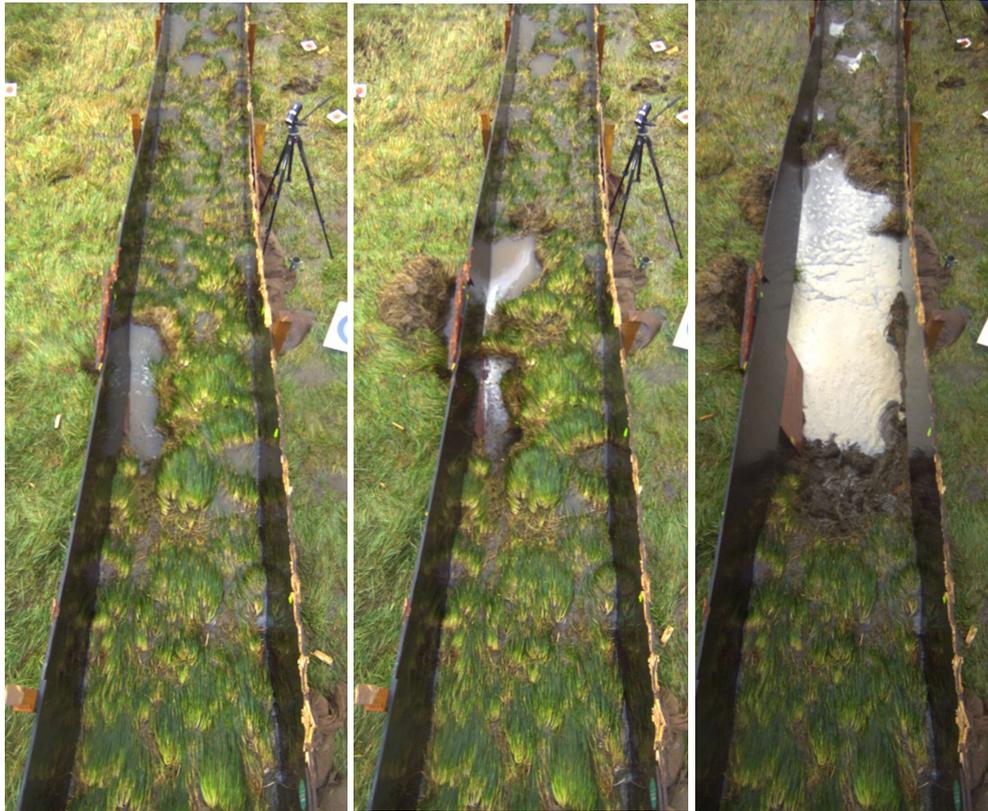
Figure 73 - Damage evolution during the last minutes of test B-OF10 (after block B08, B09 and B10). (looking downward)

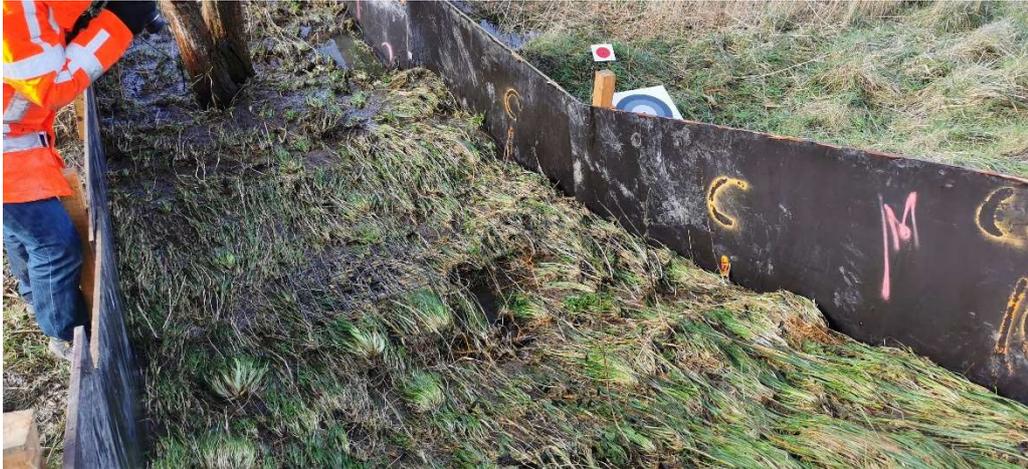
Figure 79 - Levee toe area after 2 hours of overflow.

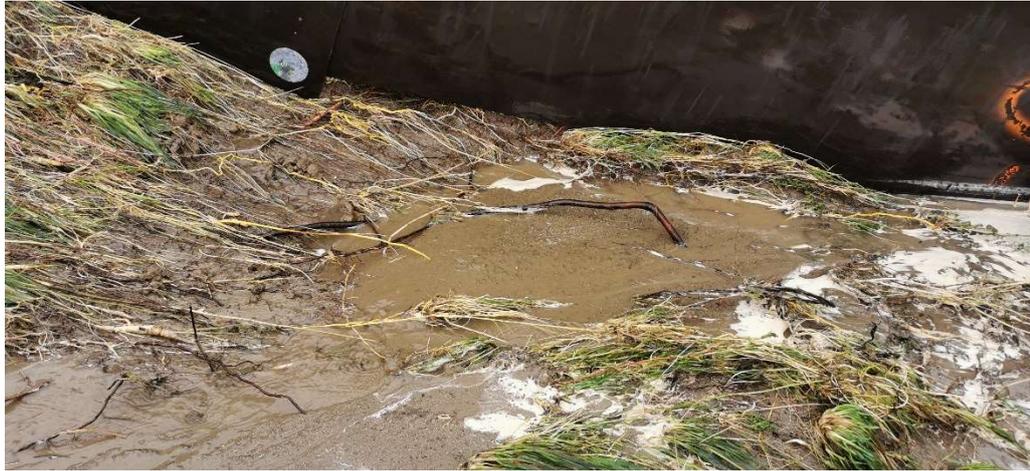
Figure 81 - Sand patch at the toe area, moments before the collapse of the levee.

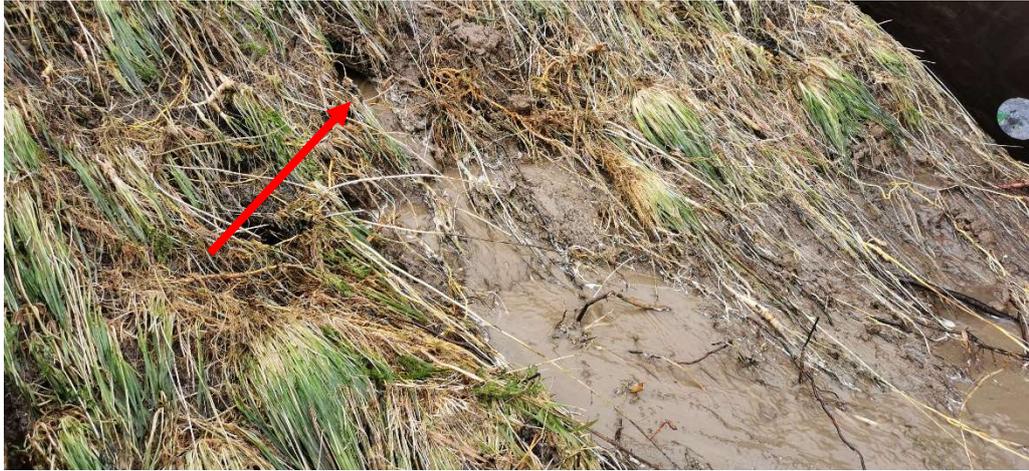
Figure 82 - presumed exit point of the sand, at the levee slope base (red arrow).

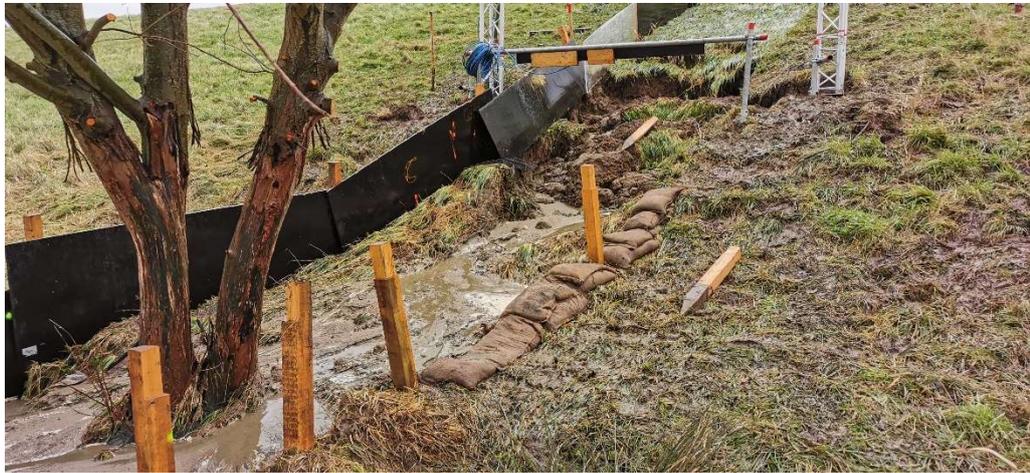
Figure 83 - Aftermath of the slope failure, with standing tree.

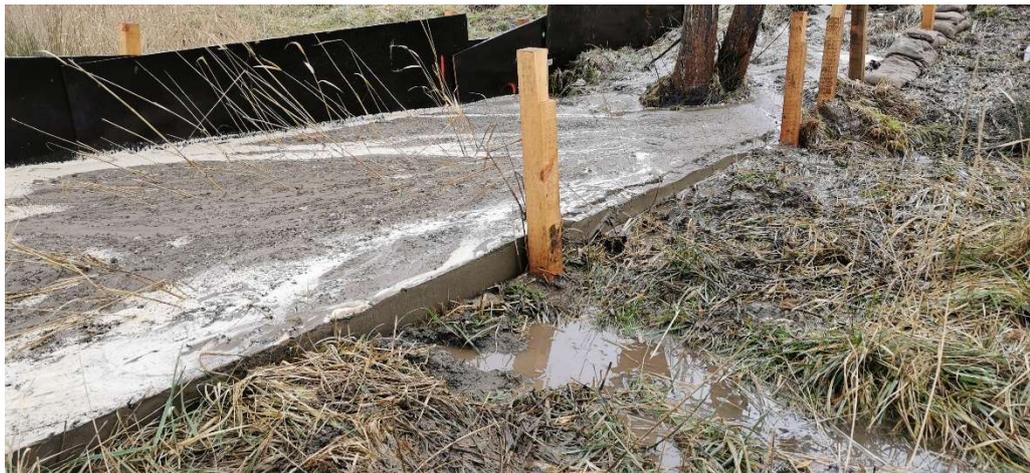
Figure 84 - Sand layer (up to 10 cm high) downstream the levee slope after the failure and after removal of the side boarding.

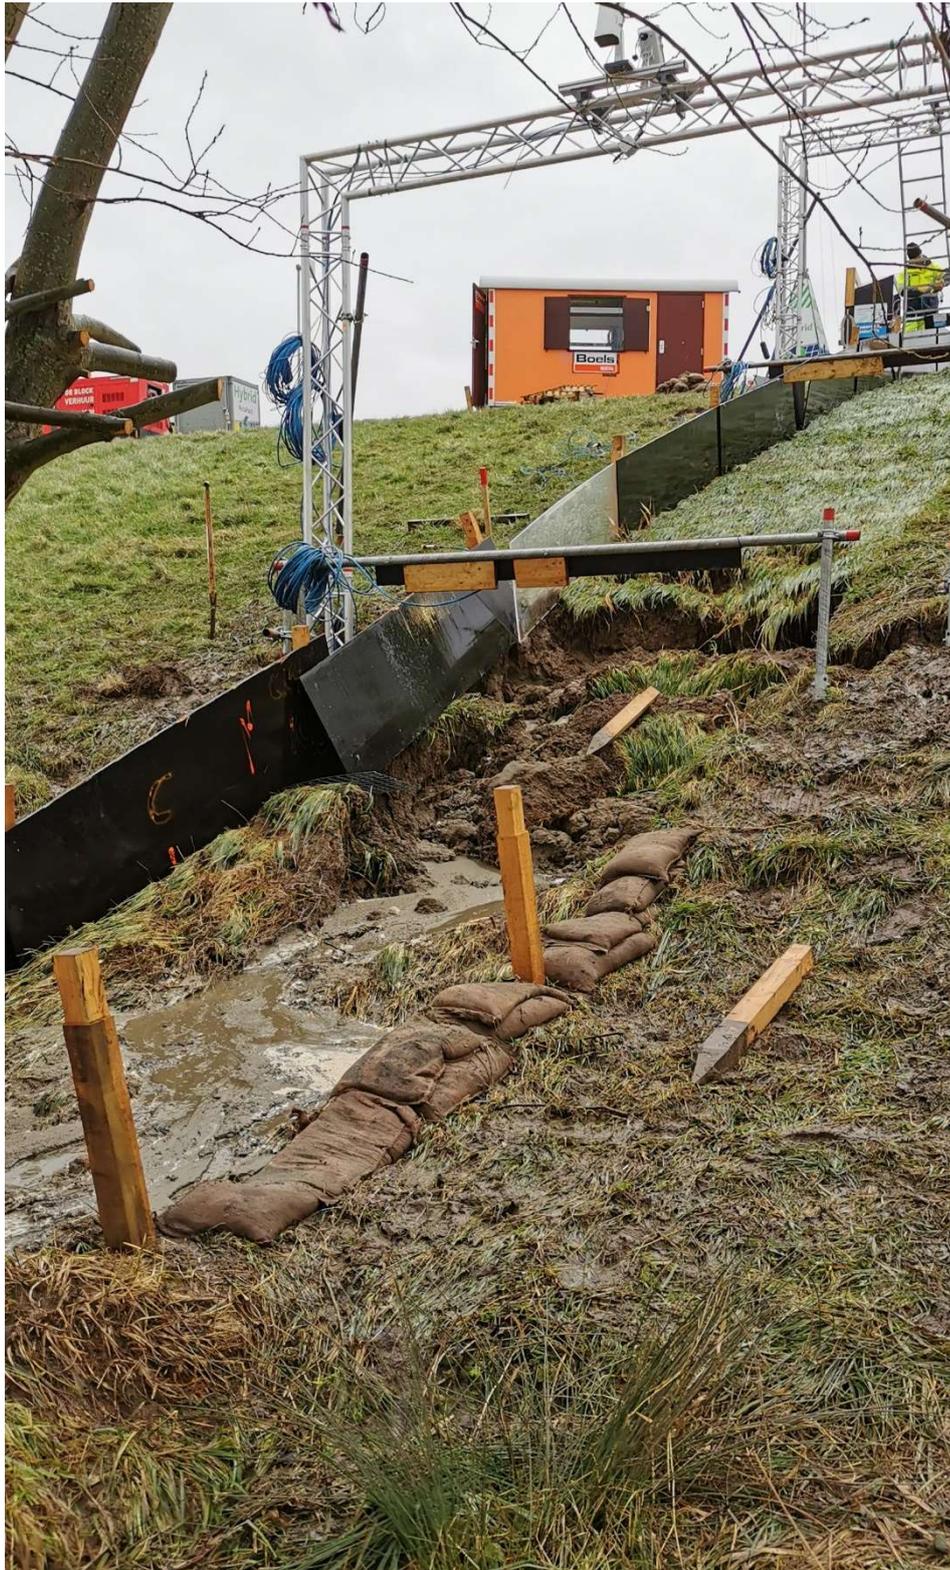
Figure 85 - Aftermath of the slope failure.

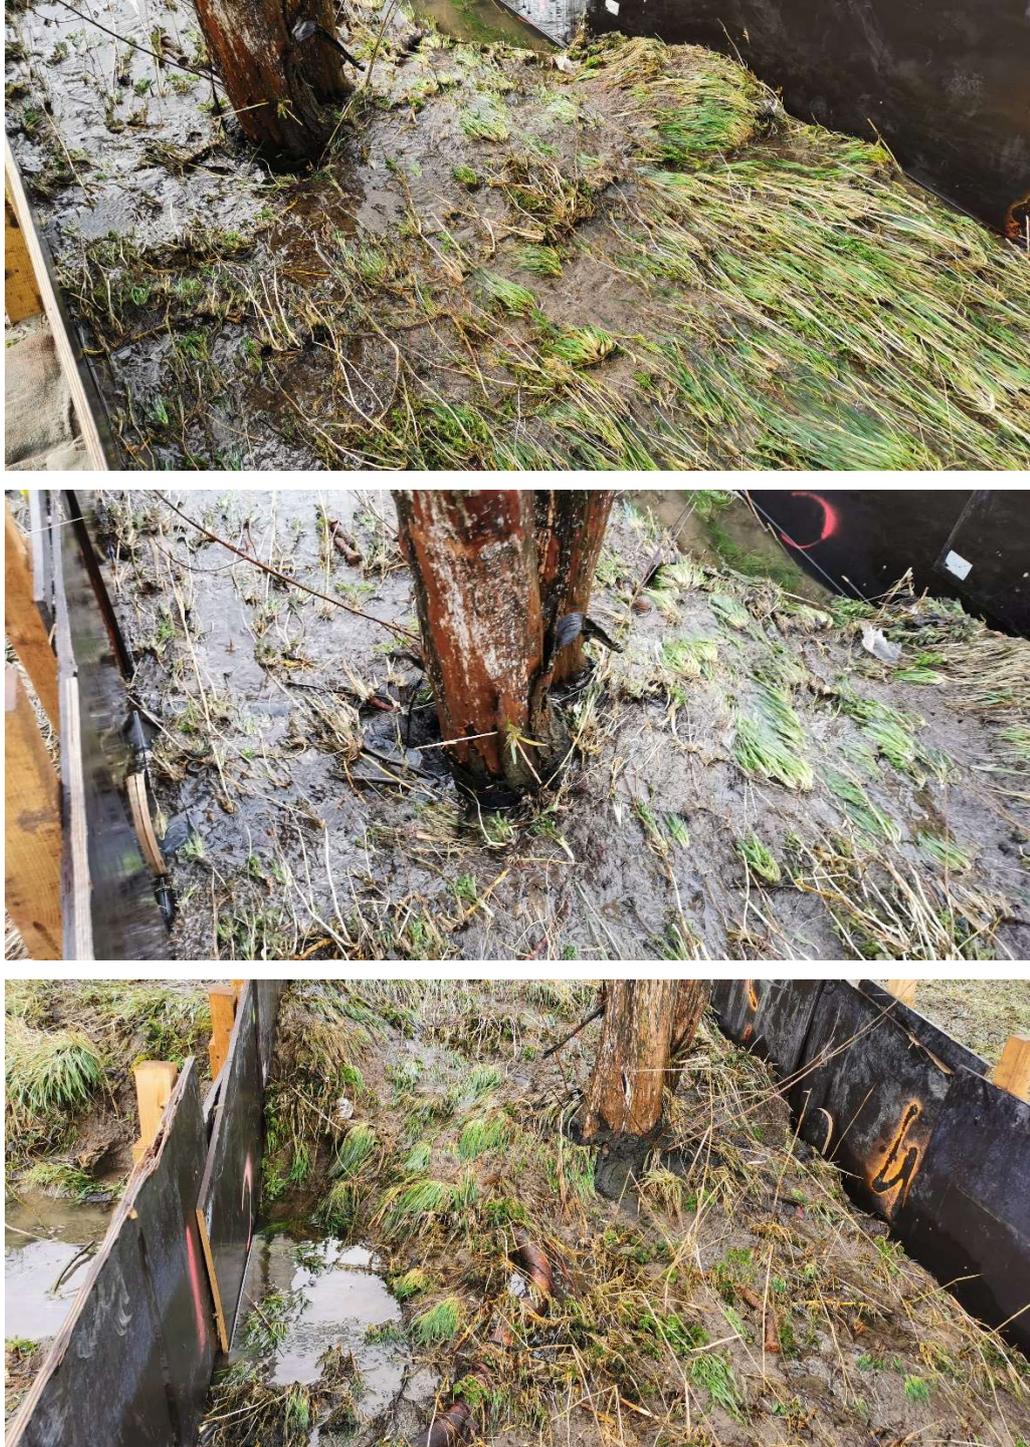
Figure 86 - Soil erosion around the tree, after 0.5, 1 and 1.5 days.
