# Management of harmful animal activities on levees: Fact finding fieldwork in the Living Lab Hedwige-Prosperpolder

Adaptation  
to climate  
change

Vana Tsimopoulou, André Koelewijn

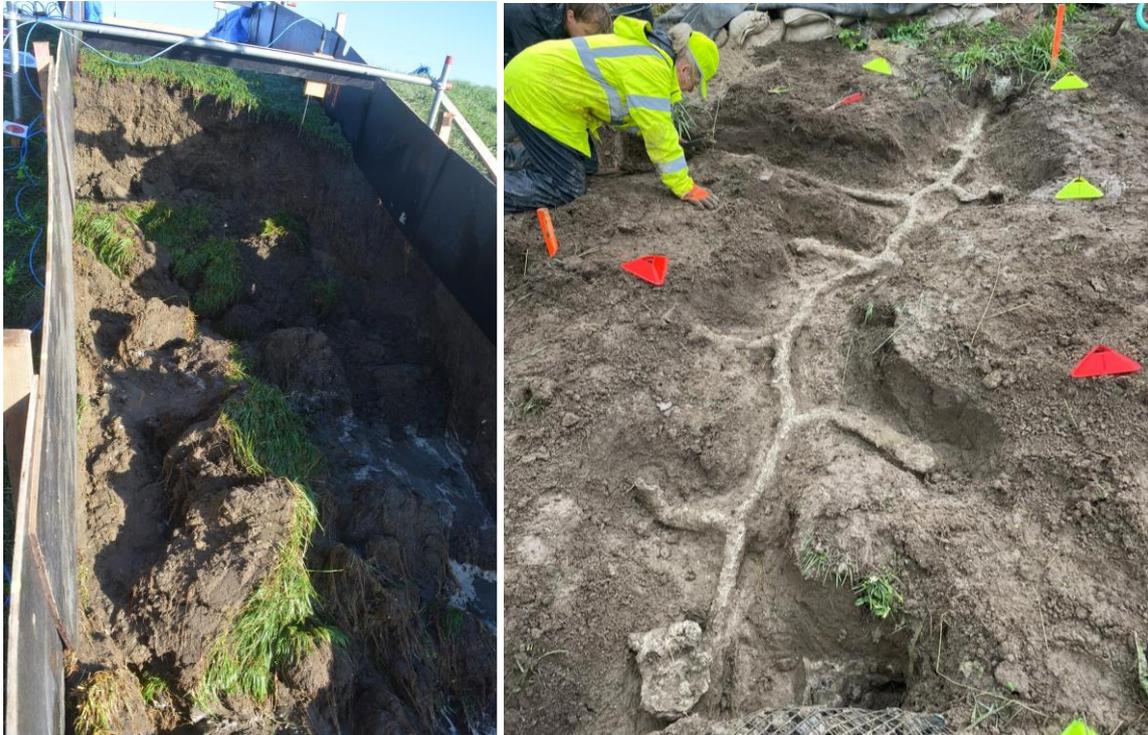
Figure 1.2. a) Foxhole on the Hedwige levee after overflow testing on 23 November 2020. Test conditions: discharge of 180 litres per second in a 2-metre-wide section for 1 hour and 13 minutes (Source: Koelewijn et al. 2020). b) Excavation of tunnel system created by mole activity, after filling it with fast hardening concrete (Source: Holscher & Zomer, 2021).

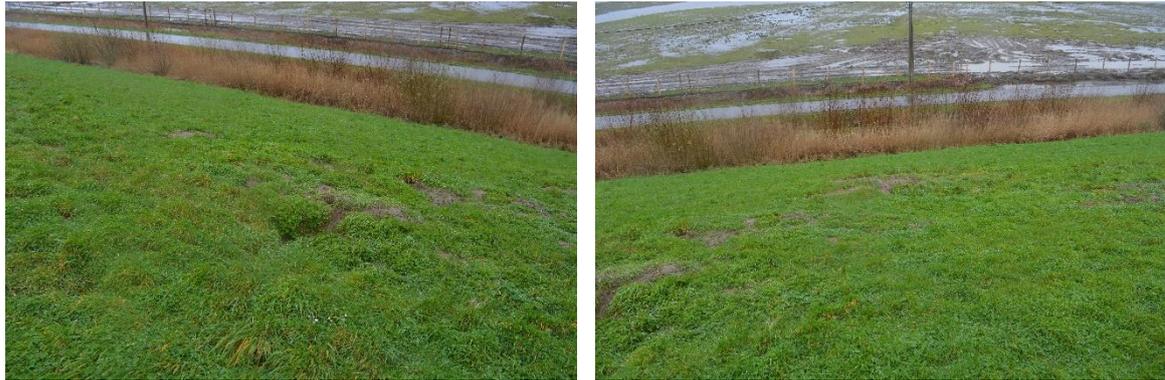
The levee along the Scheldt River continues beyond the Prosperpolder in South-East direction along the Doelpolder. In March 2020, many bare spots, some of them with animal burrows, were seen on this levee. In total, around 20 burrows of size that could be ascribed to rabbits or foxes were found, mostly on the landside slope of the levee, but some also on the waterside slope. These burrows appeared to be clustered in about five to seven groups (the number depending on the limits of some clusters). Examples are shown in Figure 2.5.

Figure 2.5. Various bare spots, some with animal burrows, on the landside slope of the levee along the Doelpolder (March 11, 2020).

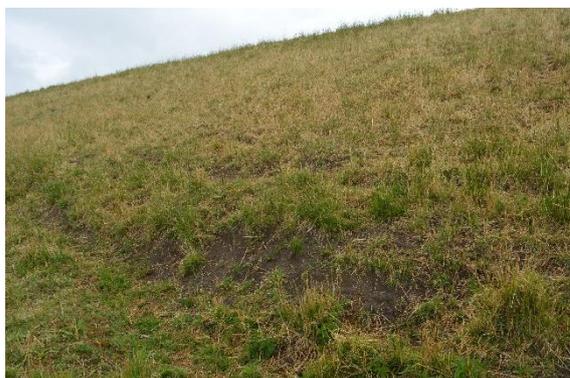
Figure 2.7. Bare spots in the grass cover caused by resting sheep at a steep part of the landside slope of the levee along the Prosperpolder (June 8, 2020).

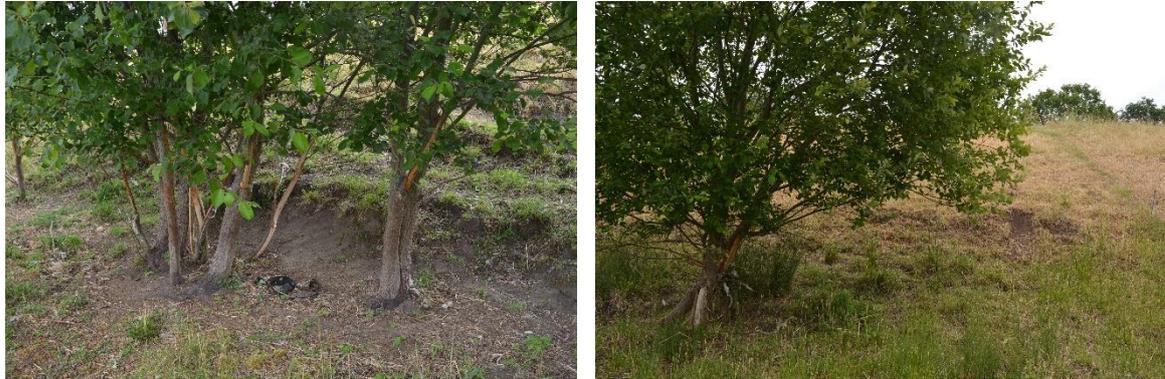
Figure 2.8. Trees and bare spots in the grass cover caused by resting sheep at steep parts of the landside slope of the levee along the Prosperpolder (June 8, 2020).

One of the locations with a 'cliff' was tested in an overflow test (Depreiter et al. 2022b). At two locations with a tree, such tests were also carried out, and failure occurred from the mole burrows present around the trees (Depreiter et al. 2022b).

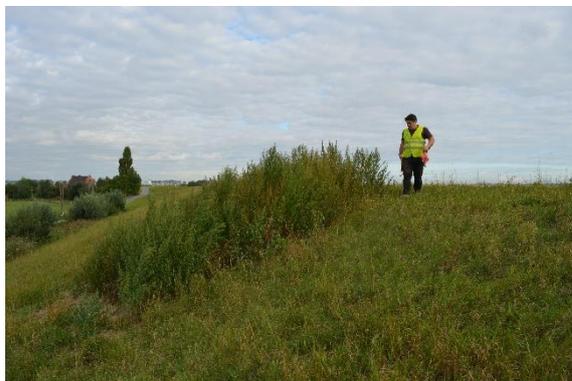
Figure 2.9. High vegetation on clay heap on top of an earlier animal burrow (landside slope along the Doelpolder, September 1, 2020).

Figure 2.10. Entrances to animal burrows in the clay heap of Figure 2.9.

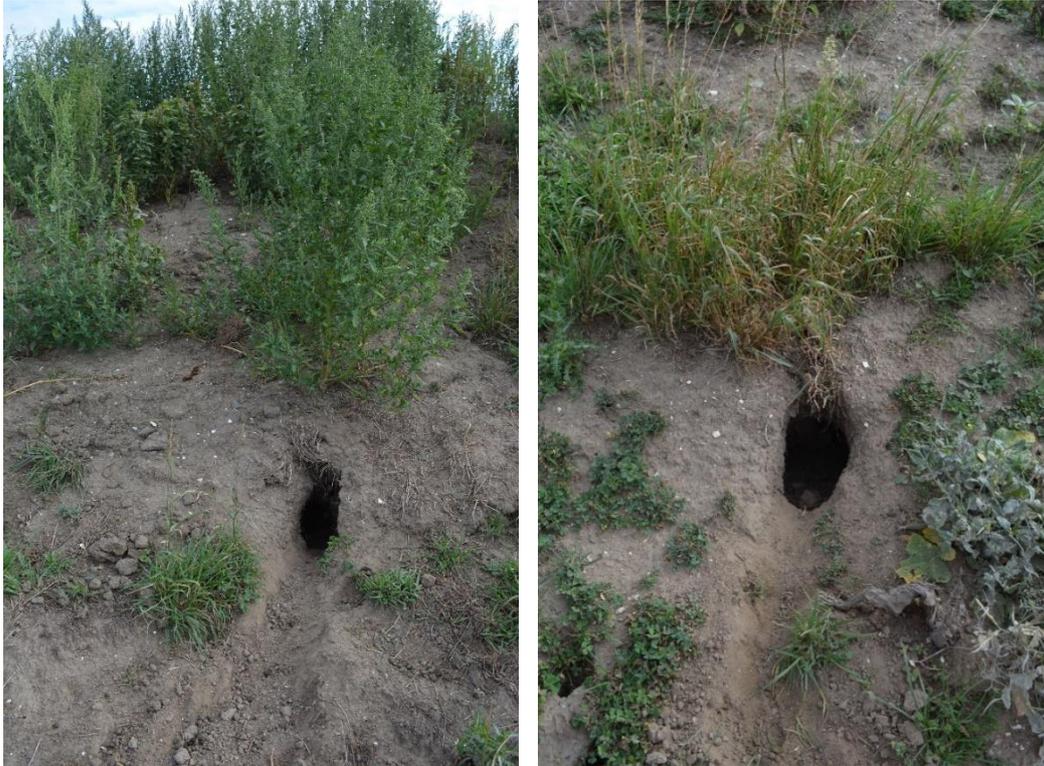
Figure 2.11. Larger animal burrows on the landslide slope of the Scheldt levee along the Doelpolder.

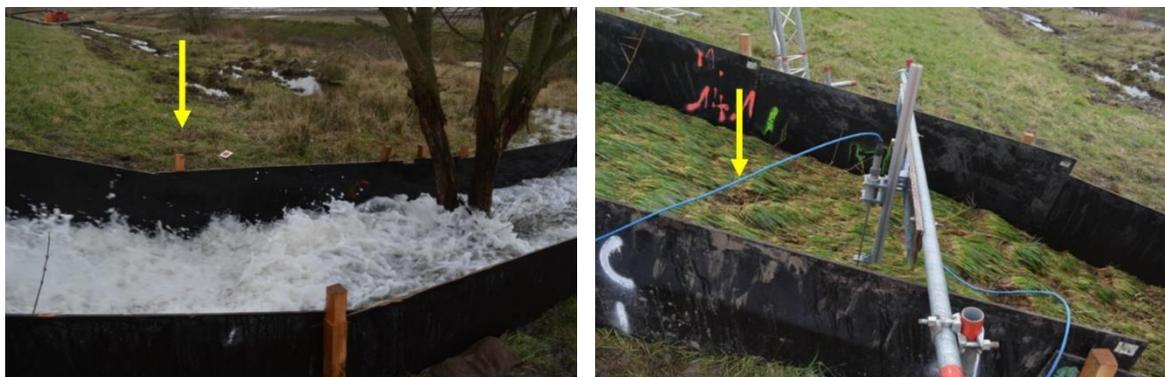
Yet, after the first two hours of continuous flow, a burrow, presumably from a mole, was found quite close to the tree inside the 2 metre wide flume. During the next six hours of flow, some additional erosion occurred here. The introduction to failure did not become visible before 10 hours of flow, with some leakage at several metres away from the flume, see Figure 2.14 (left). Two hours of flow later, the first subsidence in the flume occurred (Figure 2.14, right). An hour of flow later, more sand was visible on the surface (Figure 2.15) and more subsidence occurred inside the flume, with a newly formed exit point inside the flume (Figure 2.16, left). Only two minutes of flow later, failure through the reactivated burrow occurred. The artificial burrows created after 12 hours of flow to speed up the process did not seem to have any significant influence on the failure. In fact, the part containing the artificial burrows failed last (Figure 2.16, right). A more extensive narrative is given by Koelewijn (2021).

Figure 2.14. Left: flow at a reactivated burrow outside the flume, right: depression inside the flume.

Figure 2.15. Sand deposits at reactivated burrow exit outside the flume.

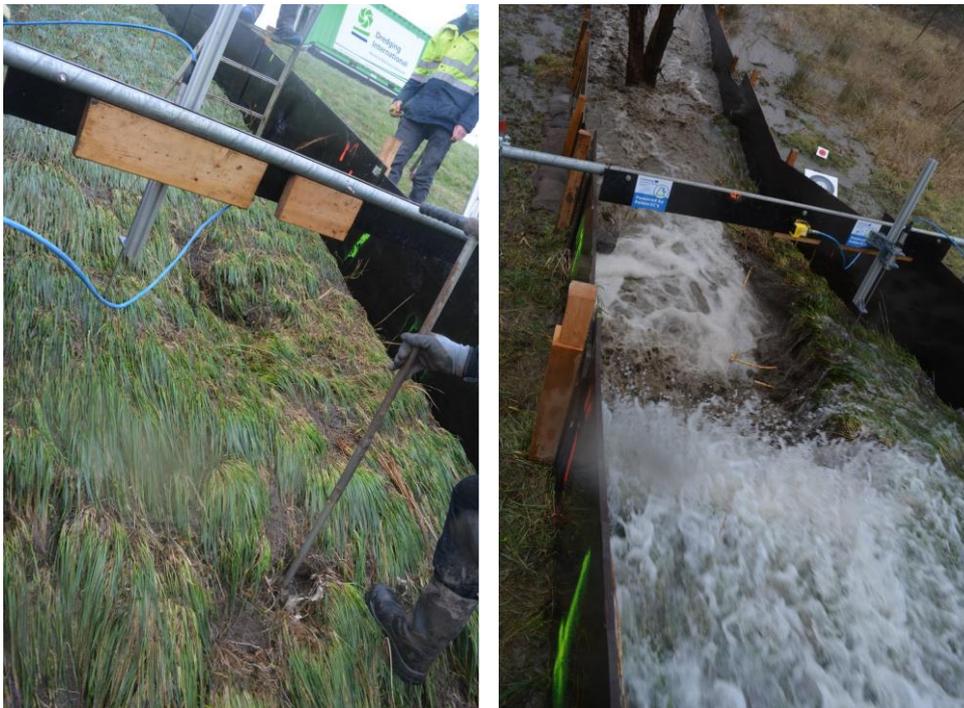
Figure 2.16. Left: subsidence at reactivated burrow (upper), newly formed exit point (lower), right: flume during failure.

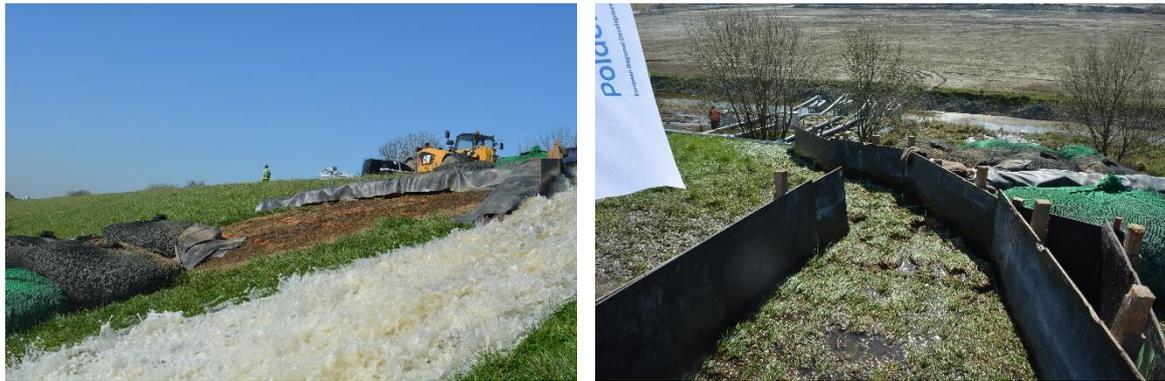
At the end of March 2021, investigations were carried out at the Prosperpolder both to test various configurations of sand bags to withstand water (on the crest of the levee) and to test the resistance to erosion of rock bags placed on the levee after a previous failure of the cover layer during an overflow test. An overview of the test location, with the sand bags visible on the right and the rock bags visible on the left, is shown in Figure 2.17, left. From a hole in the grass cover, caused by a wooden peg driven through the cover layer at the time of the overflow test, connection was made to a mole burrow system that led down the slope, underneath the grass cover. At the intersection with the rock bogs, significant erosion of the sand core occurred, even at rather low flow rates, because of the lack of a proper filter between the sand core and the rock bags. During the new tests, parts of the mole burrow system collapsed, as visible in Figure 2.17, right.

Figure 2.17. Left: Overview of the test in progress, right: openings in the grass cover of the original flume upstream of the rock bags.

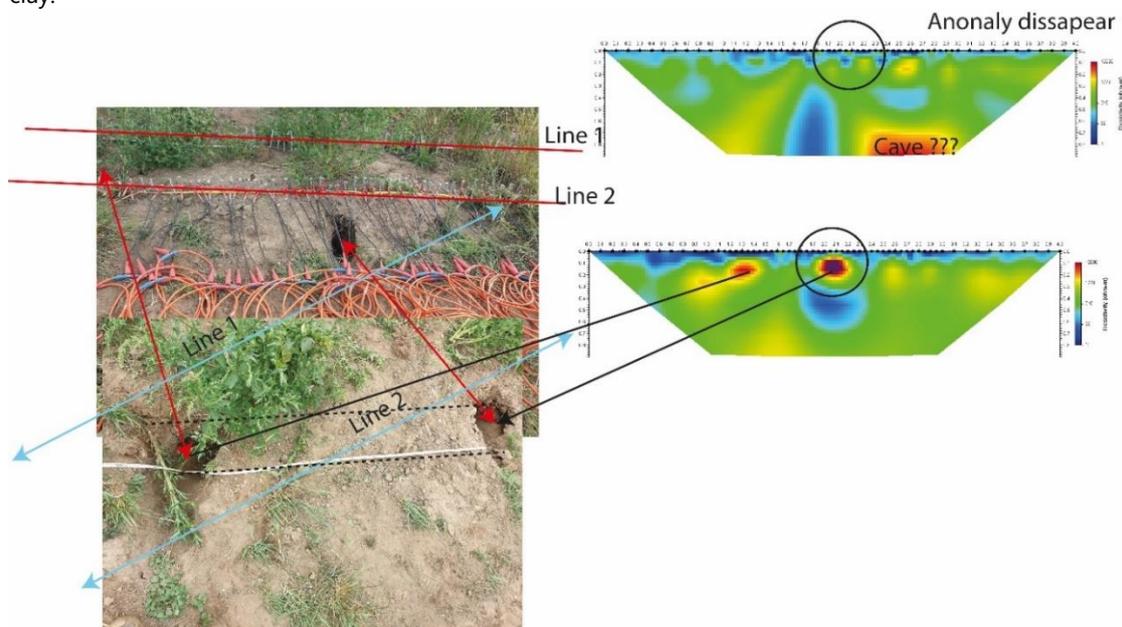
Figure 2.22. Doelpolder, interpretation of the high resistivity zones with respect to the locations of the animal burrows (note that on the left, two pictures taken from different angles are shown).

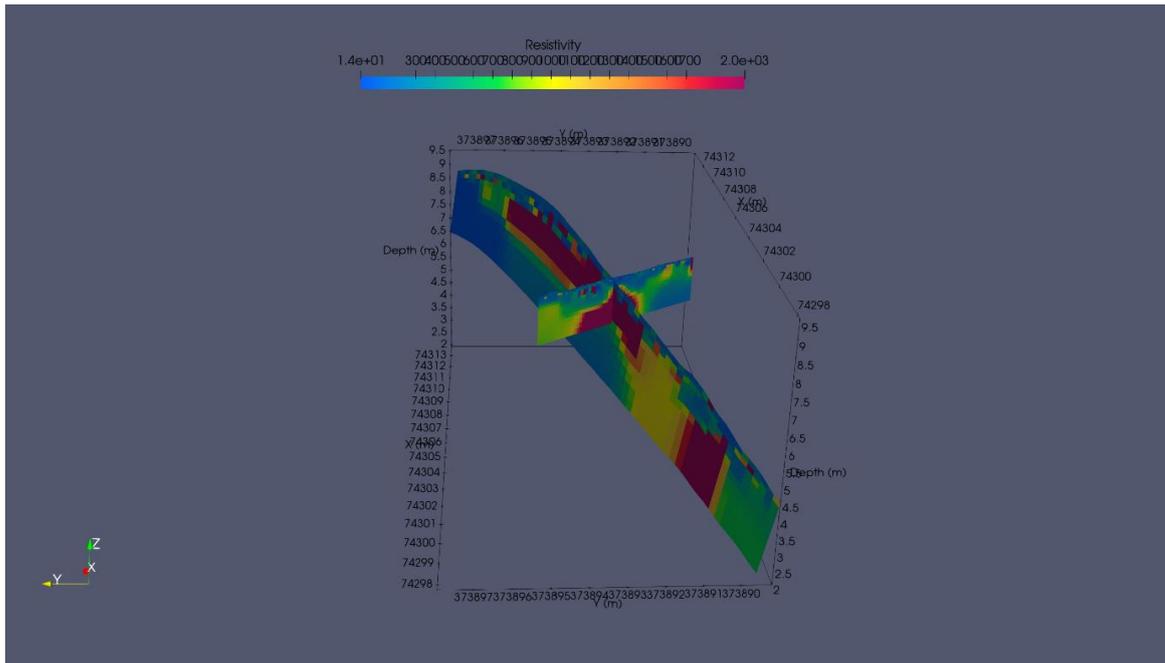
Figure 2.25 shows a 3D representation of the results. The crest of the levee (here without an asphalt layer) is near the upper left corner. In red are the high resistivity zones, suggesting multiple burrows in this area; towards the crest, rather close to the surface. This was confirmed in the destructive overflow test N-OF05 (Depreiter et al., 2022a). The final data RMS error is 3.7% for the perpendicular line and 8.5% for the parallel line. In more common words: the accuracy of the result found across the levee was much higher than the accuracy of the result found along the levee. The reason for this difference is unknown. Yet, for both lines the accuracy is within the specialists' acceptance limits.

Figure 2.25. Hedwige polder, 3D representation of the results.

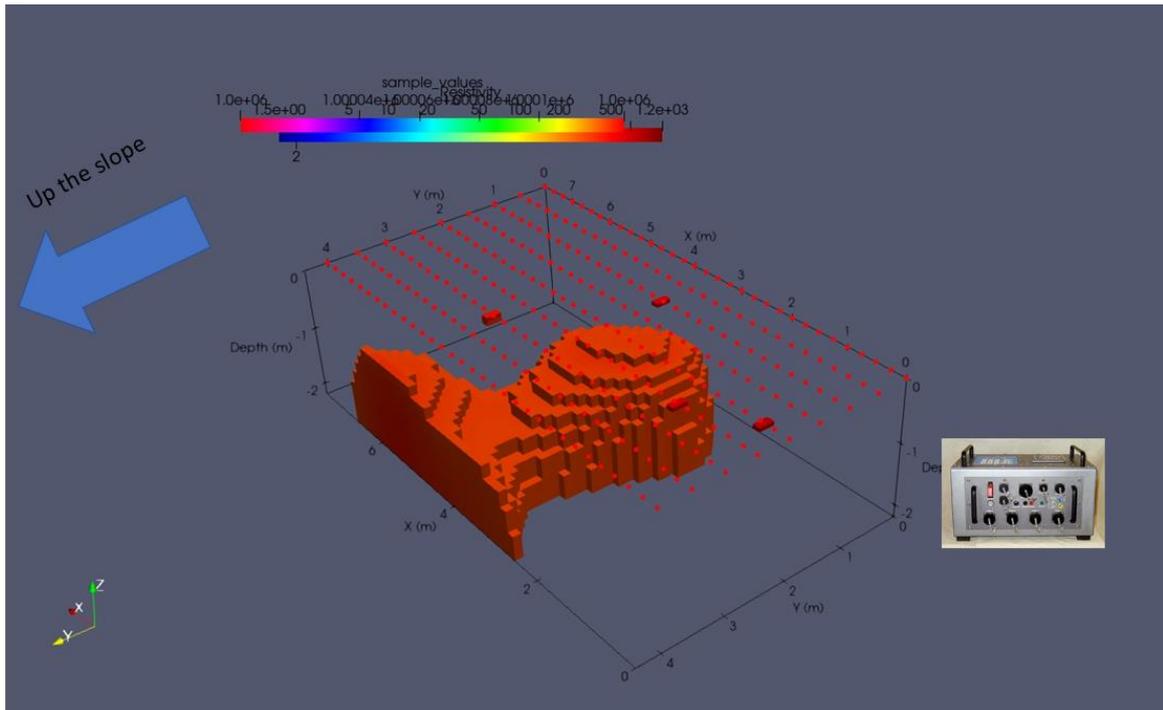
Some of the results are shown in Figure 2.28 and Figure 2.29. In the last figure, the subsurface animal burrow is clearly visible in the results.

Figure 2.29 Iso-volume of the high-resistivity zone (the animal burrow location).

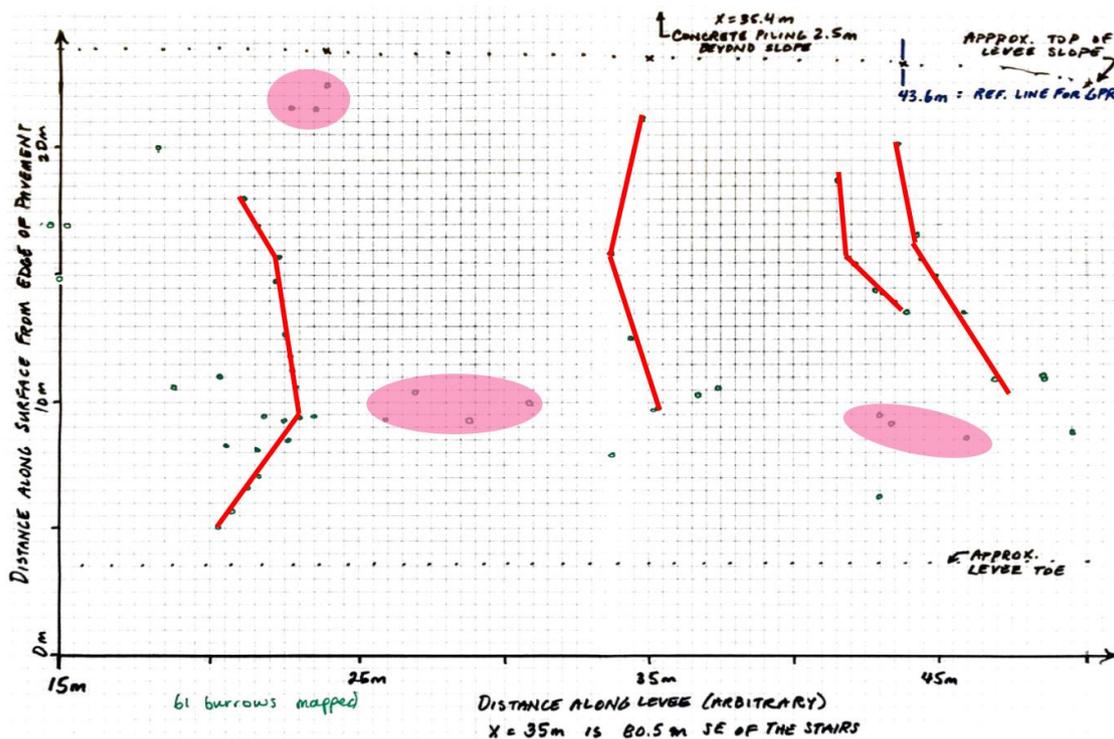
Figure 4.48. Burrows in stretch 1 with linear patterns highlighted (in red) and other clusters encircled (in pink).

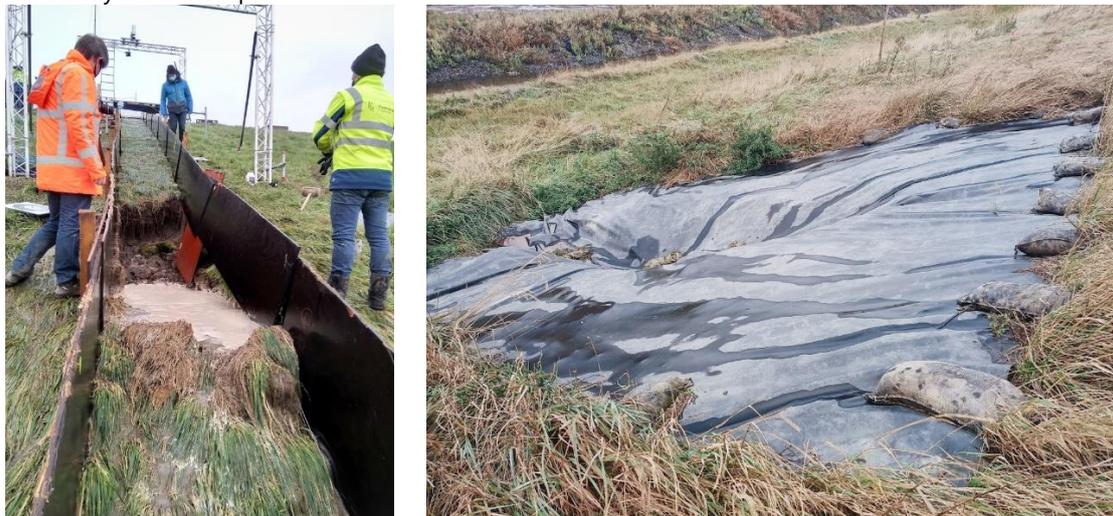
Figure 5.55. Left: Damage at the last levee section that was tested against overflow in March 2021. Right: EPDM protection covering the same damage, photographed in September 2021.

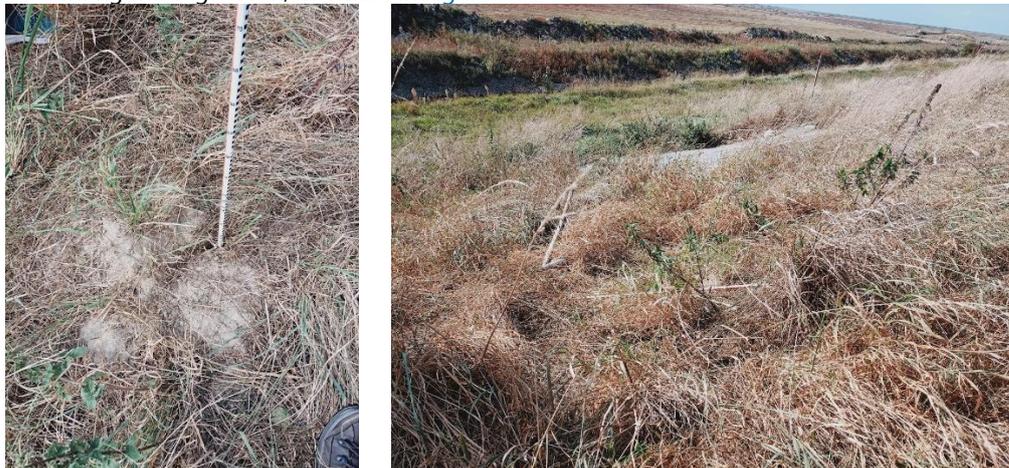
Figure 5.63. Left: Animal burrow with sand spread in the unmowed part of the levee slope; Right: Impression of vegetation surrounding the burrow. In the background the EPDM cover can be seen.

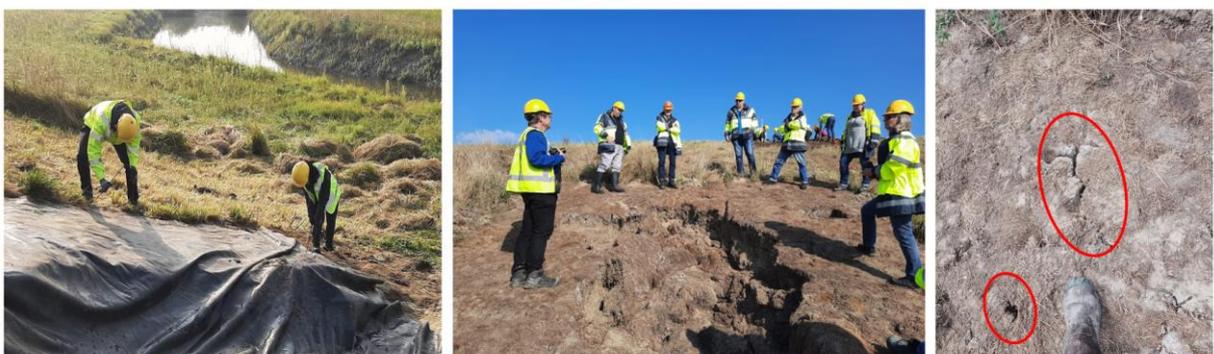
Figure 6.76. Left: Removal of EPDM protection. Middle: Impression of soil appearance after removal of the EPDM sheet. Right: Holes and channels on the soil surface that was covered with the EPDM sheet.

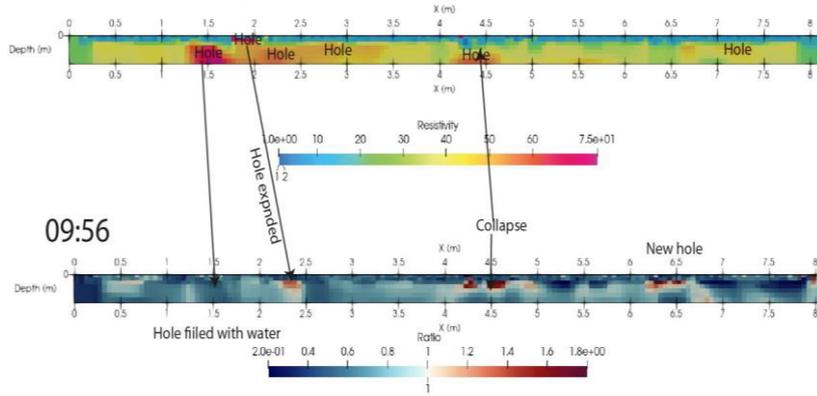
Figure 8.10. Measurement 2 from cable 1. Top figure shows the resistivity structure of the subsurface, where with high resistivities values (red) we expect the presence of multiple holes. The ratio images show that we have water infiltration in the top 25cm of soil.

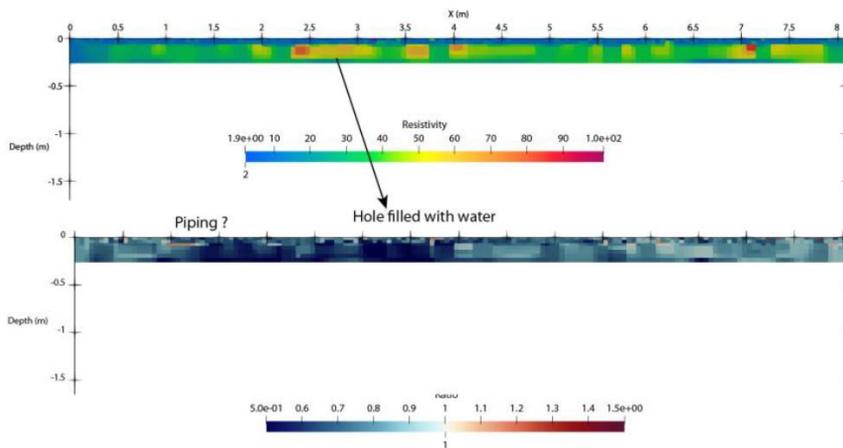
Figure 8.11. Measurement 2 from cable 2. Only small new holes were detected, and the water infiltration can be seen in the whole section.

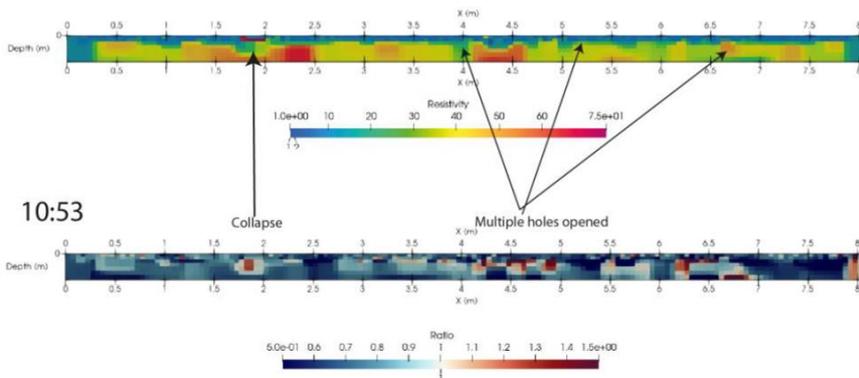
Figure 8.12. Measurement 3 from cable 1. Similar results with measurement 2. There are areas (on horizontal x-axis 4 to 6m) where we observe extended creation of new holes.

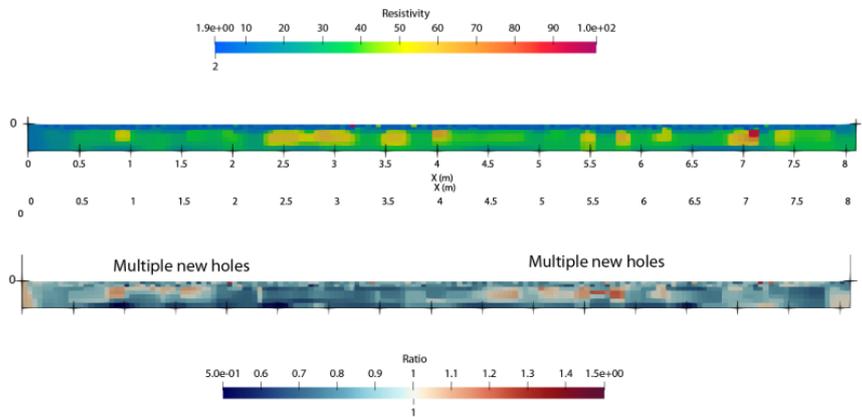
Figure 8.13. Measurement 3 from cable 2. Compared to measurement 2, the creation of multiple new holes can be observed.

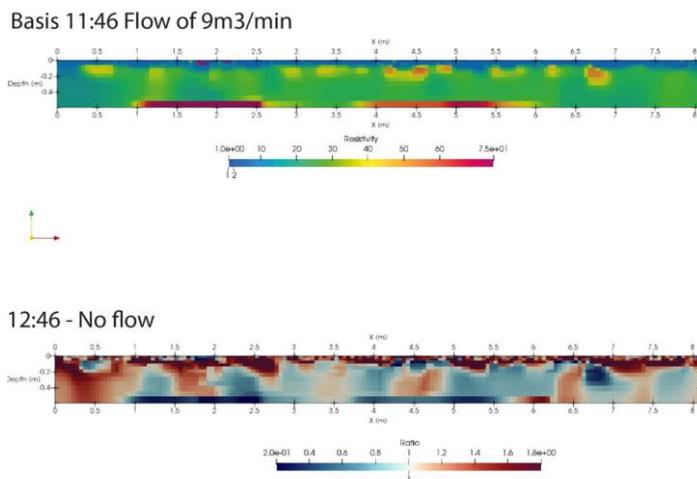
Figure 8.14. Measurement 4 from cable 1. Many more new holes can be observed that extend deeper than in measurements with lower flow rates. There are sections where the new holes are connected (i.e on the horizontal axis 0-1m). Overall the ratio images show many more red spots, indicating that the soil shows a higher activity.

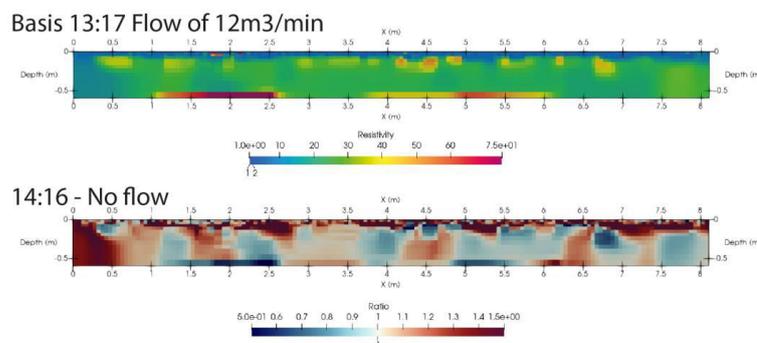
Figure 8.15. Measurement 5 from cable 1. The result here is very similar to measurement 4. No new holes created, but the existing ones are enlarged and show more connectivity (i.e. along x-axis 2-3.5m). It seems that

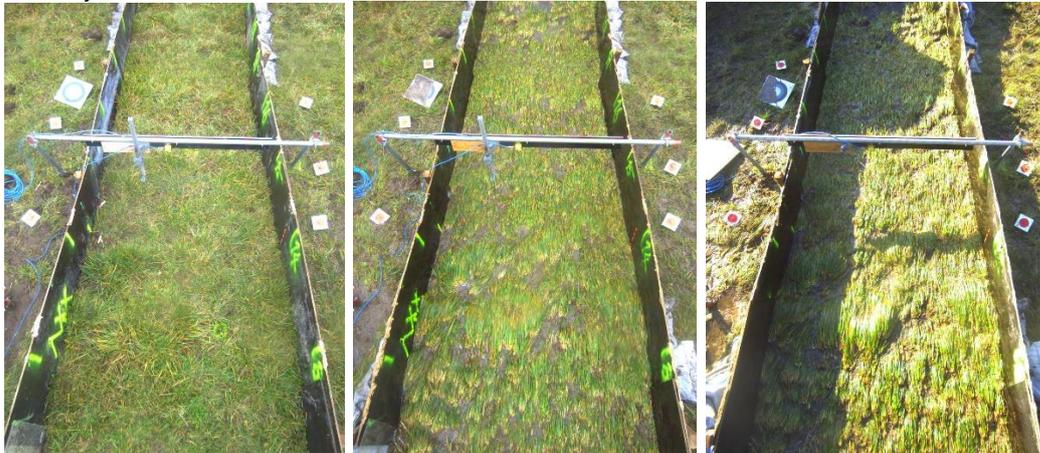
Figure 8.21. Progression of surface erosion around a small burrow in the test flume. Left: Picture before initiation of the test. A mouse burrow is marked with fluorescent spray on the grass. Middle: Picture halfway in the test. Right: Picture after completion of the test.

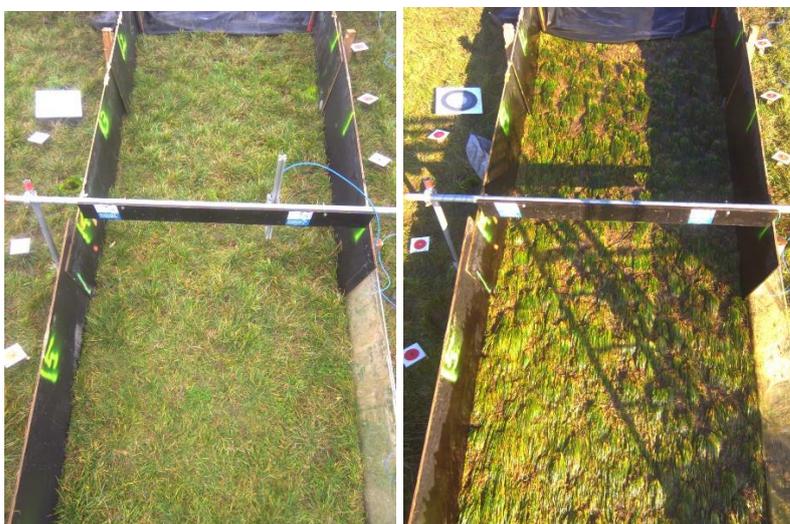
Figure 8.22. Transition between EPDM and soil close to the cress of the test section before (left) and after (right) the test.
