APPENDICES

III. VOLKERAK_1 / ST. ANTHONIEGORZEN

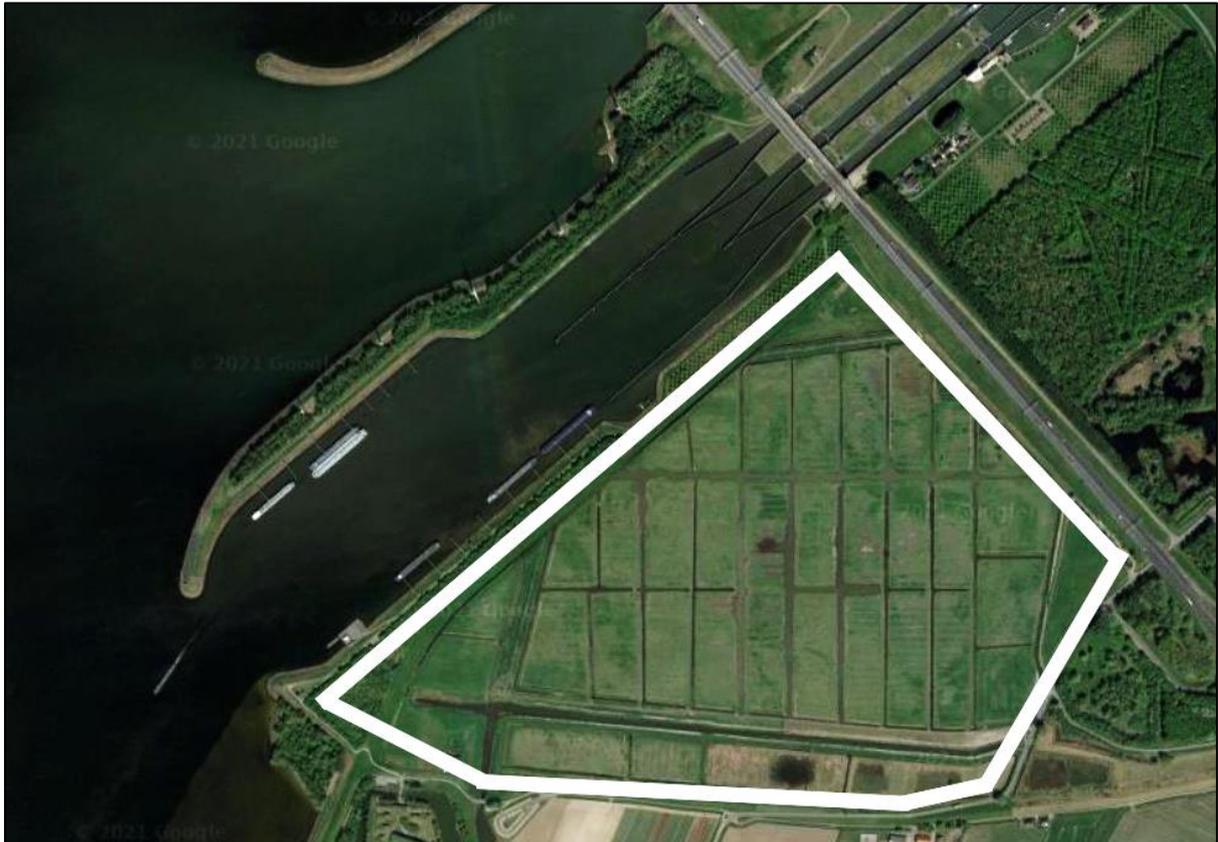
Figure 1. Overview of location Volkerak_1 / St. Anthoniegorzen, indicated with white lines. (Source: Google Maps)

This area is located in close proximity to the Volkerak lock complex, near the Hollands Diep, see Figure 1 and Figure 2 below. It is characterized by relatively low elevation levels of +0,30 m NAP to +0,80 m NAP. It has a surface area of approximately 65 ha.

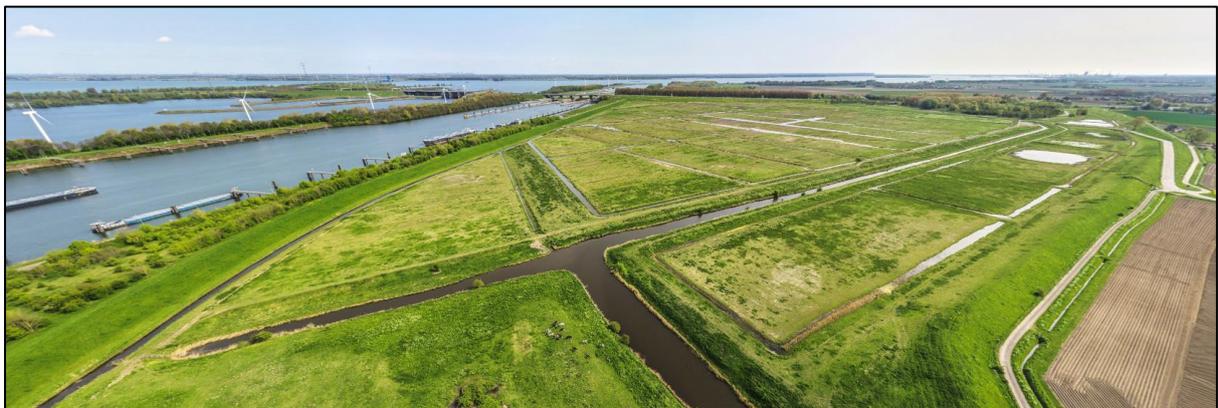
Figure 2. Drone view of the St. Anthoniegorzen, showing the main channel in the area (called Vleij) and the smaller secondary channels in the distance. Lake Volkerak can be seen on the left. (Ton, 2019)

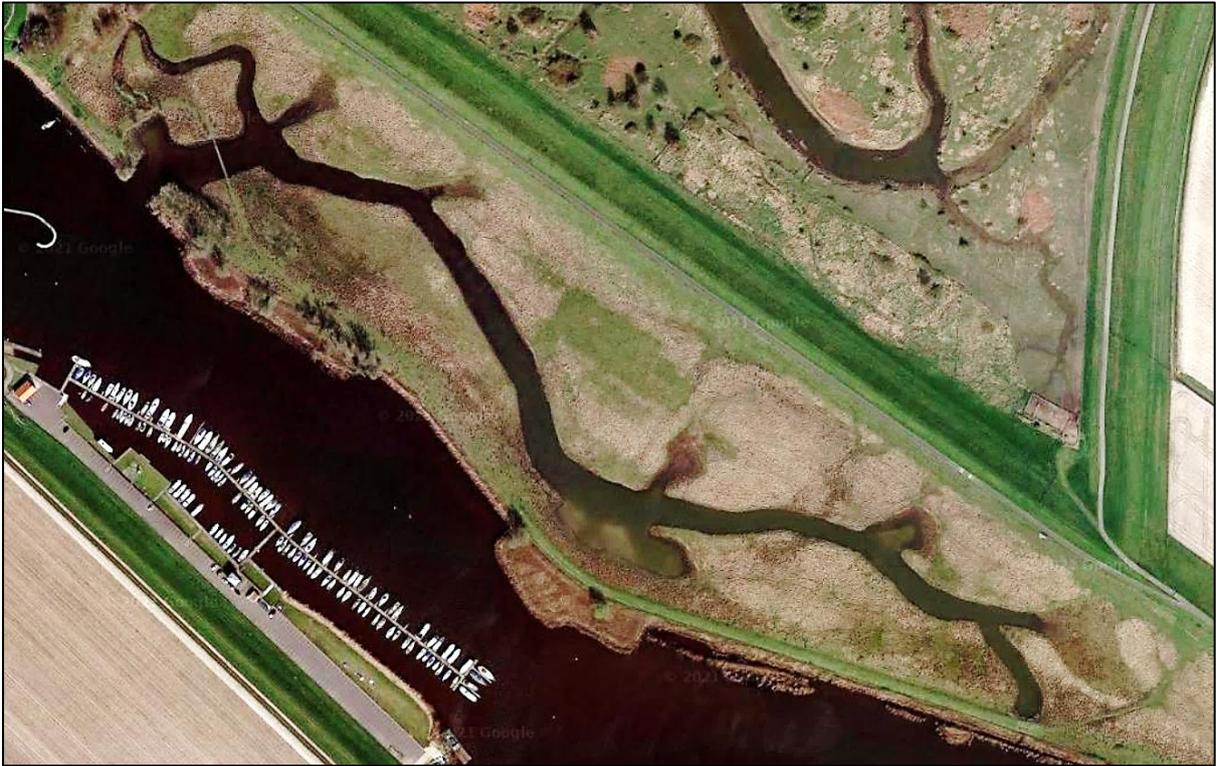
Figure 4. Satellite image of location SteenbergseVliet_1 / Saspoldertje. The channel and its small bifurcations are clearly visible.
(Source: Google Maps)

This location is located only 500 m upstream of lake Volkerak, bordering the nature reserve *Dintelse Gorzen* to the north. It has a total surface area of approximately 11 ha. This area is characterized by the presence of a channel system with some small bifurcations (Dutch: *vertakkingen*) (see Figure 4 on the next page).

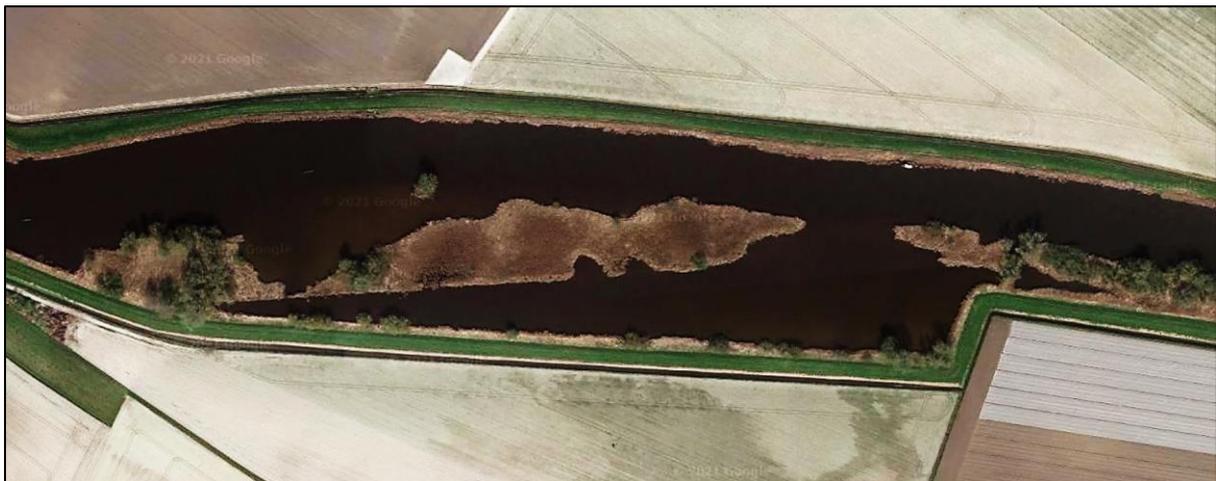
Figure 5. Satellite image of location *SteenbergseVliet_2*. (Source: Google Maps)

This location is similar to previous area (*SteenbergseVliet_1 / Saspoldertje*) as it also shares characteristics of a wetland, see Figure 5. With a maximum elevation of +0,20 m NAP, the area is expected to be subject to periodic flooding. Comparing this maximum elevation with water levels at this location, it can be concluded that the water level exceeds this value (+0,20 m NAP) only two days per year on average. This makes this specific area unsuitable for the construction of a floodplain, as this would require more frequent inundation.

Elevation levels in this area are approximately +0,30 m NAP. The areas to the south are characterized by higher elevation levels of approximately +1,30 m NAP. The relatively low elevation levels of the area adjacent to the river potentially make it suitable for wetland development. This development could be realized by either relocating the dike adjacent to the river or making an opening on the north east side, as this would allow the inflow of water into the low-elevated area. As peak levels in this part of the river are not expected to exceed the maximum elevation of the area, dredging a secondary channel would enable the water to flow from the main channel into the area. This would result in an area with similar morphology as the area seen in Figure 5, except with a more defined channel and in- and outflow.

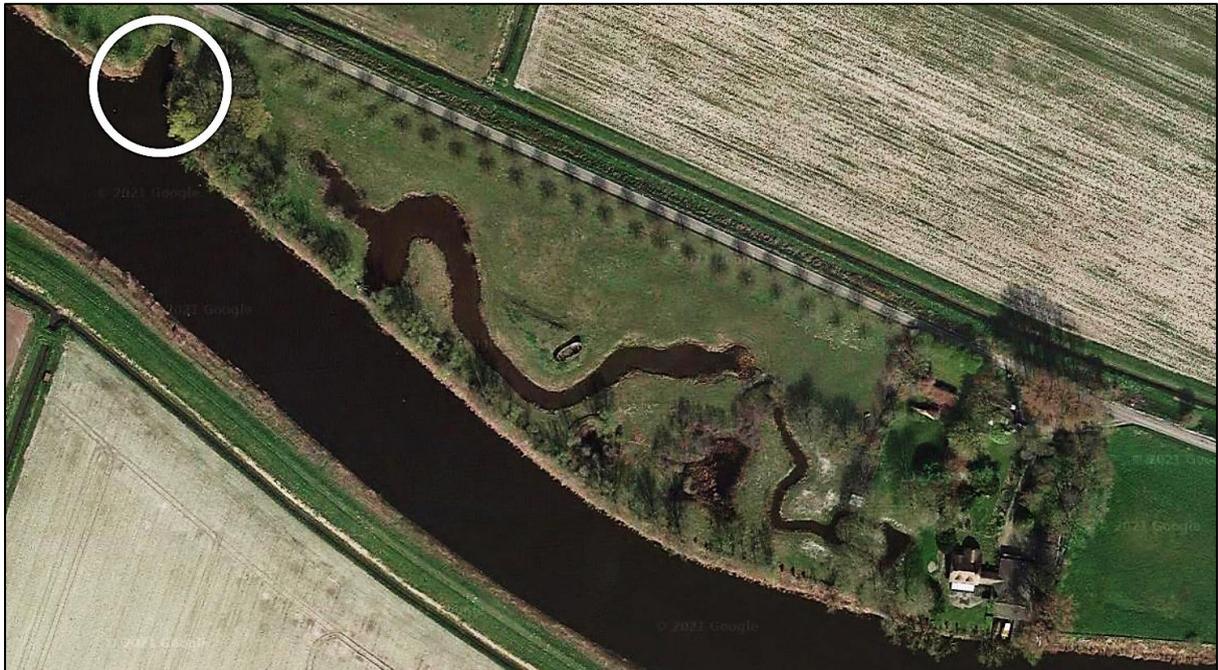
Figure 7. Satellite image of location SteenbergseVliet_3, including the outlet of pumping station Gemaal Visvliet, indicated with a white circle. (Source: Google Maps)

This location is characterized by the presence of a secondary (smaller) channel, see Figure 7 below. The surface area of this location is approximately 2 ha.

A pumping station is located to the north west of the area, called *Gemaal Visvliet* (capacity: 0,92 m³/s). Excess water from surrounding polders is pumped into the Steenbergse Vliet via this pumping station. The outlet of this pumping station is located just downstream of this area, indicated with a white circle in Figure 7. This means that water from the surrounding polders is discharged directly into the main river.

Considering the fact that this water contains a significant amount of nutrients (based on the fact that the water originates from agricultural land), a potential effective method would be to create a flow-through wetland area that is capable of (partially) removing nutrients from this discharged water. Alternatively, the discharged water could be directed to flow through the already existing secondary channel as seen in Figure 7.

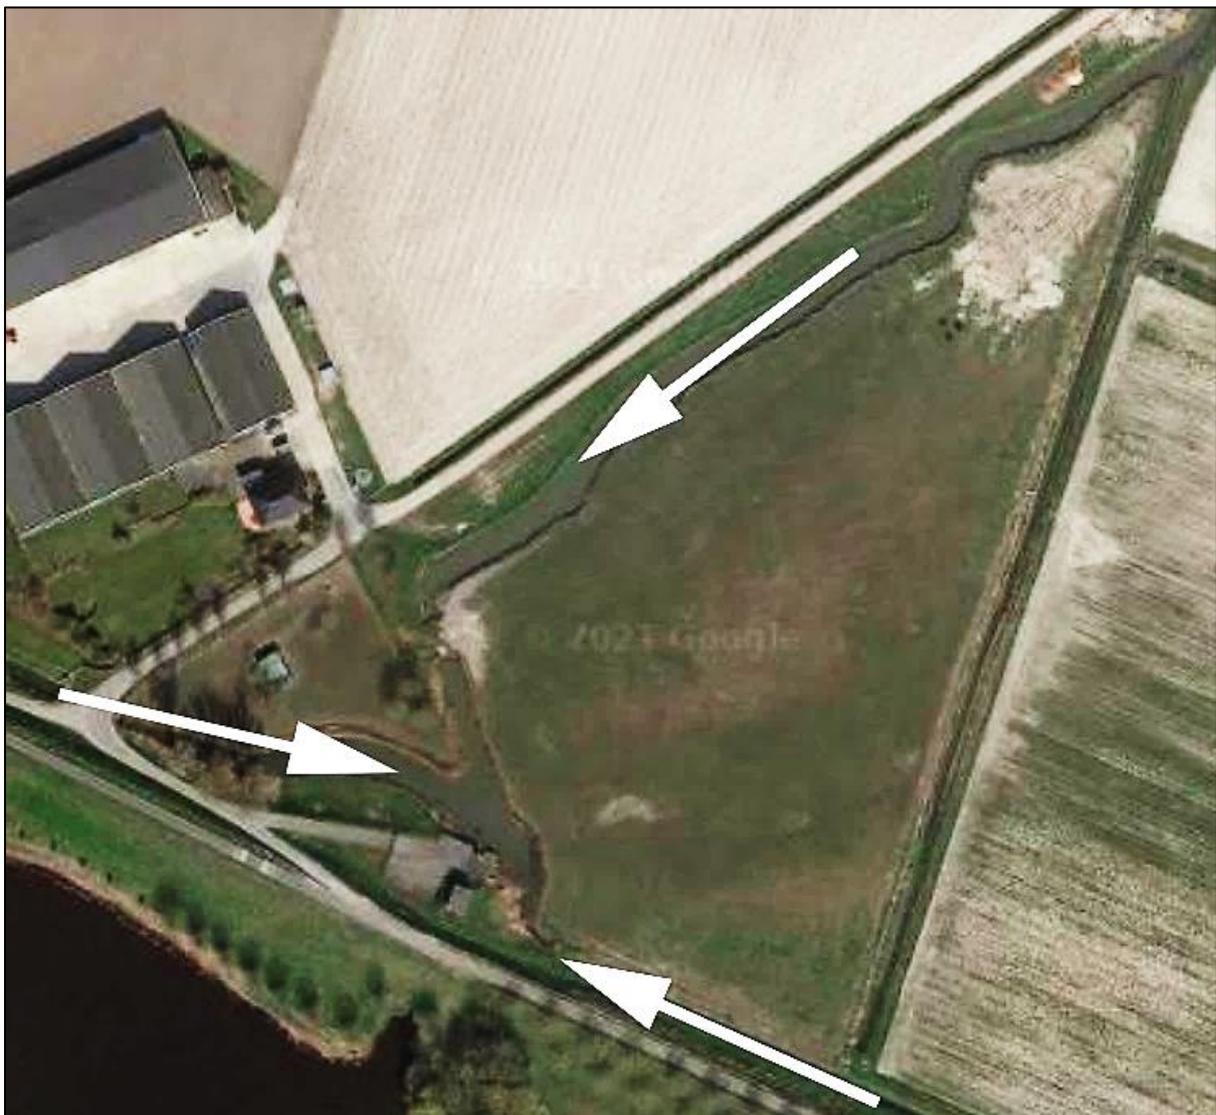
Figure 8. Location overview of the area adjacent to the pumping station Visoliet, including the flow path of the water from the ditches as indicated with white arrows. (Source: Google Maps)

For the first method, the area adjacent to the ditches north of the river Steenbergse Vliet could be used as a location for wetland creation. Figure 8 shows the top view of this specific area. This area has a total surface area of approximately 2,1 ha. Analysis by using *Vastgestelde Legger Waterschap Brabantse Delta* indicates that water from surrounding ditches flows to the pumping stations from three different directions, as indicated with white arrows in Figure 8. In order to create a functional wetland, diversions from the ditches need to be made so that

the water can flow through the wetland. Current elevation levels in this specific area range from +0,40 m NAP to -0,30 m NAP. Lowest elevation levels are found directly adjacent to the ditches.

For the second method, the water that is discharged from the pumping station into the main river needs to be diverted to area with the secondary channel as seen in Figure 8 below. Creating an area downstream with similar characteristics would be challenging, as space is limited on both sides of the river in the nearby downstream part.

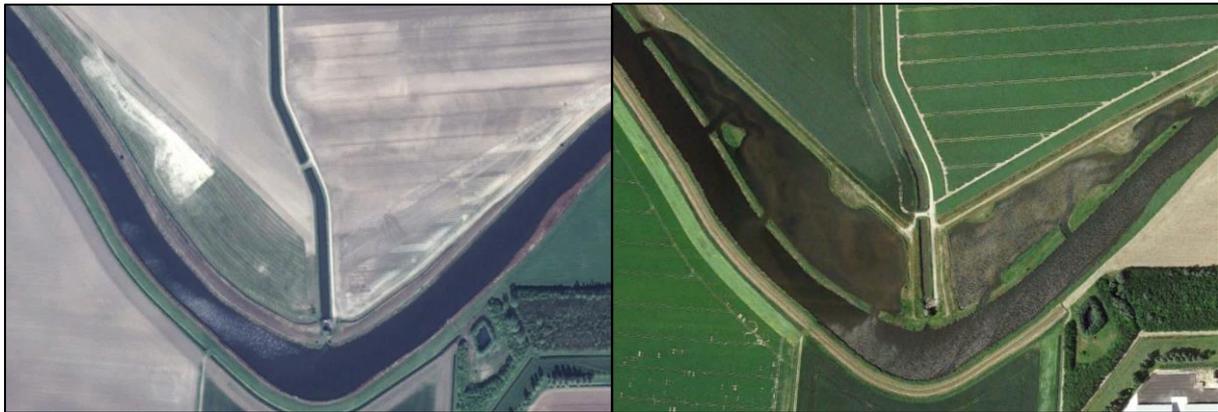
Figure 9. Location SteenbergseVliet_4, in 2011 (left) and 2013 (right). (Source: Google Earth Pro Historical Imagery)

This location is characterized by two waterbodies adjacent to the main channel, with a pumping station (capacity: 0,91 m³/s) present in the middle, discharging water from the surrounding polders into the Steenbergse Vliet. The two waterbodies, with a total surface area of approximately 5 ha, were formed between 2011 and 2013, as seen in Figure 9 below.

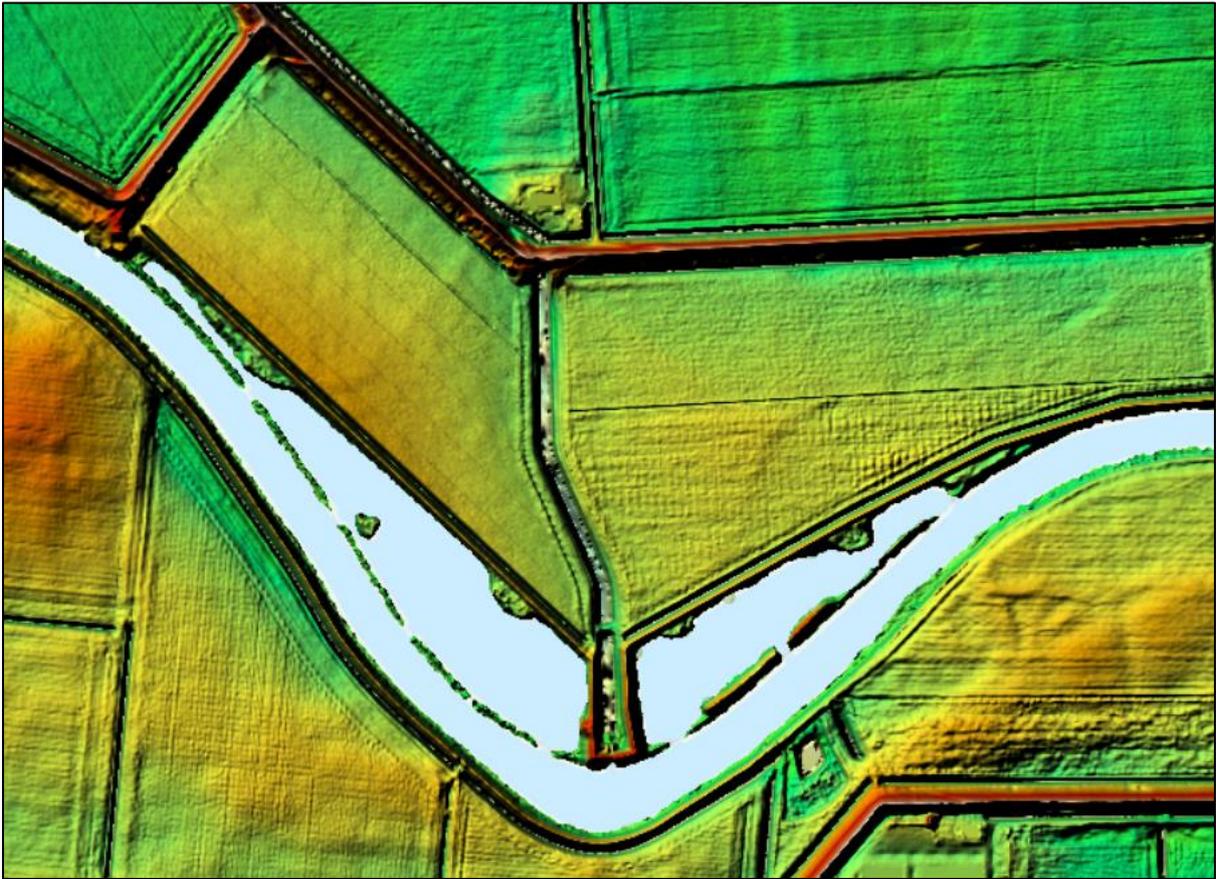
Figure 10. Elevation map of location SteenbergseVliet_4 (green = low elevation; red = high elevation). (Source: Esri Nederland, AHN)

Vegetation in these waterbodies is only present on the shores, as the water in these waterbodies is too deep for development of emergent plants. Making these waterbodies shallower would be a first step in the development of an area with characteristics of a (small-scale) wetland. Figure 10 on the next page shows the elevation map of the area. (Partial) excavation of the agricultural soils to the north of the river could provide the necessary soil needed to make the area of interest more shallow.

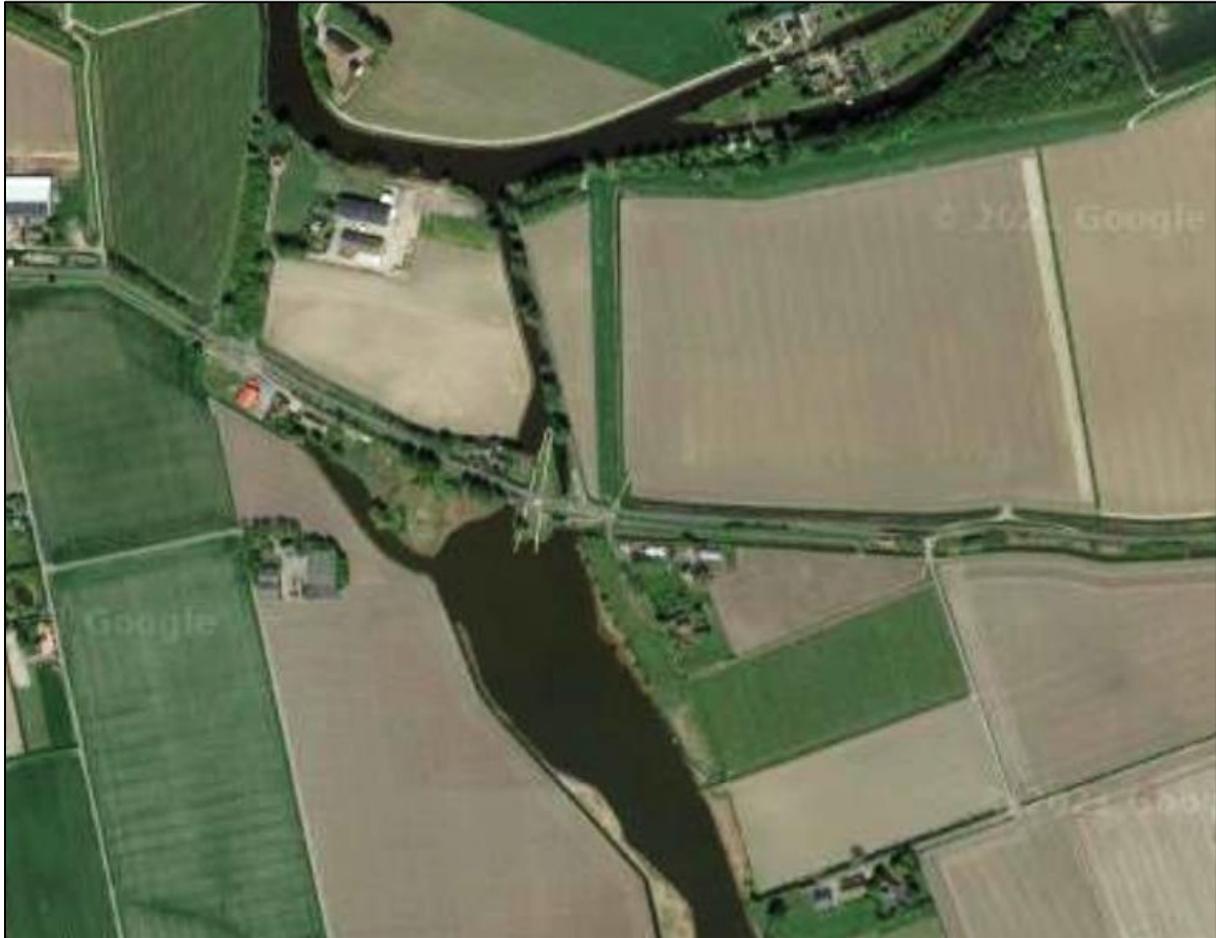
Figure 12. Overview of waterbody *De Baak*, the pumping station *Brooymans* in the middle and the river *Steenbergse Vliet* on the north. (Source: Google Maps)

Just 400 m south of the main river Steenbergse Vliet, a waterbody named *De Baak* is located with a surface area of approximately 6,5 ha, see Figure 12 below. On the north of this waterbody, a pumping station named *Gemaal Brooymans* is located (capacity: 9,67 m³/s), pumping water from De Baak (and indirectly water from channels and ditches flowing into this waterbody) to the main river to the north.

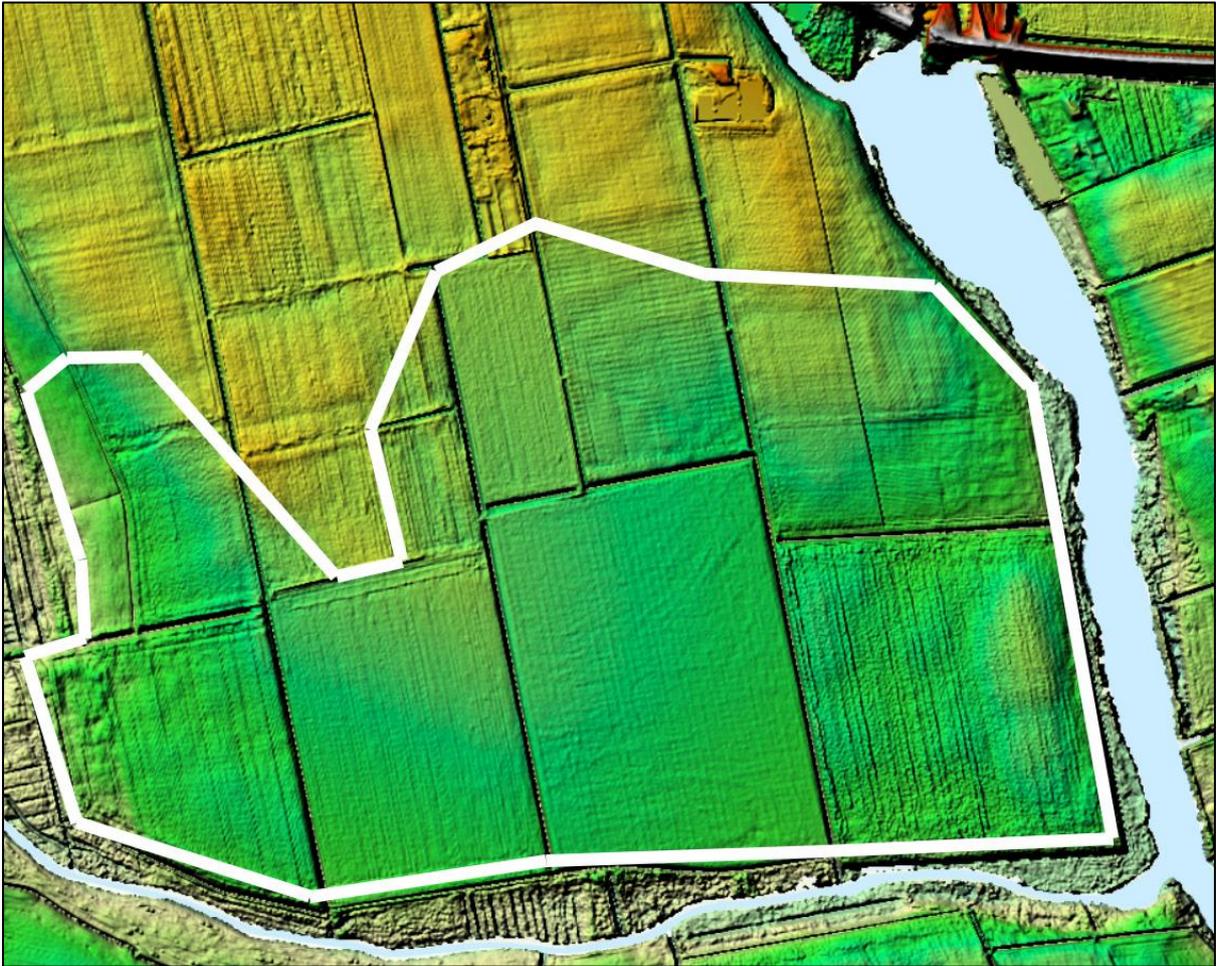
Figure 13. Overview of location SteenbergseVliet_6 / De Baak, with white contour lines indicating elevation levels lower than +0,12 m NAP (assumed water peak levels). (Source: Esri Nederland, AHN)

Areas adjacent to De Baak are characterized by relatively low elevation levels, specifically the area bordering to the south west of the water body. Elevations in this area range from approximately -0,40 m NAP to +0,40 m NAP. If peak water levels are assumed to be +0,12 m NAP, these areas would in theory be suitable for creation of wetlands. Figure 13 on the next page shows the elevation map of the area, with the area within the white contour lines having elevation levels lower than assumed peak water levels (+0,12 m NAP). This area has a total surface area of approximately 50 ha.

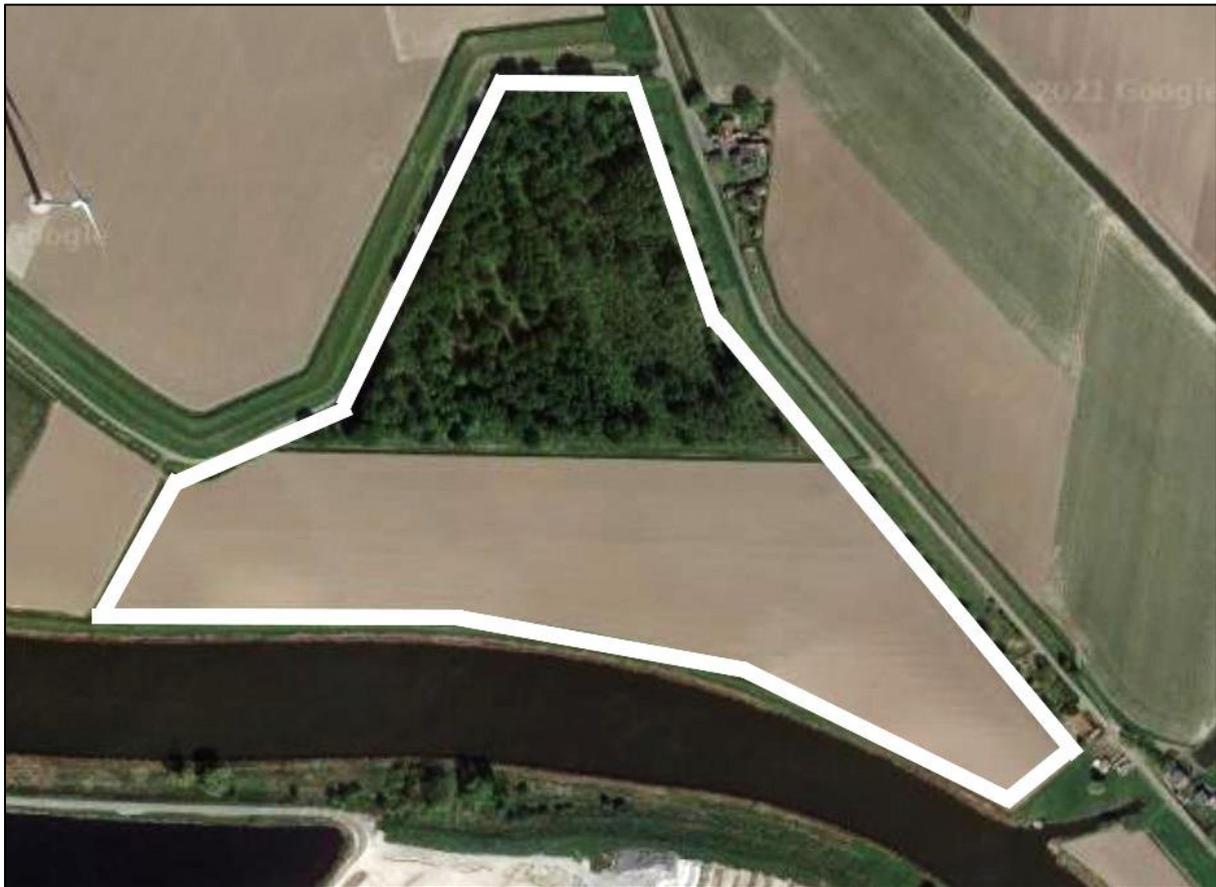
Figure 14. Overview of the location *Dintel_1*, with the pumping station *De Dintel* located in the bottom right. (Source: Google Maps)

Located just across the sugar beet factory *Cosun Beet Company*, pumping station *De Dintel* (capacity: 2,93 m³/s) pumps water from the surrounding polders into the river Dintel. The area to the north west of the discharge point is characterized by low elevation levels and an embankment on the side of the river with a height of approximately +1,20 m NAP. The elevation levels in this area range from +0,20 m NAP to +0,80 m NAP. The total surface area is approximately 11 ha. Figure 14 below shows the location of the area, indicated with white lines. The pumping station is located in the far bottom right of the map.

Similar to location *SteenbergseVliet_3* (Appendix VI), the discharge water from the pumping station is expected to contain a relatively large amount of nutrients. As the pumping station is located close to the low-elevated area to the north west, a potential measure would be to initiate the development of a wetland/floodplain in this area. Especially since this area is embanked by a dike with a height of +1,20 m NAP, it is expected that the discharge water will be well-retained in this area. The area could potentially be developed into an area characterized by a shallow, low-gradient elevation (in Dutch referred to as *plas-dras*). An

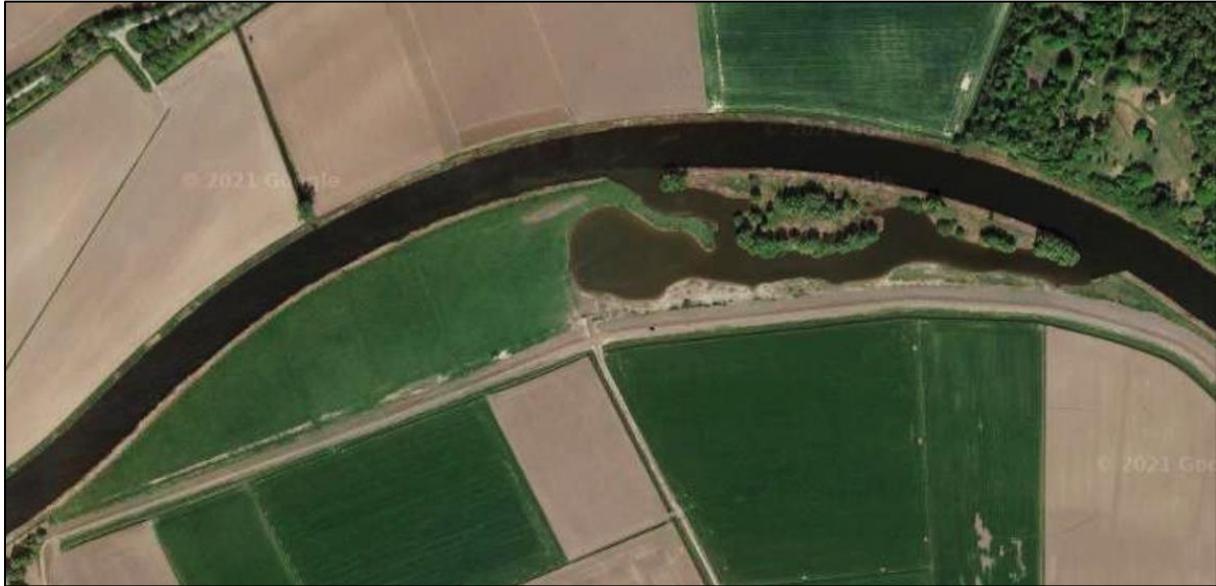
Figure 15. Satellite view of location Mark_1. (Source: Google Maps)

This location is assigned as a spawning ground of fish in Vastgestelde Legger Waterschap Brabantse Delta. It is located in one of the many meanders of the river Mark, approximately 21 km upstream of lake Volkerak. It has a surface area of approximately 5 ha, excluding the dry adjacent area to the west, see Figure 15 below.

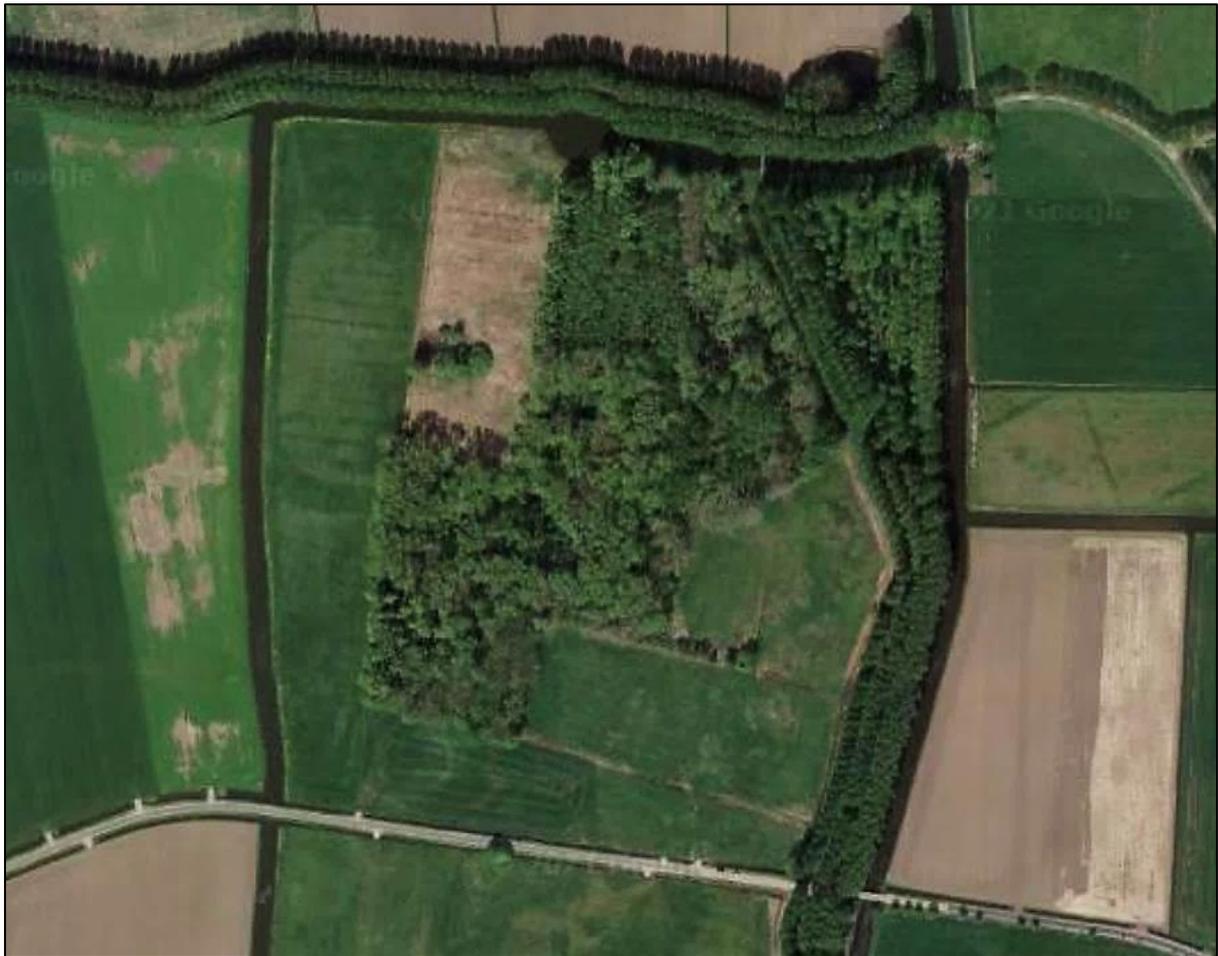
Figure 16. Satellite image of location Mark_2, with the pumping station in the top right and two dikes on the top and right of the area. (Source: Google Maps)

Along the river Mark, this location is one of the areas with the lowest elevations. These values range from -0,50 m NAP to -1,40 m NAP. The dike at the north of the area has a height of approximately +2 m NAP and the dike on the east has a height of approximately +1,20 m NAP. On the right side of this second dike, a channel is present, named *Halsche Vliet*. North west of the area, a pumping station (capacity: 1,28 m³/s) is present, pumping water from the polder to the river Mark to the north, see Figure 16 below. The total surface area is approximately 16 ha.

In theory, the creation of a floodplain could be easily initiated by breaching the secondary dike to the right of the area. A more controlled approach would be to lower this dike at a certain spot, allowing excess water from the channels to flow into the low-elevated area.

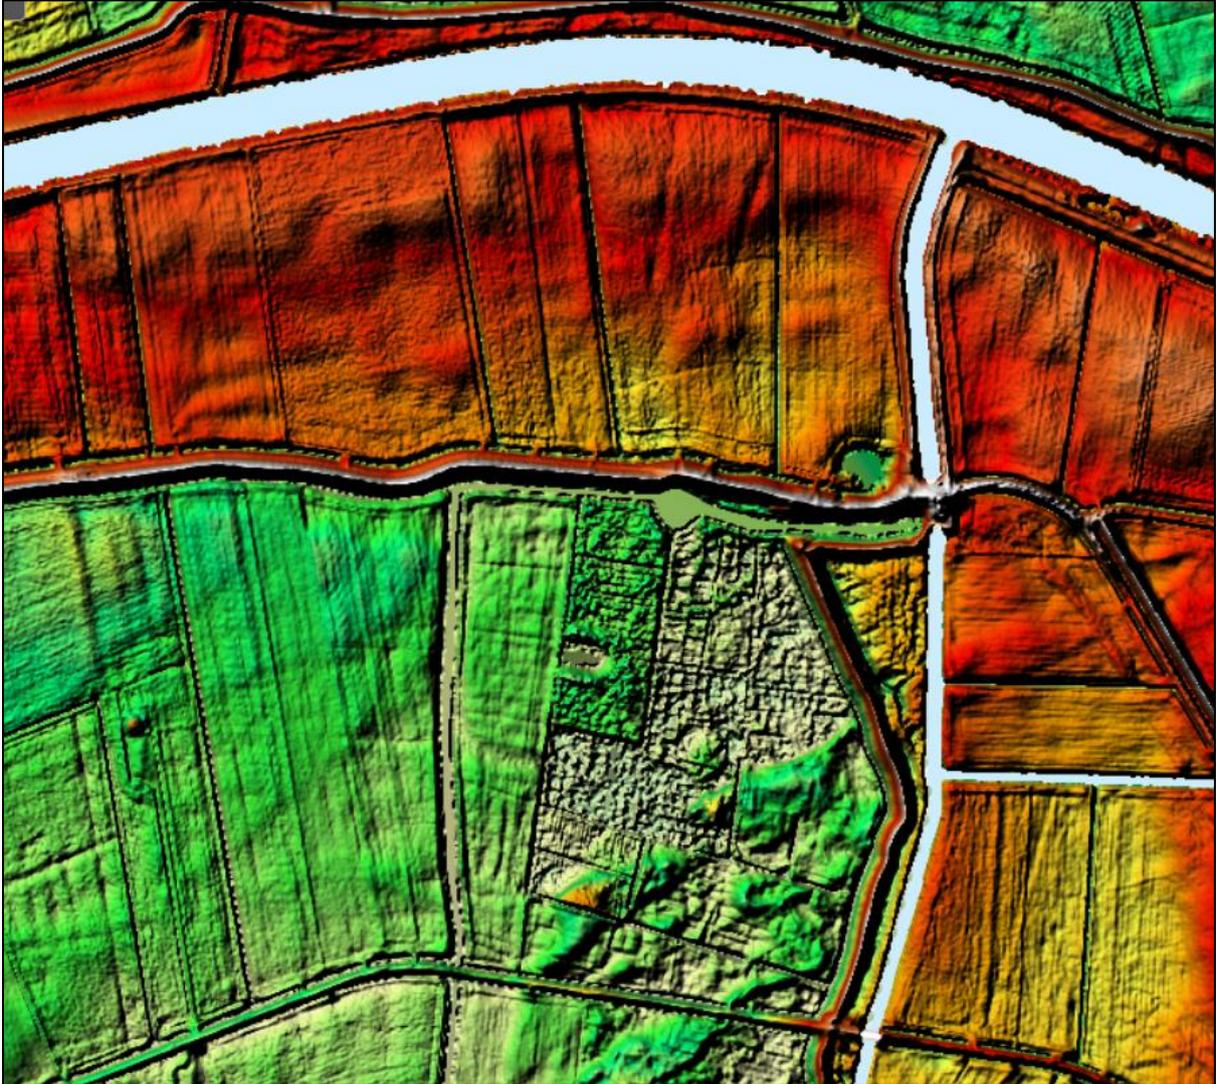
Figure 17. Elevation map of location Mark_2, with the main river (Mark) to the north and a smaller channel (Halsche Vliet) to the east. (Source: Esri Nederland, AHN)

Because of its low elevation, this area would in theory be suitable for the development of a floodplain. Elevation gradients are steep, meaning that the development of a natural wetland would be challenging, as this would require a less steep gradient.

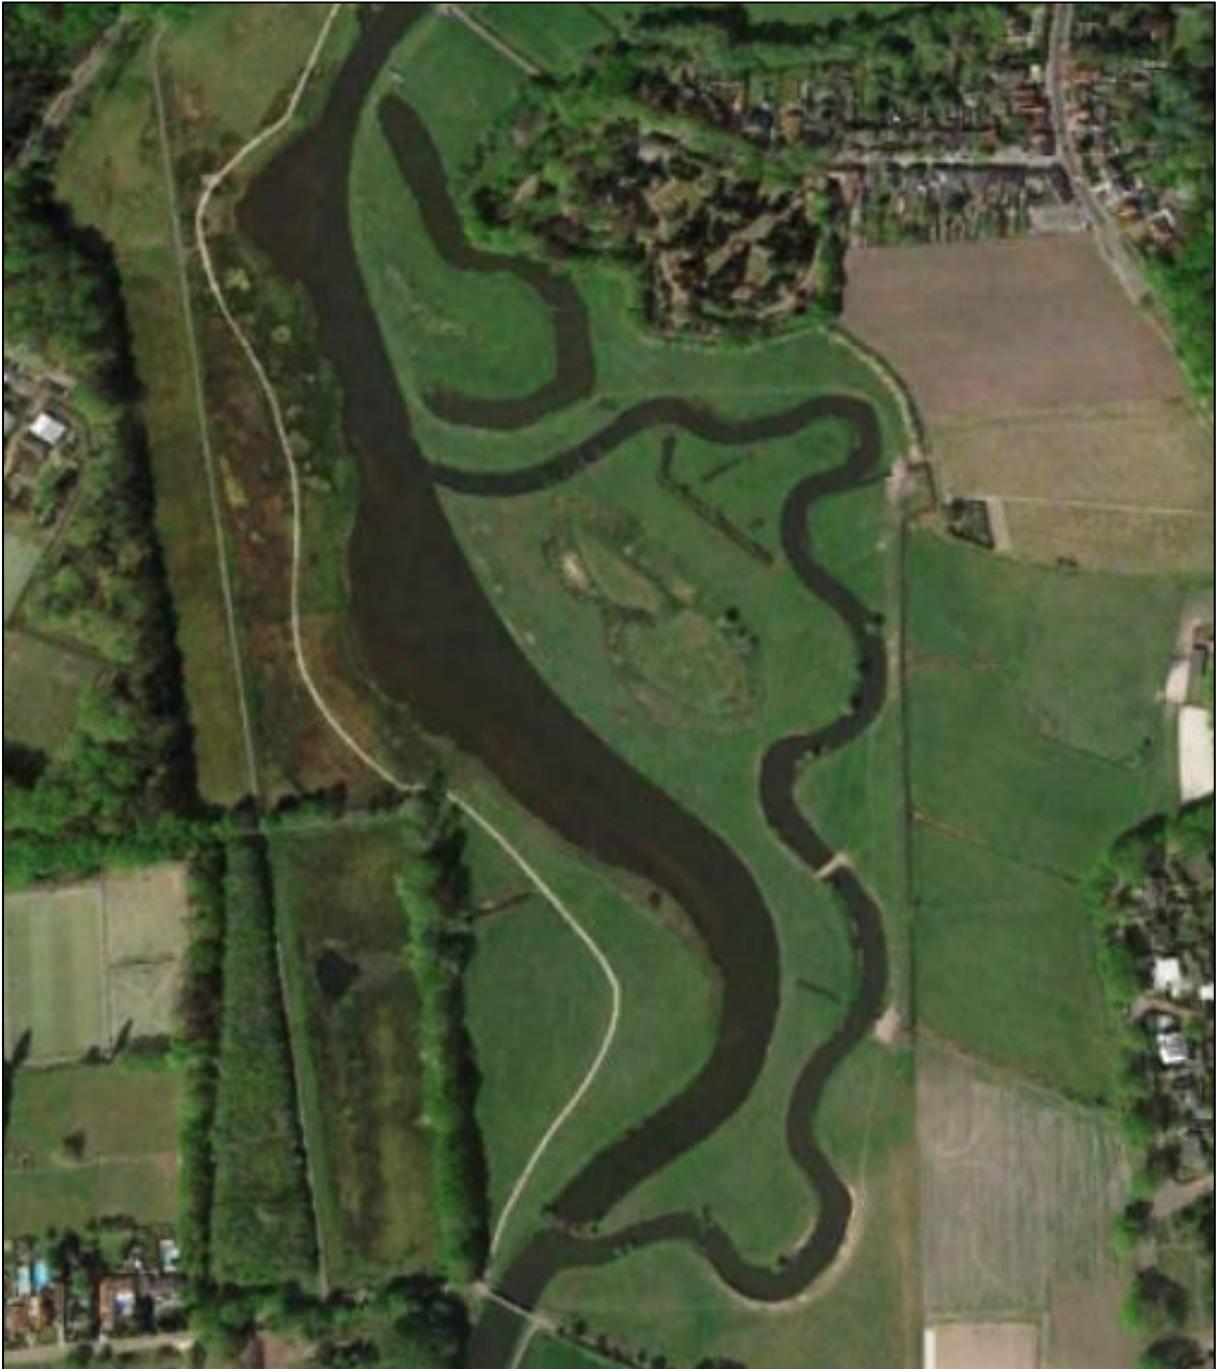
Figure 20. Satellite view of the meanders next to the main channel. (Source: Google Maps)

The first area of interest is located approximately 45 km downstream of the Dintel/Mark river system. The area is characterized by a set of meanders next to the main channel, see Figure 20. The areas surrounding these meanders are characterized by low elevation levels relative to the water level, see Figure 21. It has a total surface area of approximately 11 ha.

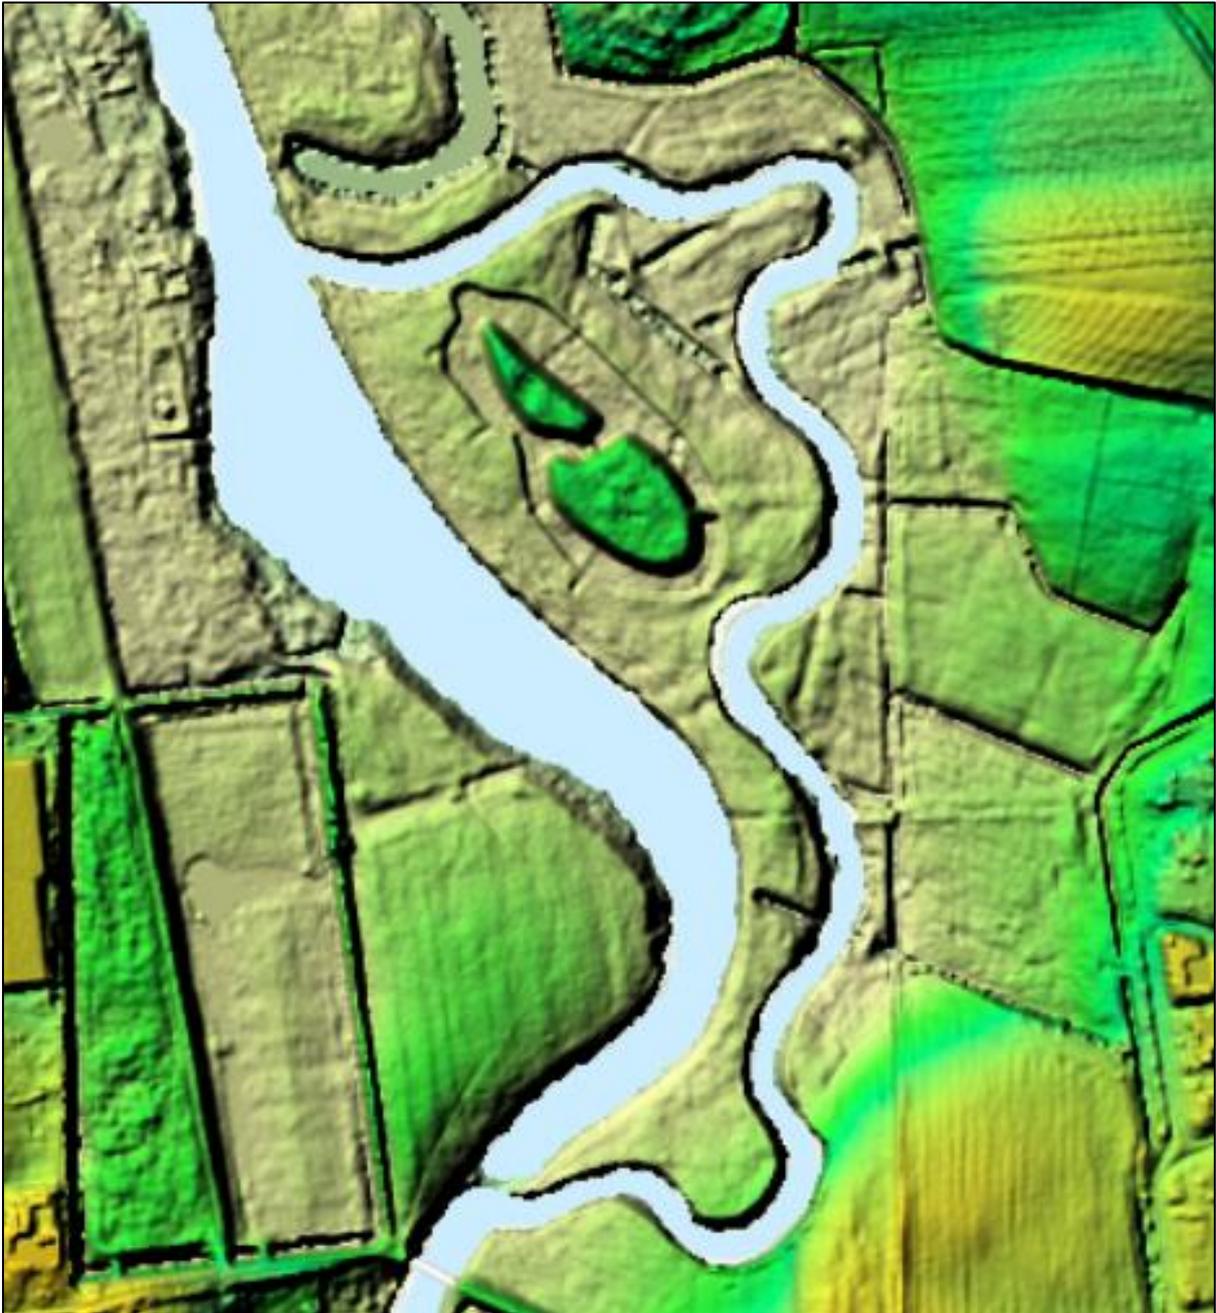
Figure 21. Elevation map of location Mark_4 / Meander Ulvenhout. (Source: Esri Nederland, AHN)
