# Overflow tests on Belgian levees

# Continuous Overflow tests on Belgian levees

1.0 - 20221115

Depreiter, D., Vercruyse, J., Verelst, K., Zomer, W., Koelewijn, A., Tsimopoulou, V., Peeters, P.

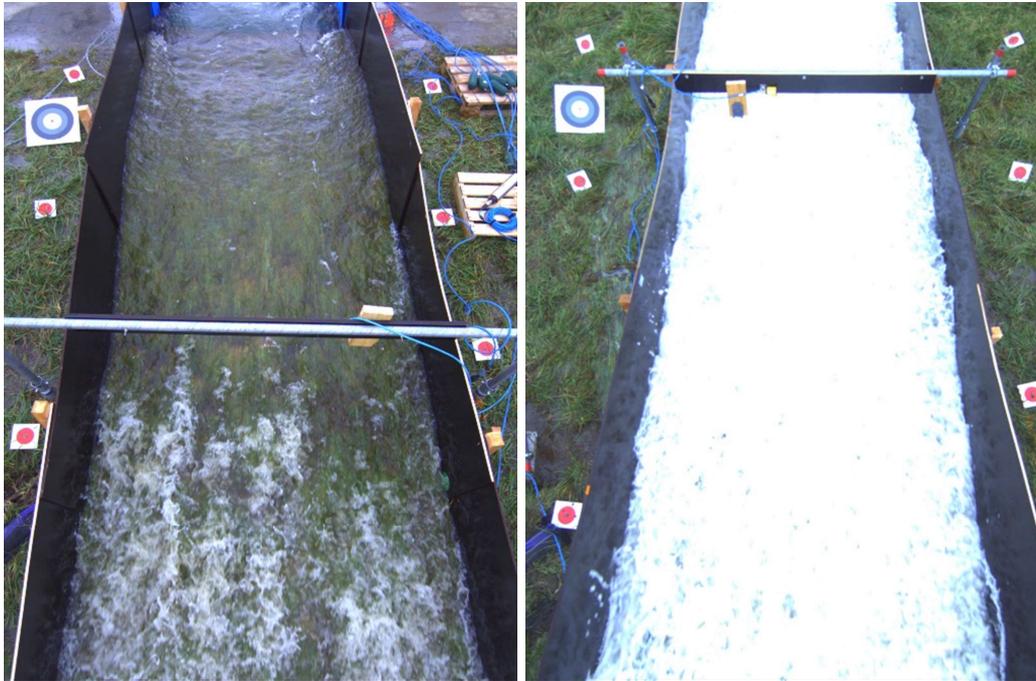
At the upstream part of the crest, a hydraulic jump occurred. At the centre of the crest, subcritical flow was accelerated and fairly uniformly spread over the entire width before flow conditions become supercritical. Aeration of the flow started around 4m from the crest, near the measurement location 'UPPER'.

Figure 8 - Left: View of the crest to slope transition and generation of aeration. Right: aerated flow further down the slope.

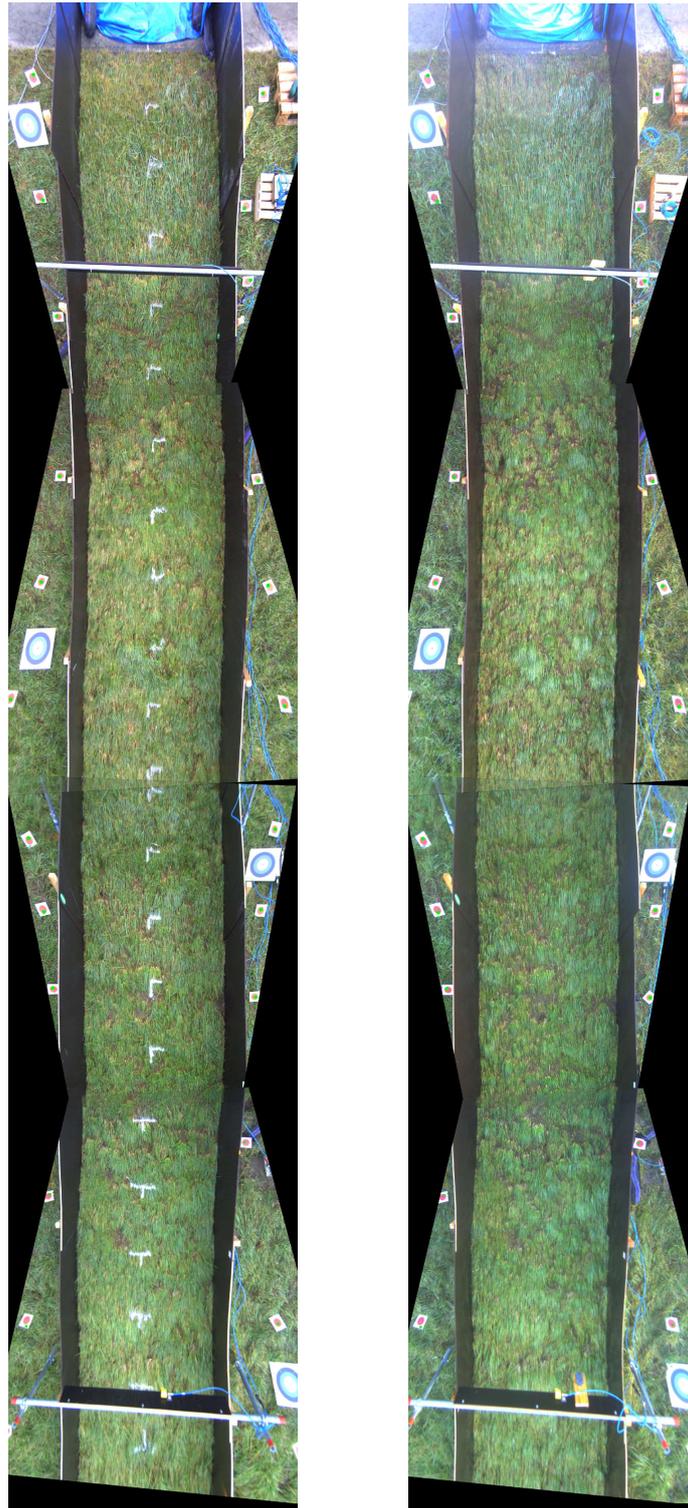
During the experiment, bare patches become more prominent, and vegetation roots became increasingly exposed. However, during the course of the test, no critical damage or failure occurred.

Figure 9 - Stitched surface image of B-OF01 at the start of the experiment (left, block B0) and at the end of the experiment (right, block B17).

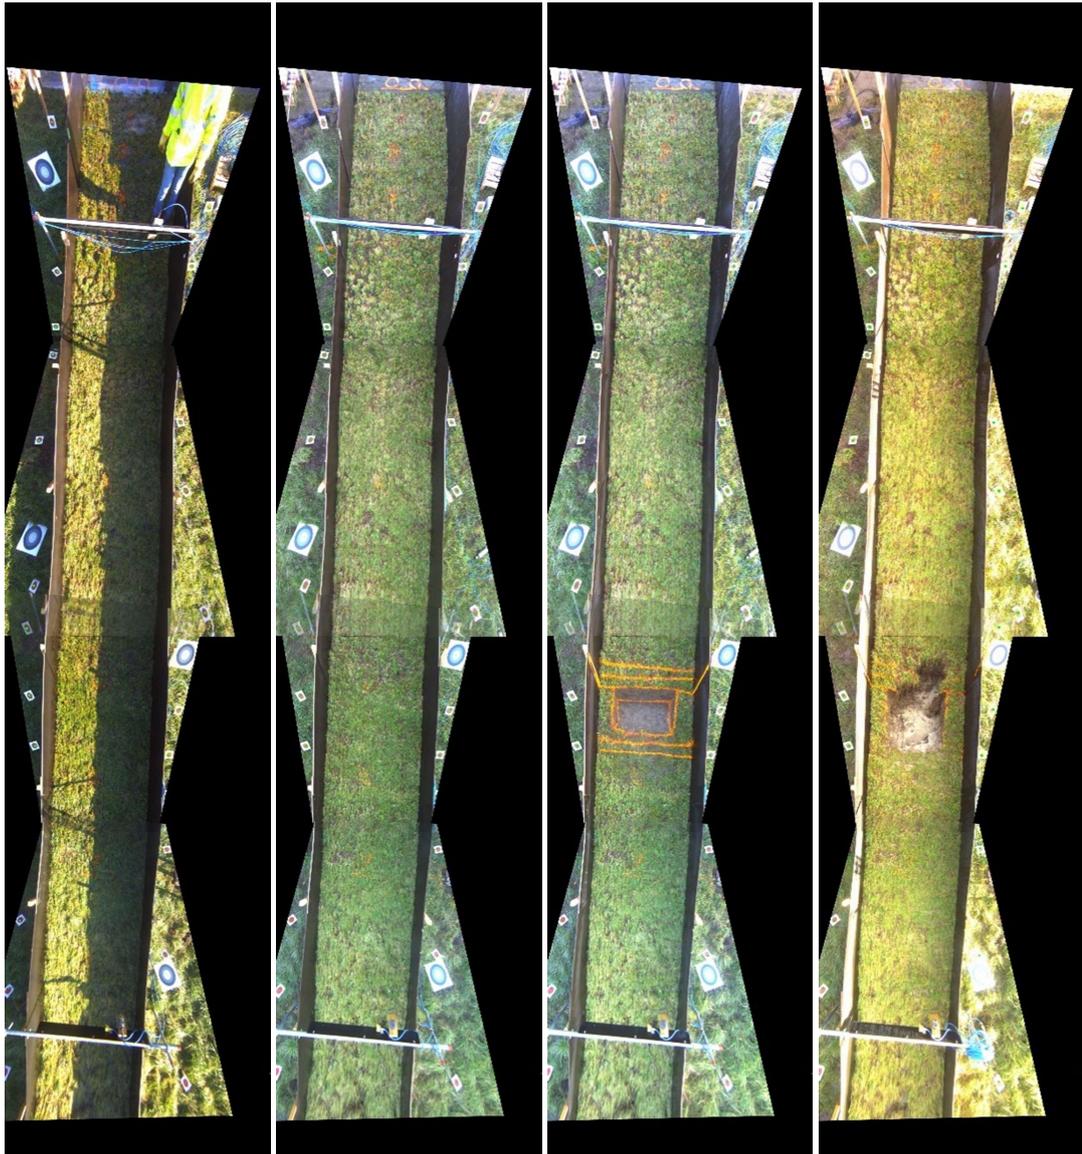
Figure 19 - Stitched surface image of B-OF02 at the start of the experiment (left, block B1) and at the end of the experiment (right, block B20). The two middle images are taken at B15 before and after the creation of artificial damage.

- Based on the visual observations, the presence of shorter grass did not lead to fast(er) erosion or failure than the reference case with normal length grass. It must be noted that the vegetation root system corresponded to that of 'long vegetation' because the vegetation was mowed only shortly before the test execution.
- The creation of an artificial (step-shaped) damage did show some evolution but was not expected to yield fast erosion. Increasing the step depth until the sand core was reached, did however result in fast (within minutes) erosion and damage evolution.

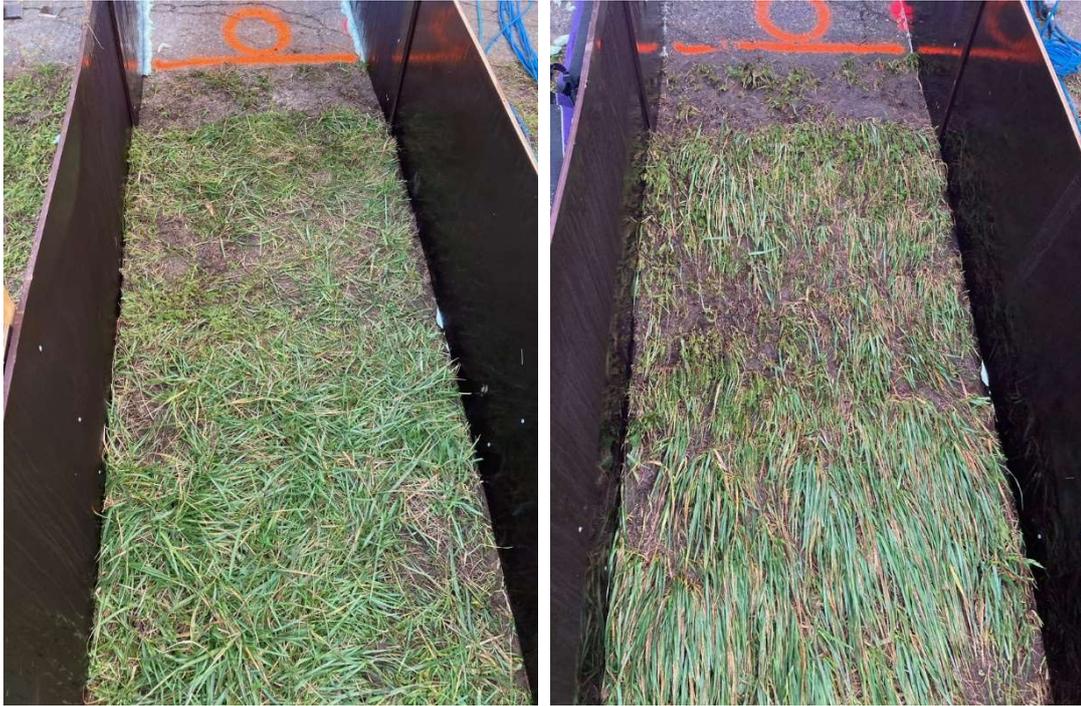
During the experiment, it is observed how bare patches appear and erosion occurs and evolves through time. However, no critical damage is present during the entire experiment. Fairly extensive leakage along the boarding was noted, which hampered the execution of the experiment.

Figure 24 - Comparison of the levee vegetation aspect at B0 (left) and B8 (right) at the upper 3 meter of the levee.

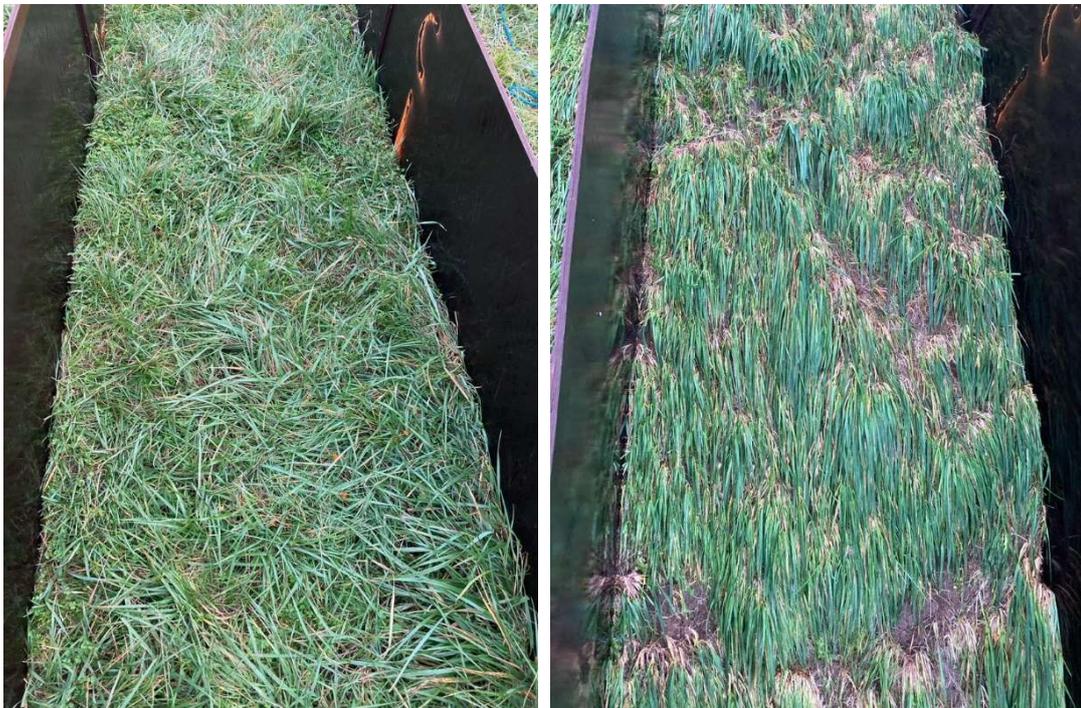
Figure 25 - Comparison of the levee vegetation aspect at B0 (left) and B8 (right) halfway the levee slope (15-17 m).

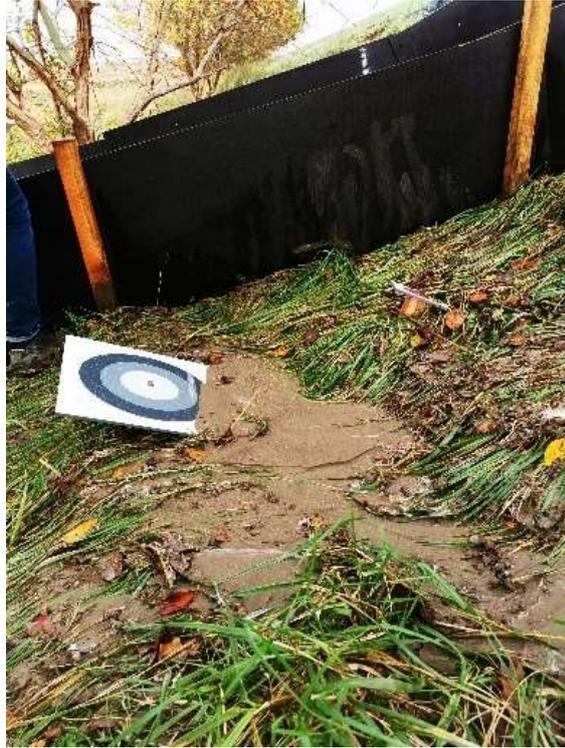
Shortly after the start of the experiment, it was observed that 'sand boils' were present outside the test strip. On the left side of the test section (i.e. southwards), water and sand was emerging from small (mice?) holes near the levee toe area.

Figure 29 - Sand emerging from small burrows outside the test section.

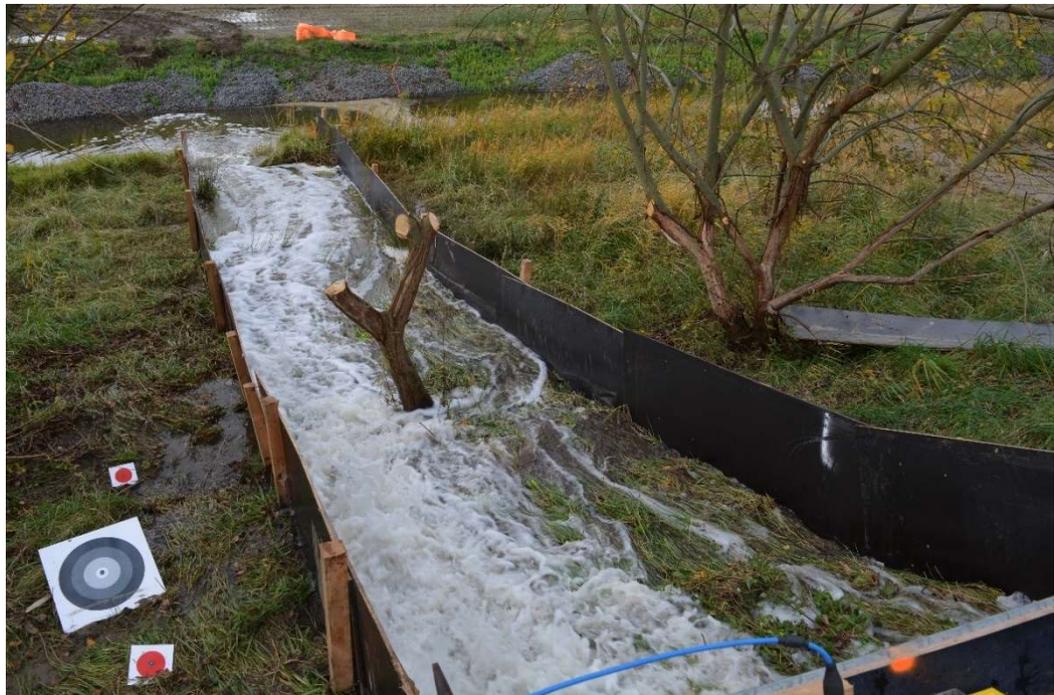
Figure 30 - View on the overflow around the tree.

Besides these sand boils, the normal exposure of grass roots and appearance of bare spots in between sods of grass became visible. This indicates soil erosion, but not to a critical state.

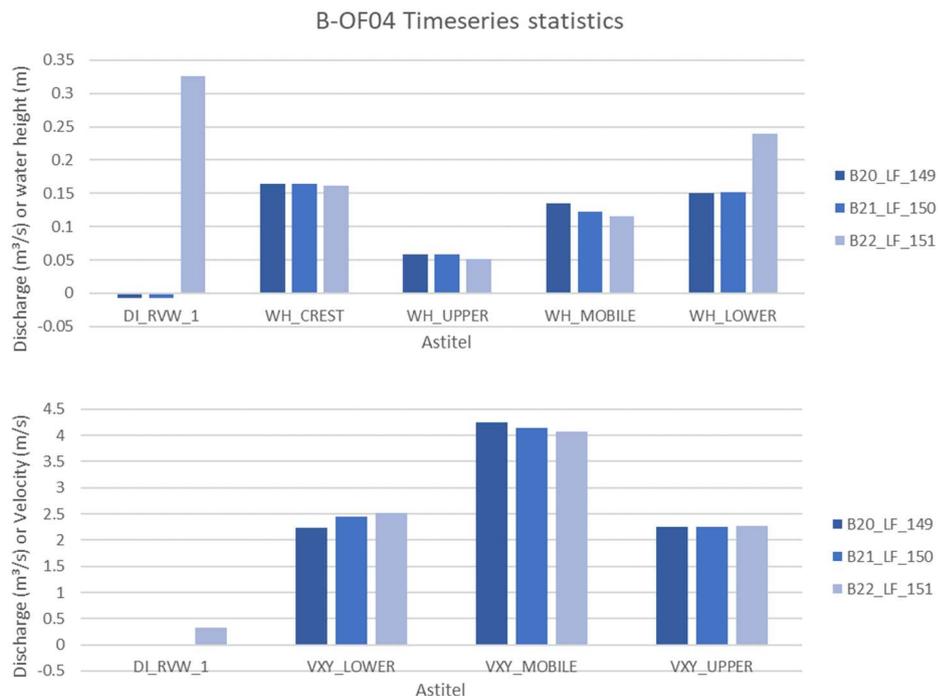
Figure 34 - Timeseries statistics per overflow block.

It is noted that the water height at the lower location in the last block is 8-9 cm higher than in the preceding two blocks. This is not a measurement error, but due to ground subsidence under the sensor (indicating imminent/approaching failure). Due to the impending collapse of the cover layer (see the description and interpretation above), the distance to the sensor had increased already (this was also visually observed).

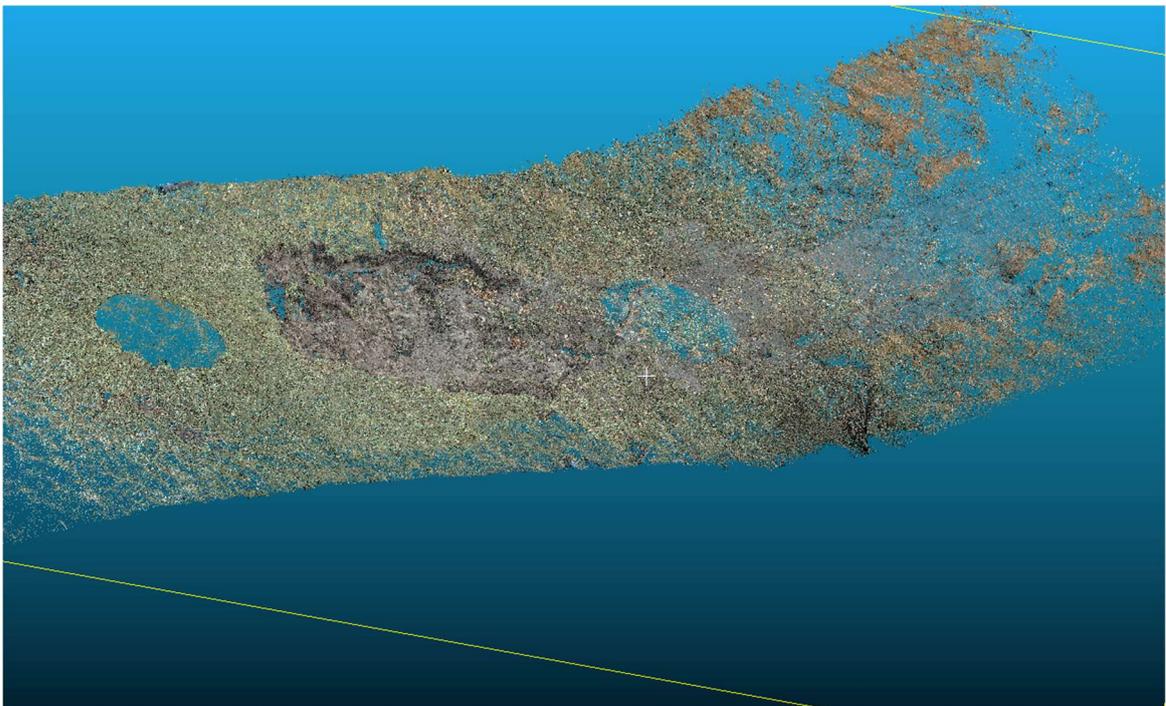
After the initial collapse, it was observed how the sand core under the cover layer had a fluidized aspect, mobilized and led to a further collapse of the cover layer. After the sand core was sufficiently drained, this collapse process stopped. In this manner, the cliff wall travelled back- and upwards for about 2 meters after the initial collapse.

Figure 36 - Screenshot of the 3DLS scan of the damage.

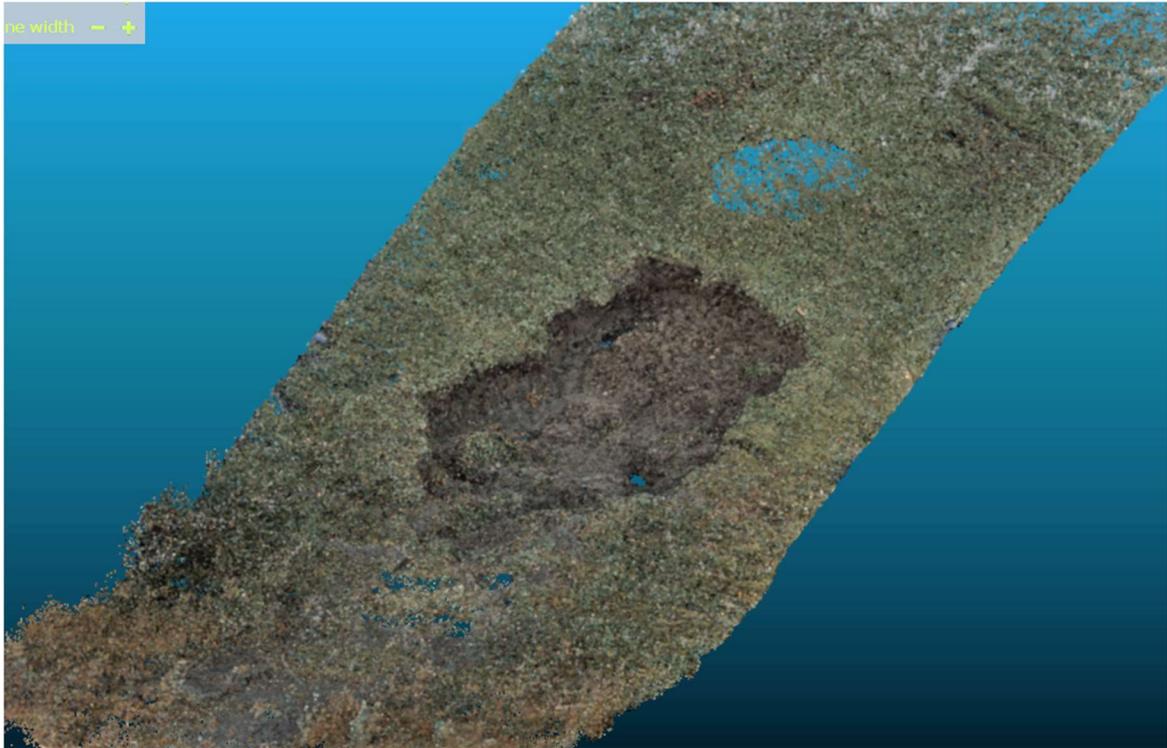
Figure 37 - Screenshot of the 3DLS scan of the damage.

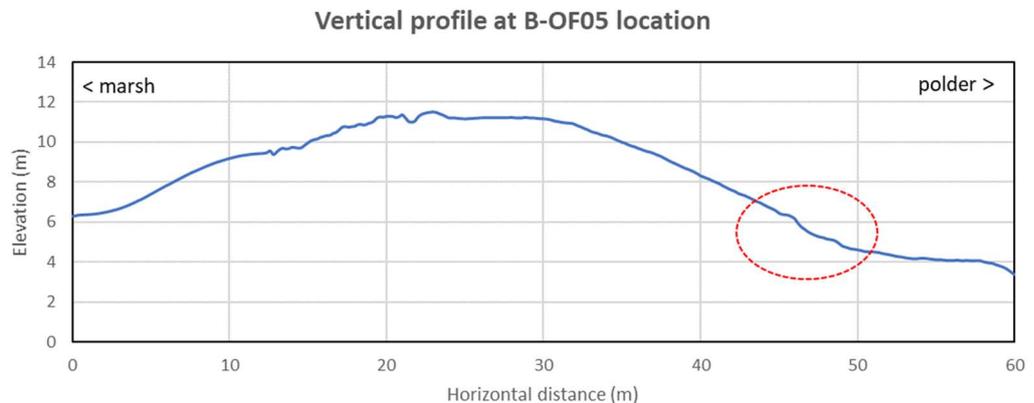
The levee slope is characterized by a local, steep cliff of more than 1 meter high near the levee toe (Figure 39). This cliff probably originates from grazing and sleeping of animals (sheep).

Figure 38 - B-OF05 topographic profile (erosion cliff noted in red circle).

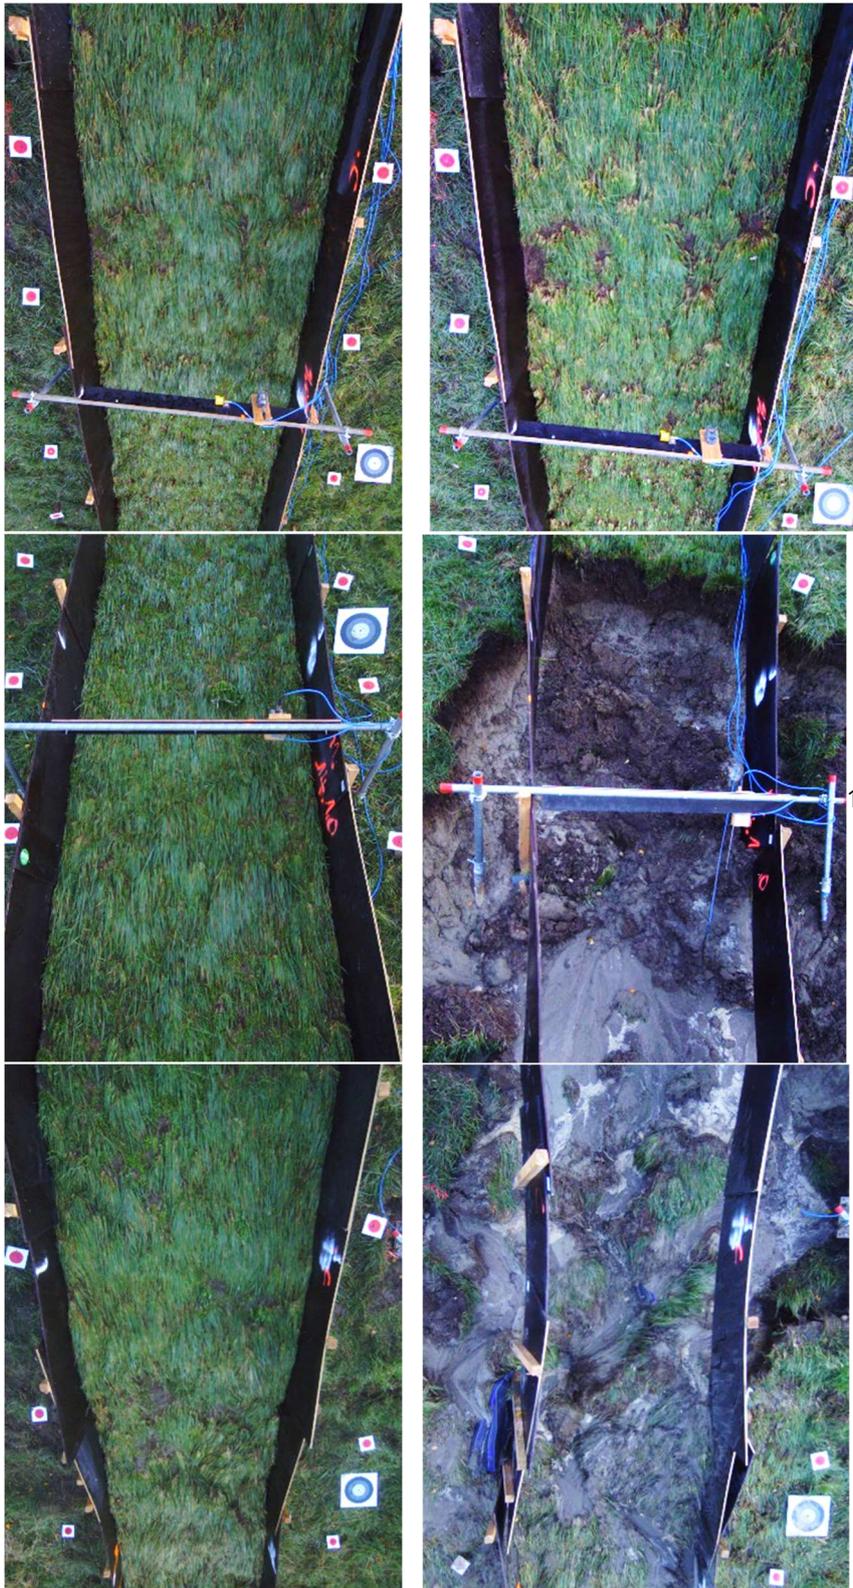
Figure 42 - Image composition of the test section state at the start (left) and the end (right) of the B-OF05 test.

- The section B-OF05 has developed into a slope instability after 17.1 hours of overflow. The process responsible for this is, however, not exactly known. It is assumed that gradually surface erosion of the cliff area, resulting in steepening of the slope and a cover layer getting thinner, suddenly gave rise to a connection with the sandy core, giving rise to an abrupt failure.

The damage created during the B-OF05 test, was repaired with an infill of rock bags. Later, this area has been subject to further investigation. The description and discussion of design, emplacement and mechanical performance of this damage repair solution is outside the scope of this report. Overflow was performed and it was found that animal burrows facilitated the flow of water under the cover layer, into the rock filled void.

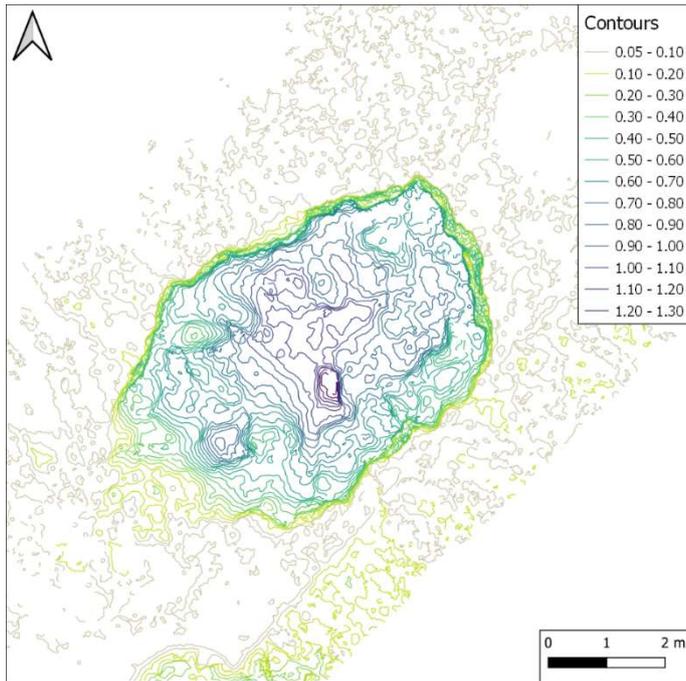
Based on the 3D-laser scanning data acquired before and after the experiment, it is possible to perform volume calculations of the damage. It appears that the cavity created has a volume of approx. 16.4 m<sup>3</sup>. A contour map of the height difference, and visualisation of the damage based on the LiDAR data are shown in Figure 45 and Figure 46..

Figure 45 - Contour map of the T0-T1 vertical height difference .

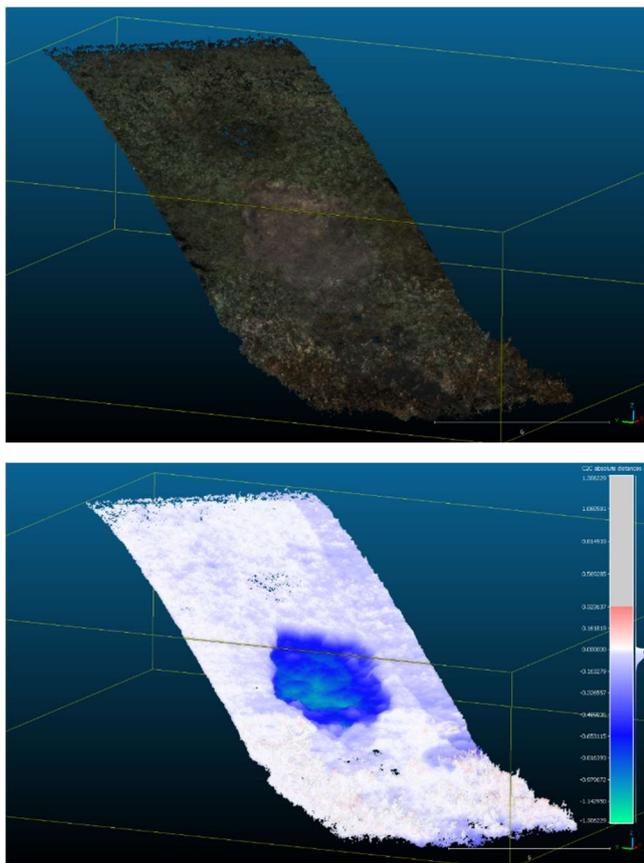
Figure 46 - Top: RGB coloured point cloud. Bottom: Difference between point cloud at initial state (not shown; T0) and the damaged section (T1)

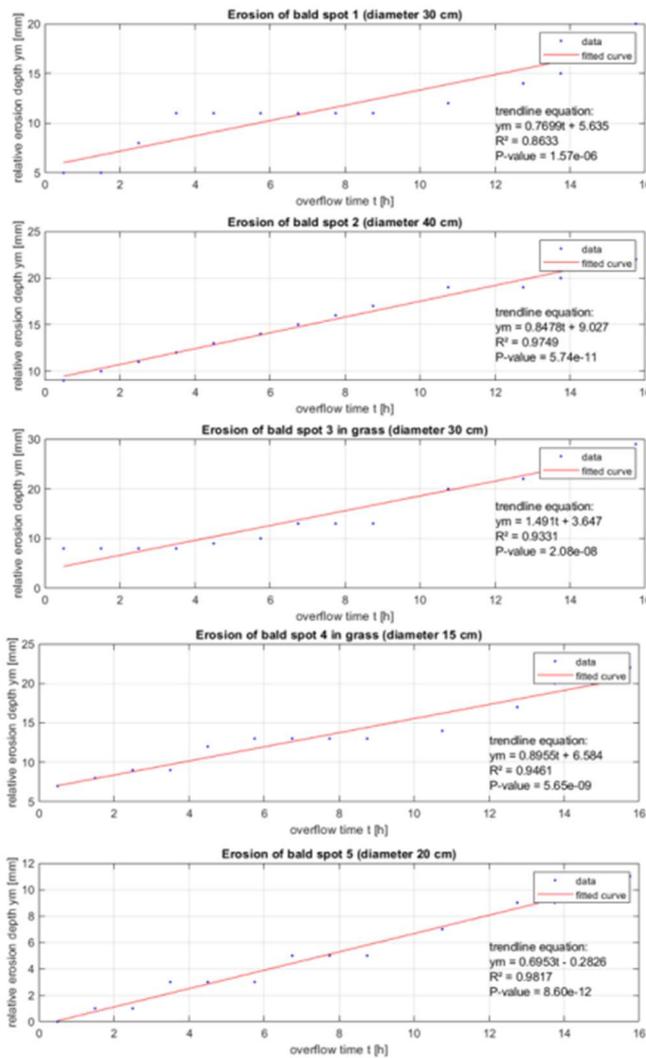
The results of this test relate to the erosion of patches on the levee slope and are discussed in Van Daele & Vandenbussche (2021). The erosion data and trends are reproduced here. Based on this data, a calibrated erosion curves relating maximum water velocity and duration was presented and compared with other data and models.

Figure 50 - Erosion measurements and trends of the different patches (from Van Daele & Vandenbussche, 2021).

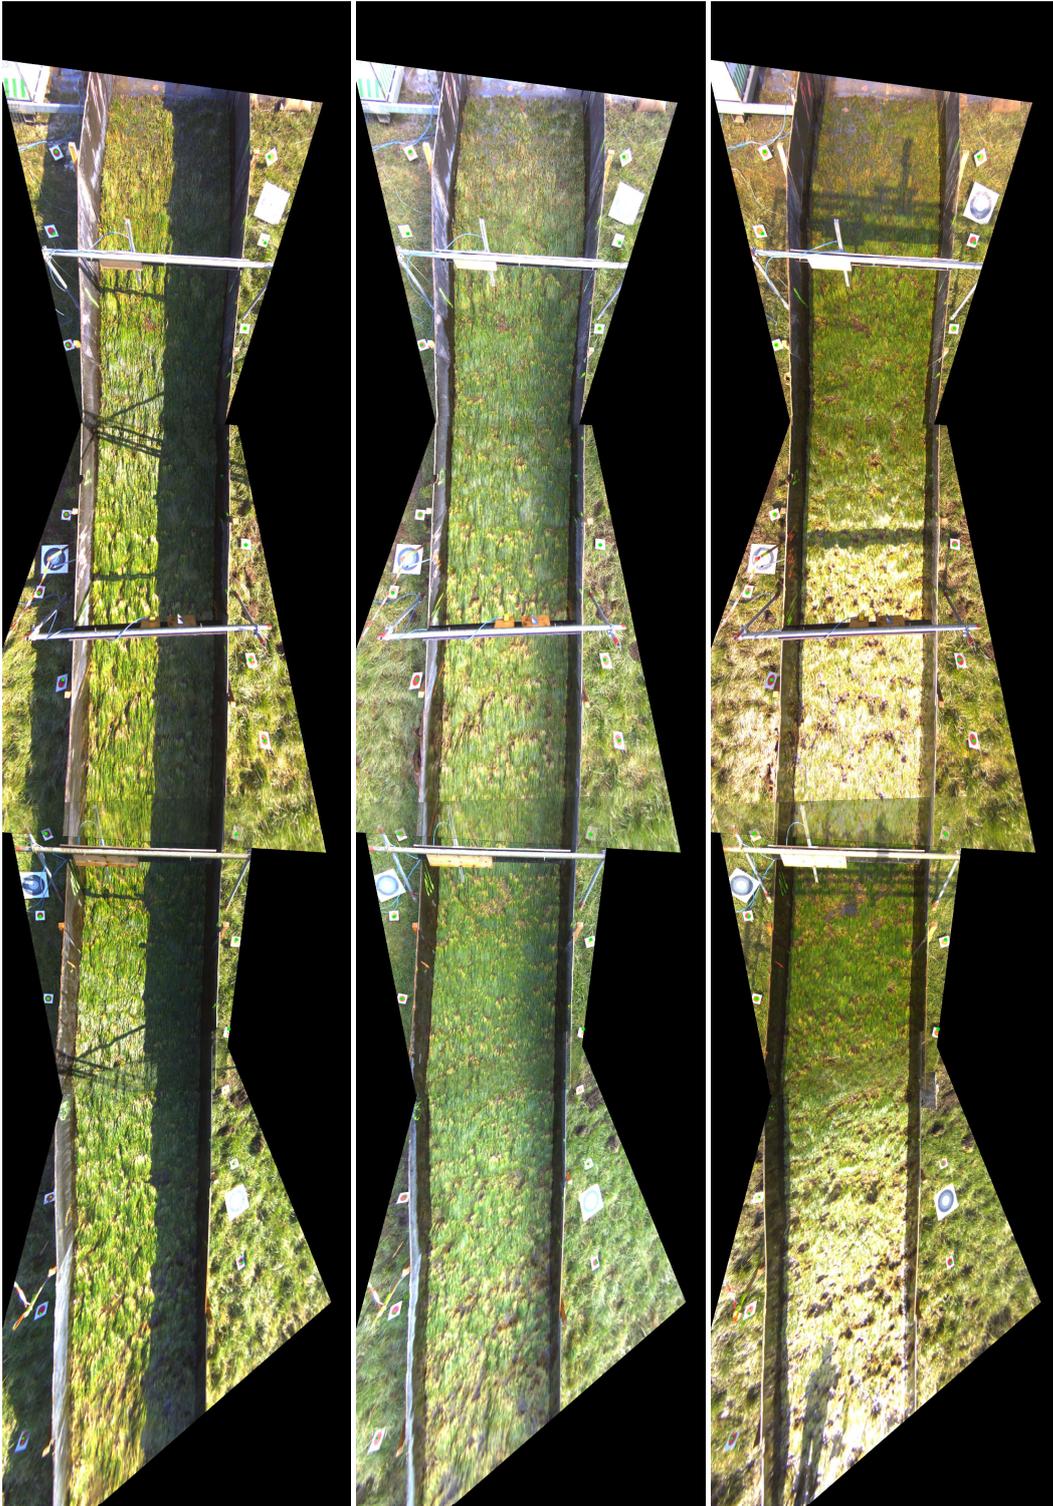
Figure 67 - Evolution of surface during experiment B-OF09 after block 1, 4 and 12.

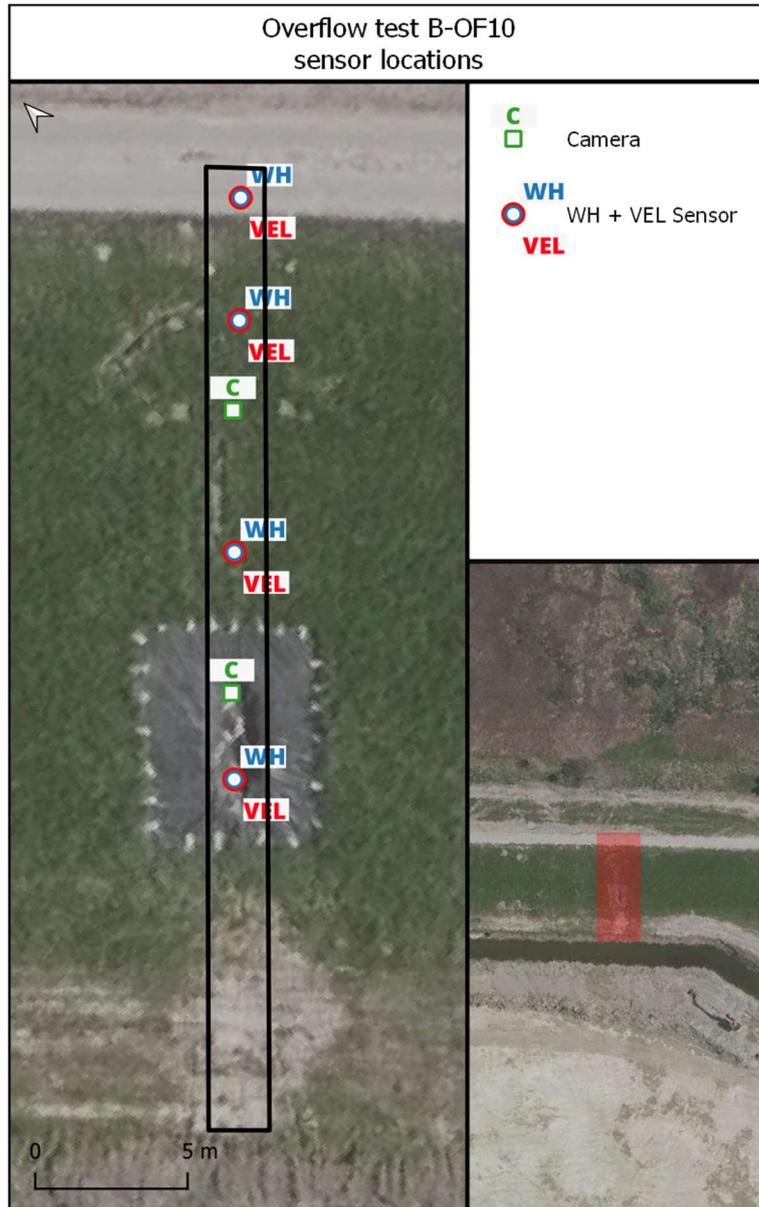
Figure 71 - Sensor location of the B-OF10. Aerial photograph background shows damage repair.

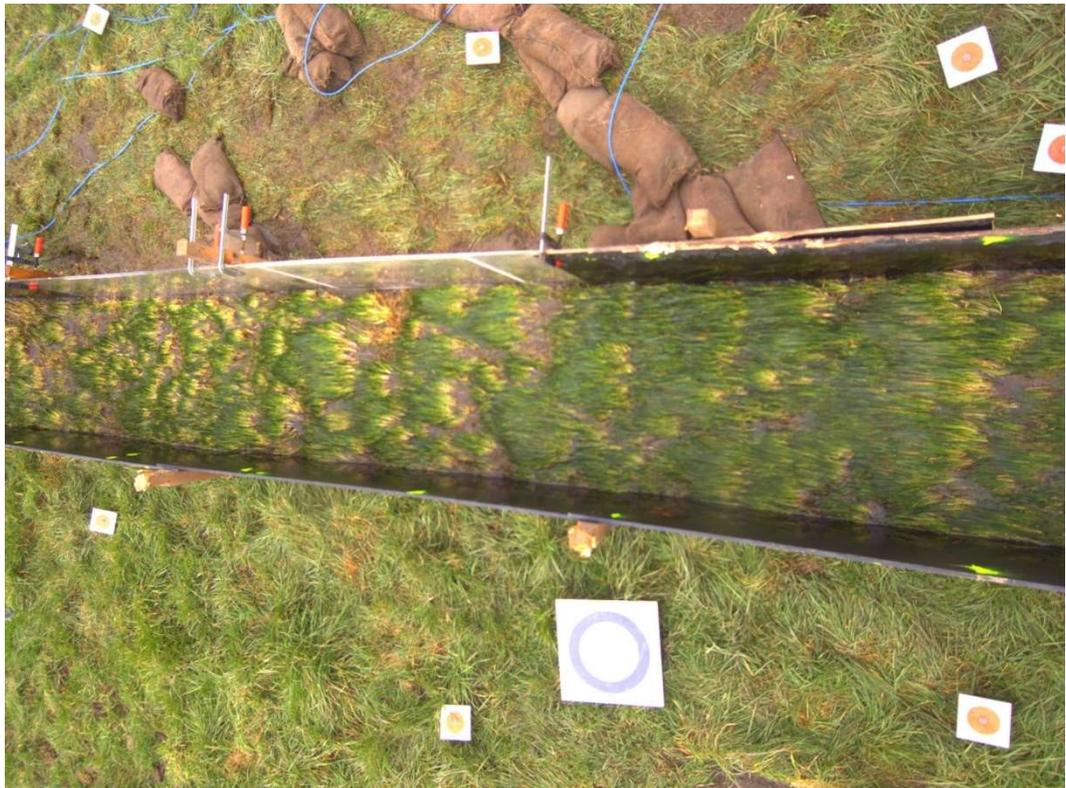
During the B-OF10 test, a normal progression of top layer and vegetation erosion was visible. With increasing duration grass roots became increasingly exposed and parts of soil became visible. However, during the first 4 hours of this very high discharge load ( $550 \text{ l.s}^{-1} \cdot \text{m}^{-1}$ ) the cover layer itself stayed intact along the entire slope.

Figure 72 - Example of vegetation and top layer state after block B08.

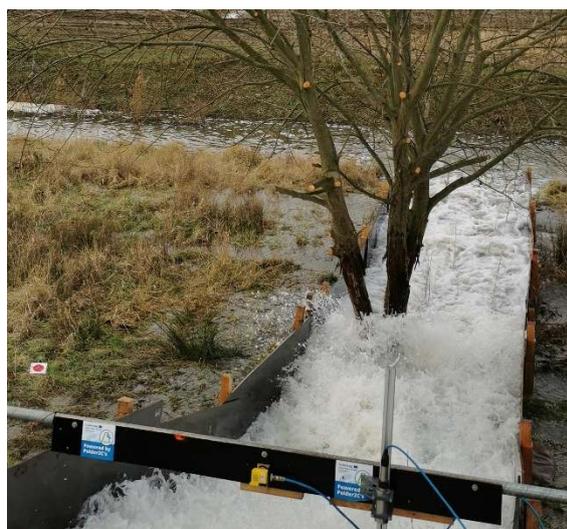
The main anomaly, and simultaneously the test objective of this test, is a large tree situated at the toe of the levee, as shown in Figure 76. Besides the tree, no major or significant anomalies were observed before the start of the experiment.

Figure 76 – View on lower part of the B-OF11 section, with tree at the levee toe.

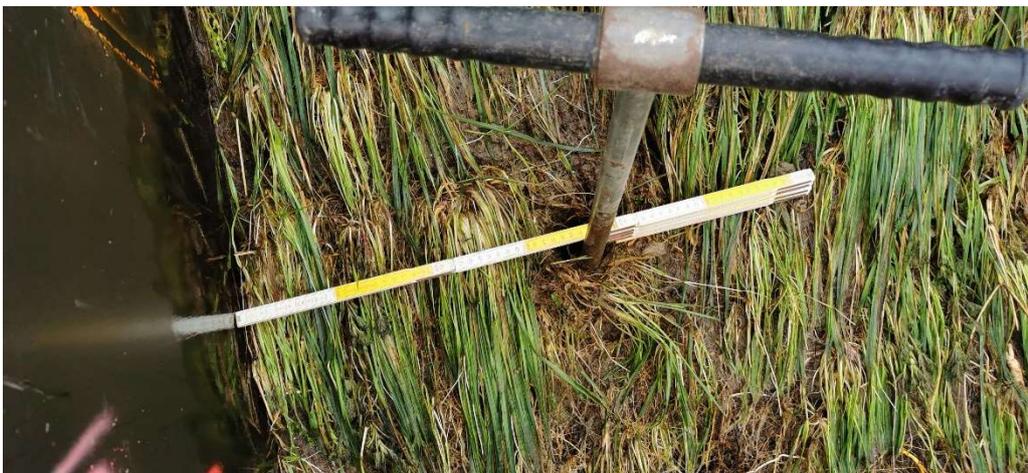
The erosion around the tree was not seen as a real threat or risk. The overflow continued at  $500 \text{ l.s}^{-1}$ . Because of timing constraints (the experiment would have to be ended on this day) and the question whether burrows played a role in the levee slope destabilization, two burrows were dug: one vertical hole inside the levee test section, and one horizontal hole outside the levee section, so that an 'artificial burrow system' was created, because the two drillholes made contact. During the subsequent overflow block, it was observed how water flushed through the connected pipes, however not transporting any sediment. (It was thought that the length of the burrow under the cover layer was too short to significantly entrain sediments). After 30 minutes, the burrows were drilled a bit deeper, up to 70 cm and an additional hole from outside the section was drilled.

Figure 80 - Drilling a hole 70 cm deep, 40 cm from the "right bank" of the channel.
