# Management of harmful animal activities on levees: Fact finding fieldwork in the Living Lab Hedwige-Prosperpolder

Adaptation  
to climate  
change

Vana Tsimopoulou, André Koelewijn

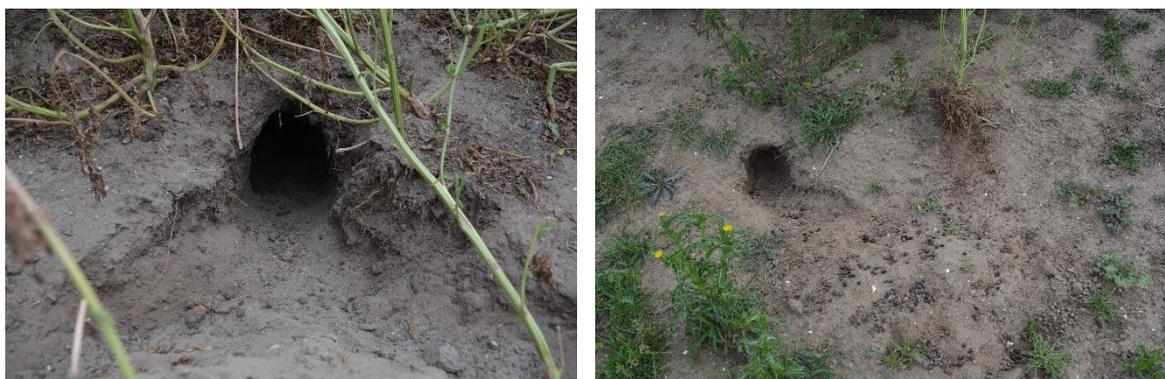
Several months later, the Scheldt levee along the Doelpolder was revisited to carry out an ERT survey (see §2.4.1). By then, the clay heaps were overgrown and new entrances to animal burrows were found in many of them. Some examples are shown in Figure 2.9 to Figure 2.11.

Figure 2.10. Entrances to animal burrows in the clay heap of Figure 2.9.

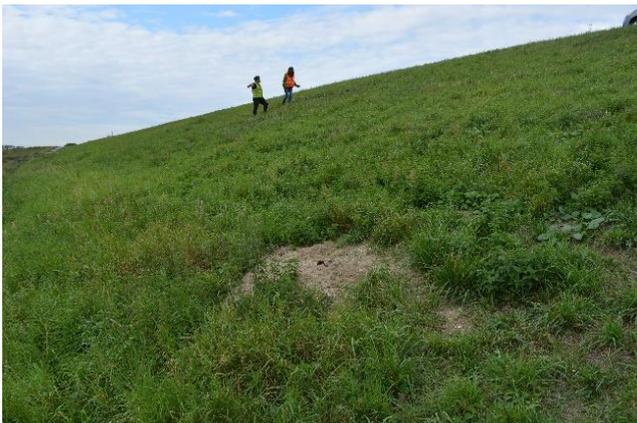
Two weeks later, on the occasion of the ERT measurements at the Hedwigepolder (§2.4.2), a foxhole was discovered near the landside toe of the Scheldt levee along the Prosperpolder, as shown in Figure 2.12. ERT measurements were carried out here on the 27<sup>th</sup> of October 2020 (§2.4.3).

Figure 2.12. Landside slope of Scheldt levee along the Prosperpolder, with an animal burrow in the foreground showing fox's excrements.

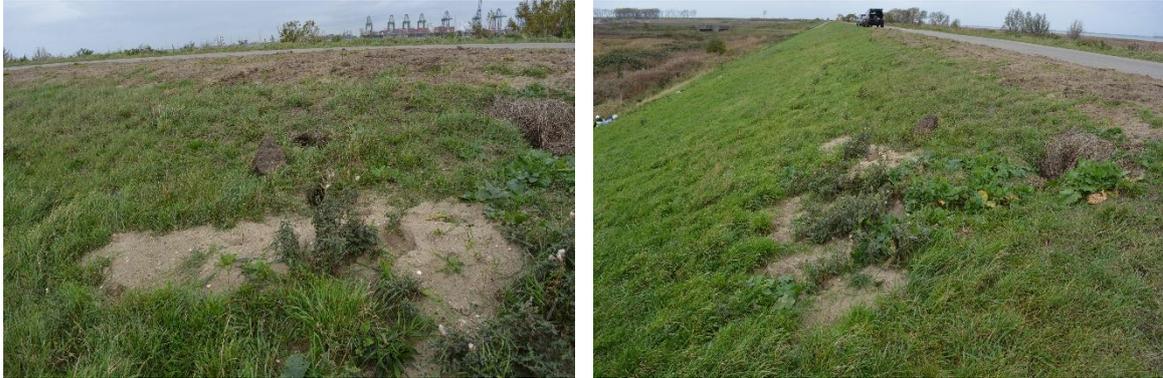
The next month, at a location near to the location shown in Figure 2.12, but much higher on the slope, close to the crest, new and fairly large holes were discovered, see Figure 2.13. The sand indicates that the hole extended into the sandy core of the levee, i.e. beyond the clay cover layer. The vegetation that already had

grown on top of the sand indicates that this must have happened rather soon after the exploration of the foxhole mentioned in §2.2.5 and §2.3.2.

Figure 2.13. Excavated sand close to the crest of the landside slope of the Scheldt levee along the Prosperpolder.

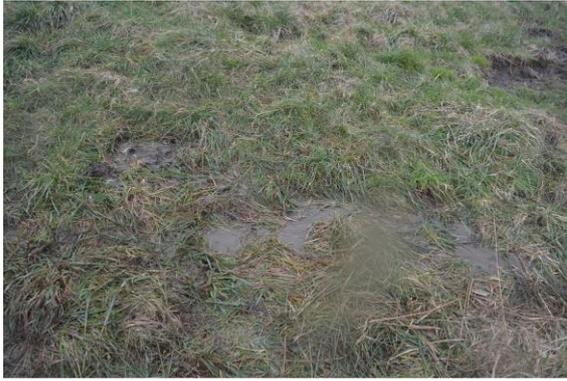
Figure 2.15. Sand deposits at reactivated burrow exit outside the flume.

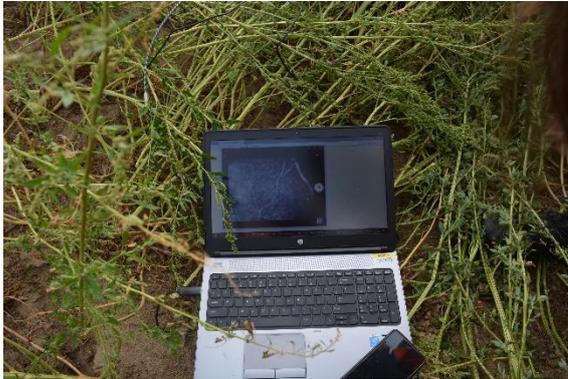
The system was first employed at the landside slope of the Scheldt levee along the Doelpolder, on the 1<sup>st</sup> of September 2020 (Figure 2.19). It appeared to be virtually impossible to determine the location and the orientation of the camera, including a detail like the direction of gravity (although often roots hanging down

in the burrow gave a useful indication). Moreover, it appeared impossible to steer the device into the desired direction, e.g. a different burrow than before at an underground intersection.

Figure 2.19. Screen during application of the camera in the Doelpolder

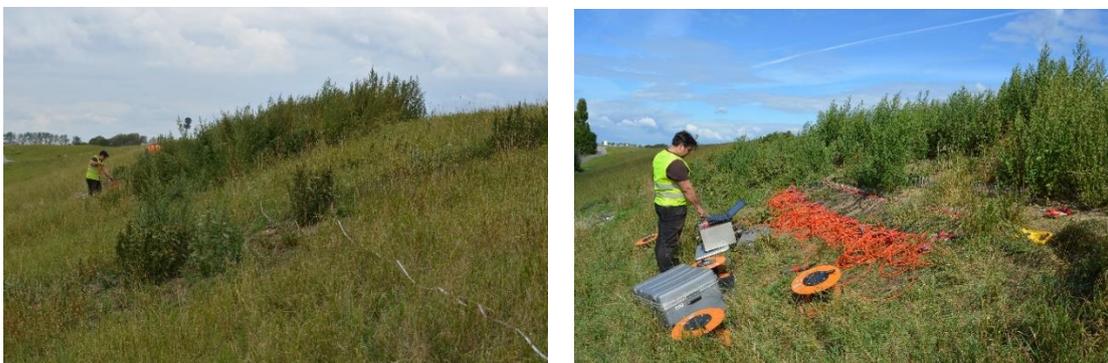
Some characteristics of this site are already given in §2.2.1, §2.2.2 and §2.2.4. For this first ERT survey of animal burrows, a location was chosen where two large holes were clearly visible at a location where earlier animal burrows were covered by clay. Presumably, the older burrows had been accessed again. First, two lines along the slope were measured after each other. Each of these lines had a 10 cm electrode spacing and 50 cm between the lines, as shown in Figure 2.20 and Figure 2.21. This spacing has initially been chosen to ensure sufficient resolution to enable detection of holes in the size of 5-10 cm, and larger.

Figure 2.20. Site at Doelpolder. Left: overview, right: data acquisition in progress.

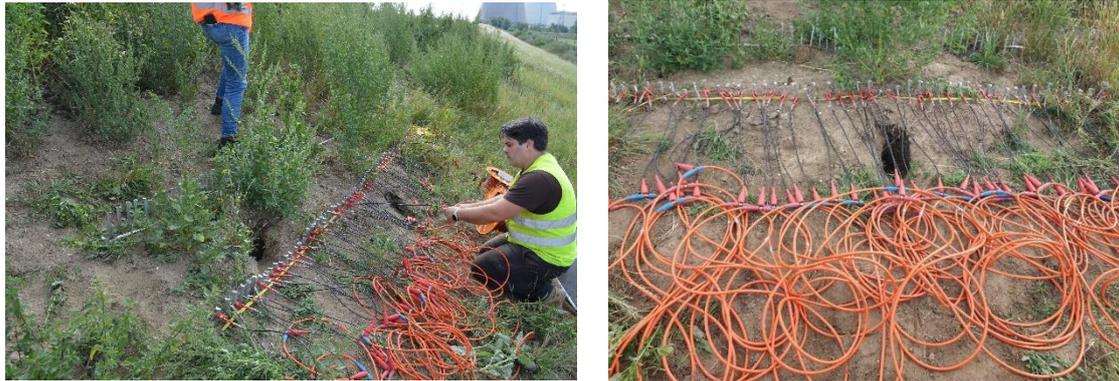
Figure 2.21. Doelpolder, left: two rows of pins across two holes (connected underneath), right: view from below. An interpretation of the results is given in Figure 2.22. At the lower line, both holes are clearly visible. This corresponds with other observations in the field. At the upper line, a larger hole seems to be present at a depth of about 1 m. Near to the surface, no hole is detected. The blue parts indicate low resistivity, likely from (wet) clay.

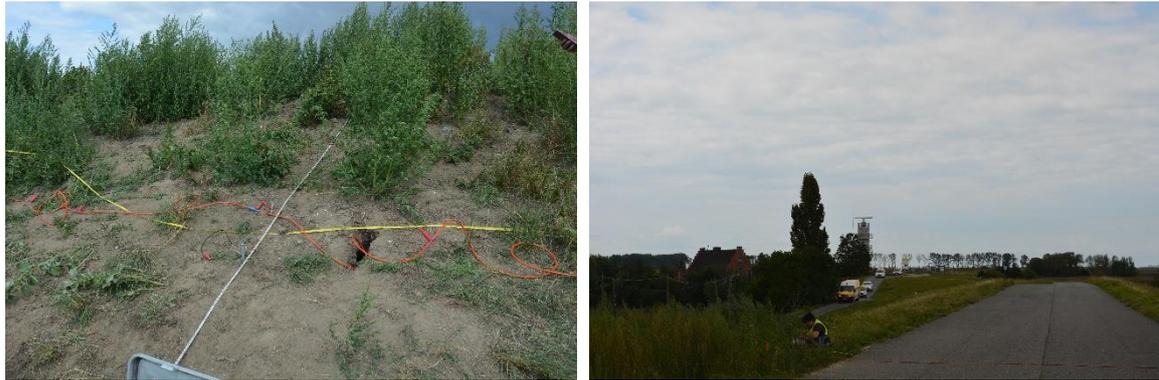
In addition, two lines were measured perpendicular to each other, with a much larger spacing: 50 cm between the electrodes. One line was laid out in the same direction of the previous two lines, extending in both directions beyond the limits of the previous lines, see Figure 2.23 (left). The other line was laid out across the levee, starting at the landside toe and ending on the waterside slope, across the crest, see Figure 2.23 (right). Unfortunately, no meaningful results were obtained. The presence of the asphalt layer on the crest, effectively reducing the number of electrodes connected to the soil, had a significant impact.

Figure 2.23. Doelpolder, lines with 50 cm spacing between electrodes. Left: lines crossing near the holes, right: line across the crest.

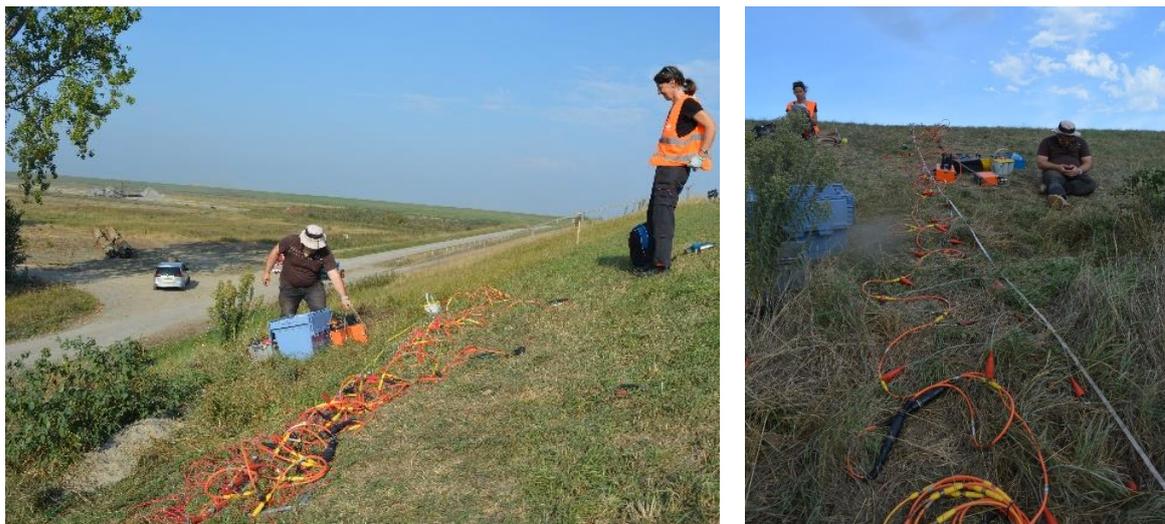
The next series of ERT measurements was carried out at the location on the Scheldt levee along the Hedwigepolder where in the past years repeatedly a larger animal burrow with a fox was detected, near the staircase and the former summer house of the owner. Here, two perpendicular lines were applied, shown in Figure 2.24. The electrode spacing differed between the two lines: for the line parallel to the levee, a 10 cm spacing was applied, while for the line perpendicular to the levee, a 30 cm spacing was applied.

Figure 2.24. Hedwigepolder, left: measurements parallel to the levee, right: measurements across the levee.

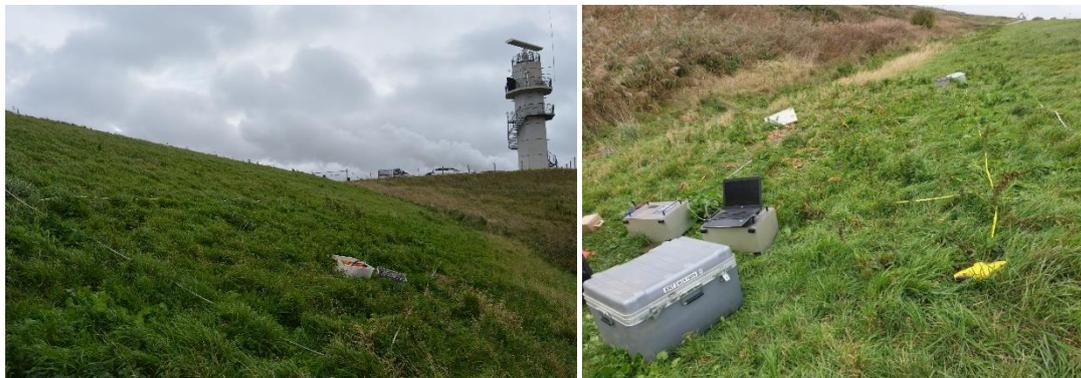
The third series of ERT measurements was carried out at a foxhole close to the toe of the landside slope of the Scheldt levee of the Prosperpolder, near the radar tower (Figure 2.26 left). At this location, a full 3-dimensional configuration was utilized, with 9 parallel lines having 0.25 m electrode spacing along each line and 0.5 m interline spacing. The field situation during acquisition is shown in Figure 2.26 right.

Figure 2.26. Prosperpolder, left: location of the ERT measurements, right: overview of the acquisition site during the measurements.

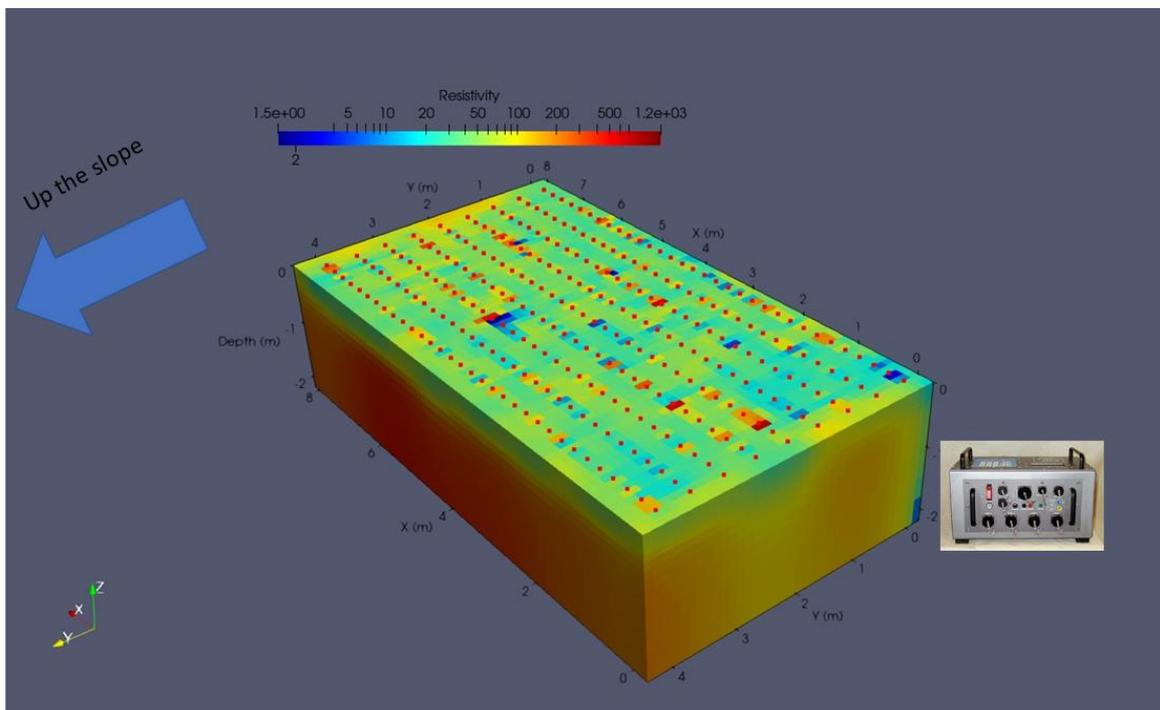
Some of the results are shown in Figure 2.28 and Figure 2.29. In the last figure, the subsurface animal burrow is clearly visible in the results.

Figure 2.28 3D volume results.

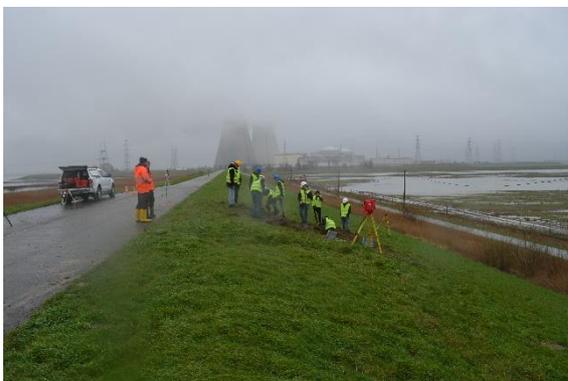
Figure 2.30. Overview of the animal burrow excavation alongside the Doelpolder.

The main conclusion from this exercise was that it is rather difficult to keep track of the original excavation depth and to discern all, or at least any, branches in the burrow. The excavated material partly falls into the burrow, obscuring the view of the people excavating. Besides, proper mapping of the excavation on levee with a varying slope appeared to be more difficult than anticipated.

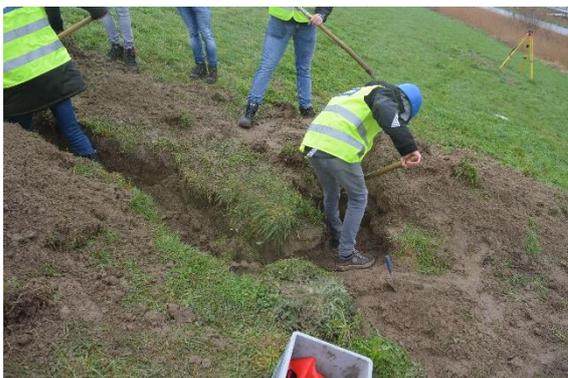
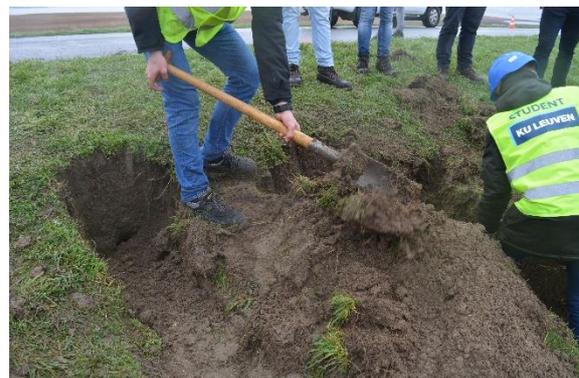
Figure 2.31. Excavation of animal burrow in progress.

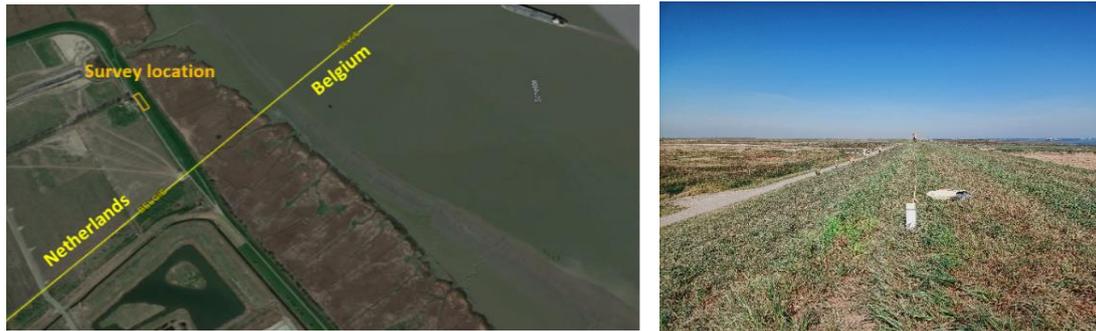
Figure 4.37. Left: Map indicating the location of the animal burrows survey on 8th September 2021. Right: Picture of the surveyed levee from the crest.

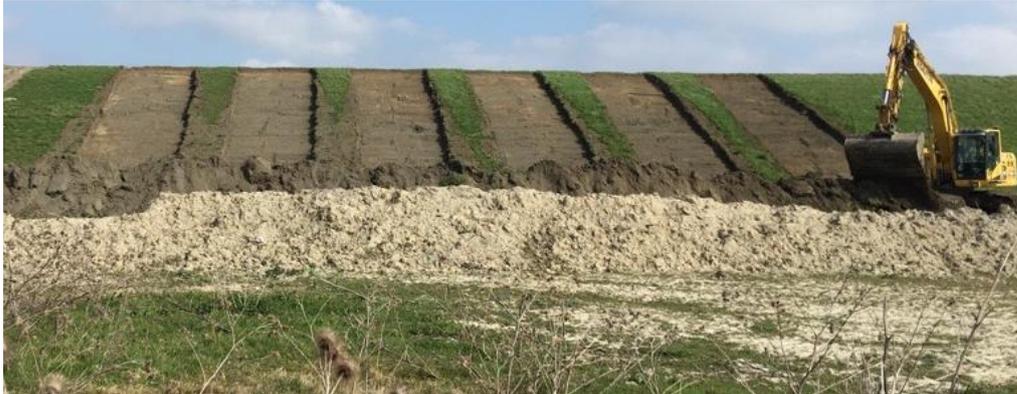
Figure 4.44. Preparation of sections before application of repair strategies on the southeast side of the concrete staircase in June 2021.

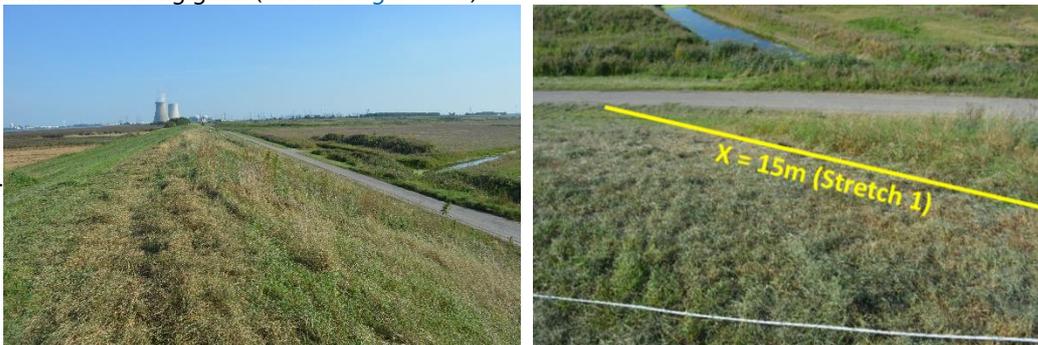
expected. For this reason the team decided to only record the exact location of every burrow without keeping a detailed record of the diameter and depth per burrow. By the end of the survey the group confirmed that the diameters of all burrows were in the range 1-10 cm, and their depths did not exceed 25 cm. Considering the time needed and the fact that burrows were difficult to spot even in mowed areas, the team decided not to survey the area with long grass. A casual observation of the transition between the mowed and unmowed area made it clear that it would be very difficult and time consuming to spot burrows with diameters of 10 cm in areas with long grass (see also [Figure 4.45](#)).

Figure 4.45. Left: Landside slope with long grass in the first 15 m of stretch 1. Right: Transition between mowed and mowed grass in stretch 1.

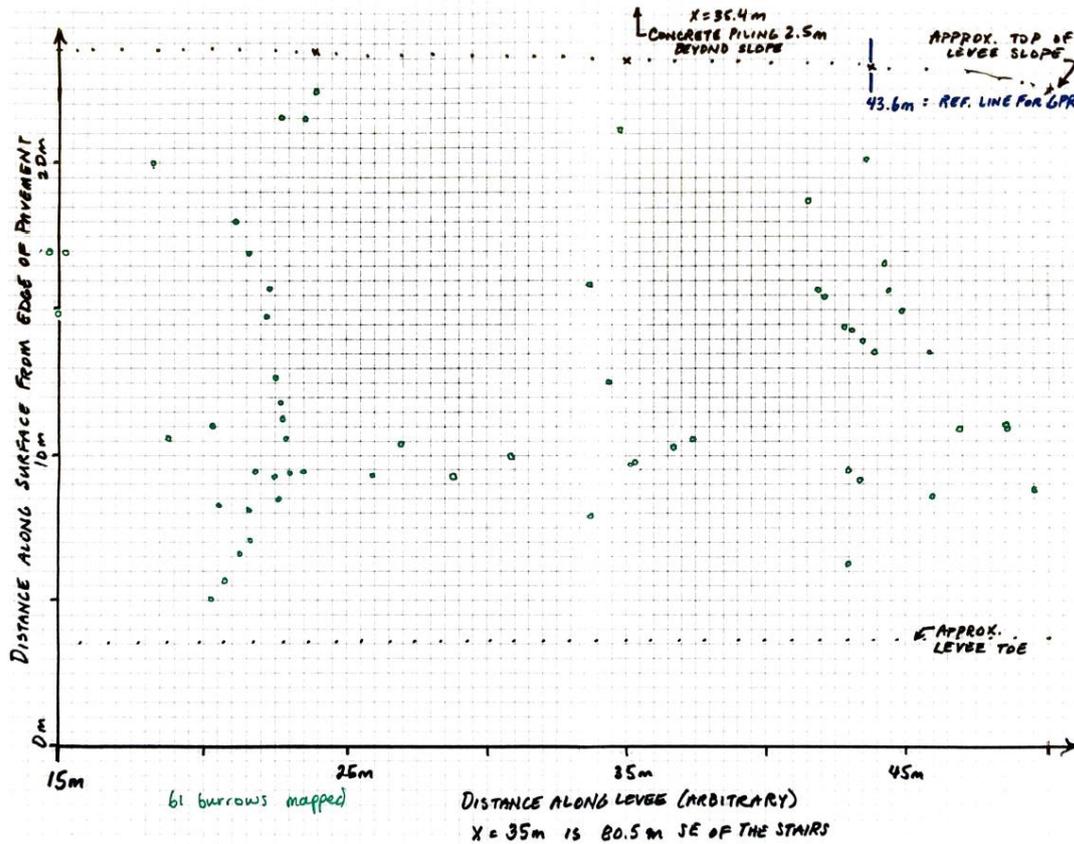
In stretch 1, the team started from the 35m-long levee part with mowed grass, whose area is  $35 \times 22.5 = 787.5$  m<sup>2</sup>. In that part they detected in total 61 burrows, resulting in 0.08 burrows per m<sup>2</sup> or 1.7 burrows per linear m of levee. This part was completed within 3.5 hrs, which was almost twice as much time as it had been initially

Comparing the two stretches, it is clear that in stretch 1 there is a higher density of burrows, but this is likely a random fact. There were no obvious differences in the physical characteristics of the two stretches that could justify this difference. The vegetation was homogeneous and in both stretches the grass was mowed. The levee geometry and the layers of clay and sand in the subsoil were also uniform, as evidenced by the surveys that were performed in June and July 2020 by the Polder2C's team (Depreiter et al. 2021). The difference in the density of burrows could be partly attributed to the fact that a visual inspection cannot be 100% accurate. Based on previous research, the accuracy of visual inspections can be considered limited as the detection capacity can vary significantly among inspectors (Klerk et al. 2021, Klerk 2022). This finding was also confirmed during this survey, as the inspectors noticed that most burrows were missed the first time that an inspector walked close to them. The more eyes that scanned a spot, the more burrows were found.

Figure 4.46. Spatial distribution of burrows in stretch 1

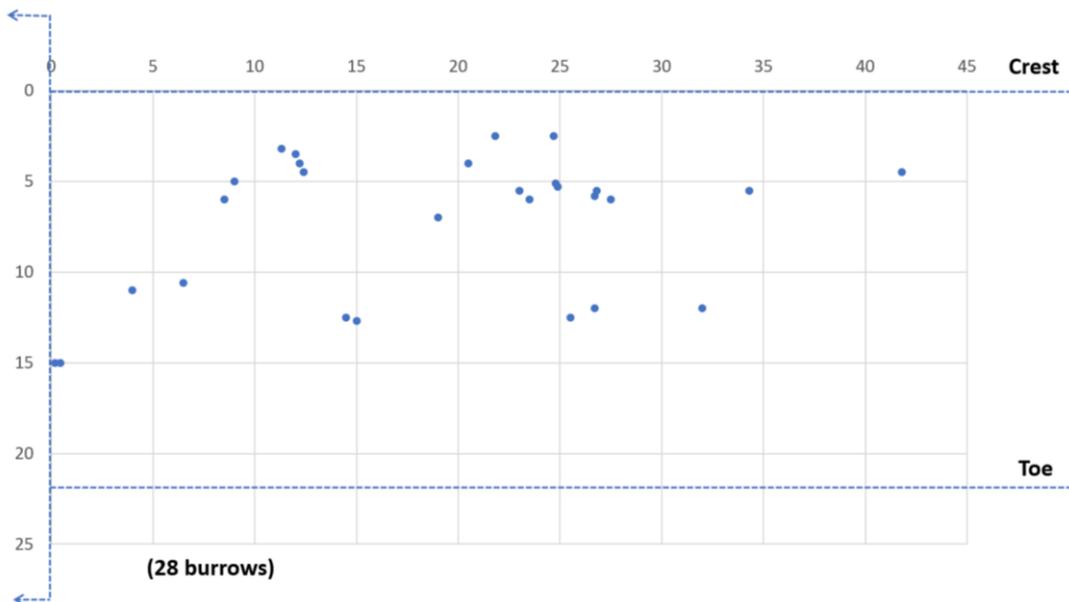
Figure 4.47. Spatial distribution of burrows in stretch 2

These images make it clear that the burrows are not uniformly distributed on the levee slope. There are areas without any burrows and there are areas where burrows are clustered in a relatively small space. Burrows that are concentrated in a small area may be an indication of an underground den of small rodents that can have multiple chambers interconnected with corridors and multiple exit points (see e.g. Avenant & Smith 2002). In stretch 1, apart from clusters, burrows positioned in linear pattern with vertical orientation could also be discerned (see also Figure 4.48). Such linear patterns can be an indication of a linear underground tunnel,

which is characteristic of mole burrow systems (see also Thomas et al. 2013). According to Abel de Boer from Wetterskip Fryslân, who participated in the mole burrow grouting in the living lab in June 2021 and has long experience in the detection of animals on levees, moles build their nests in dry spots, but they create tunnels towards more humid soil, where they can easily find food. This is because warms and other insects are more likely to be found in soil with higher concentration of water. This could be an explanation of the vertical orientation in the linear patterns. It is likely that moles living on a levee build their nests closer to the crest than the toe, where the subsoil can be dryer, but they create tunnels towards the toe, where the soil can be more humid. Based on this analysis it is realistic to assume that burrows that are clustered close to each other and burrows that form a line with orientation crest to toe may be interconnected.

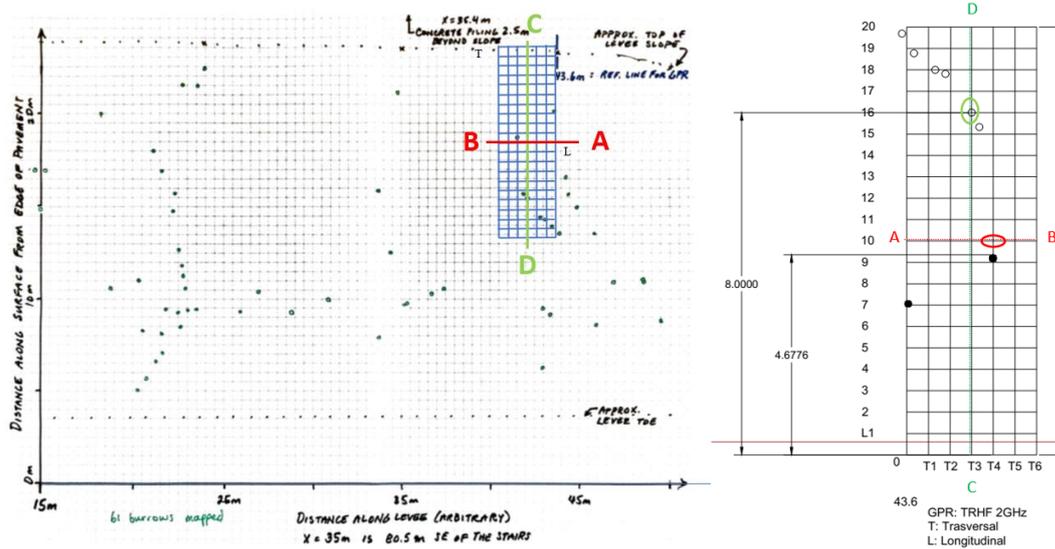
Figure 4.49. Left: Grid indicating the area that was scanned with GPR. Right: Top view of the GPR grid juxtapose with the inspection map, with indications of the positions of burrows and the longitudinal and transversal profiles C-D and A-B, respectively.

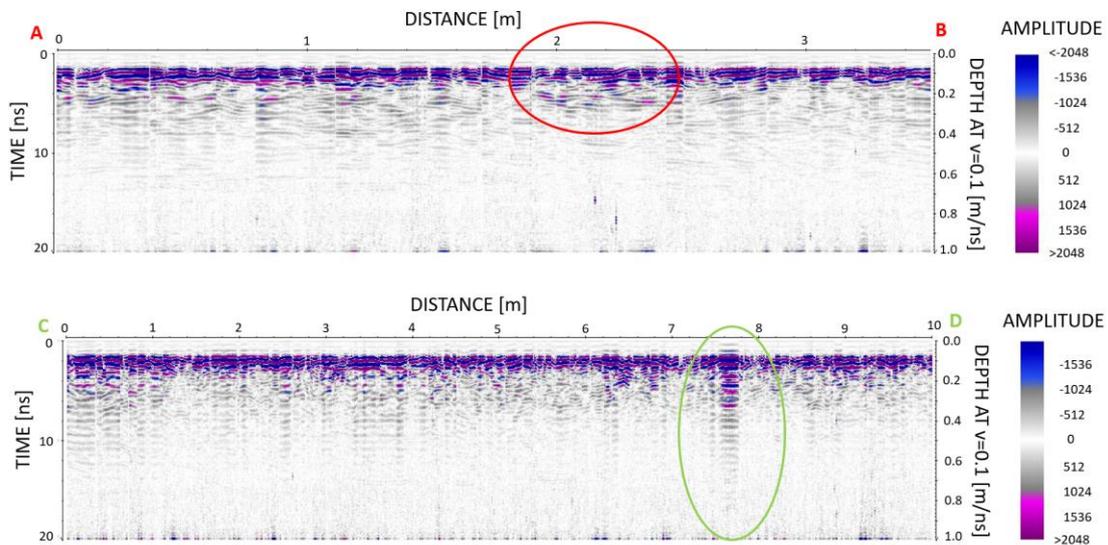
In Figure 4.50 the GPR results for the profiles A-B and C-D are shown. In the A-B profile the red circle shows inhomogeneity of up to a depth of about 25 cm from the surface, as the colour of the produced image is different, which shows that the consistency of the soil was different. Since in a distance of about 40 cm from that spot a burrow was detected (Figure 4.49, right), this inhomogeneity is most likely a trace of the underground structure of the burrow system. This inhomogeneity is indicated by a different colour in the produced image. In the C-D profile the green circle shows a similar inhomogeneity up to a depth of 35 cm. This is exactly at the spot where a burrow was detected.

Figure 4.50. GPR scans at the longitudinal profile A-B (top) and at the transversal profile C-D (bottom).

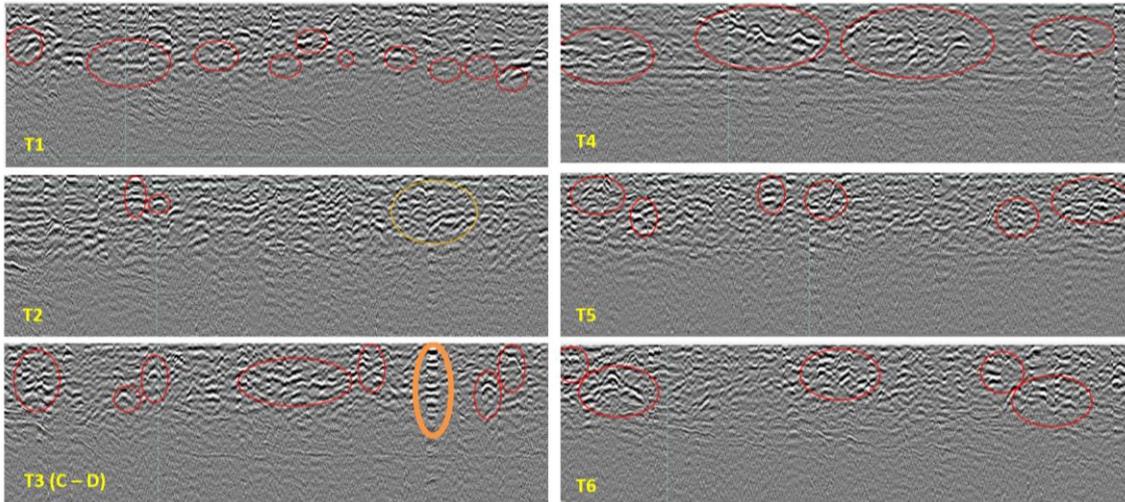
An overview of all 2D results for transversal transects from the 2GHz radar are shown in Figure 4.51. The circles indicate discontinuities that could be attributed to burrows. Further comparison with the results of the visual inspection may provide additional insights.

Figure 4.51. Overview of all 2D transversal transects that were scanned in 2GHz. Traces of discontinuities that could be attributed to animal burrows are indicated with circles.

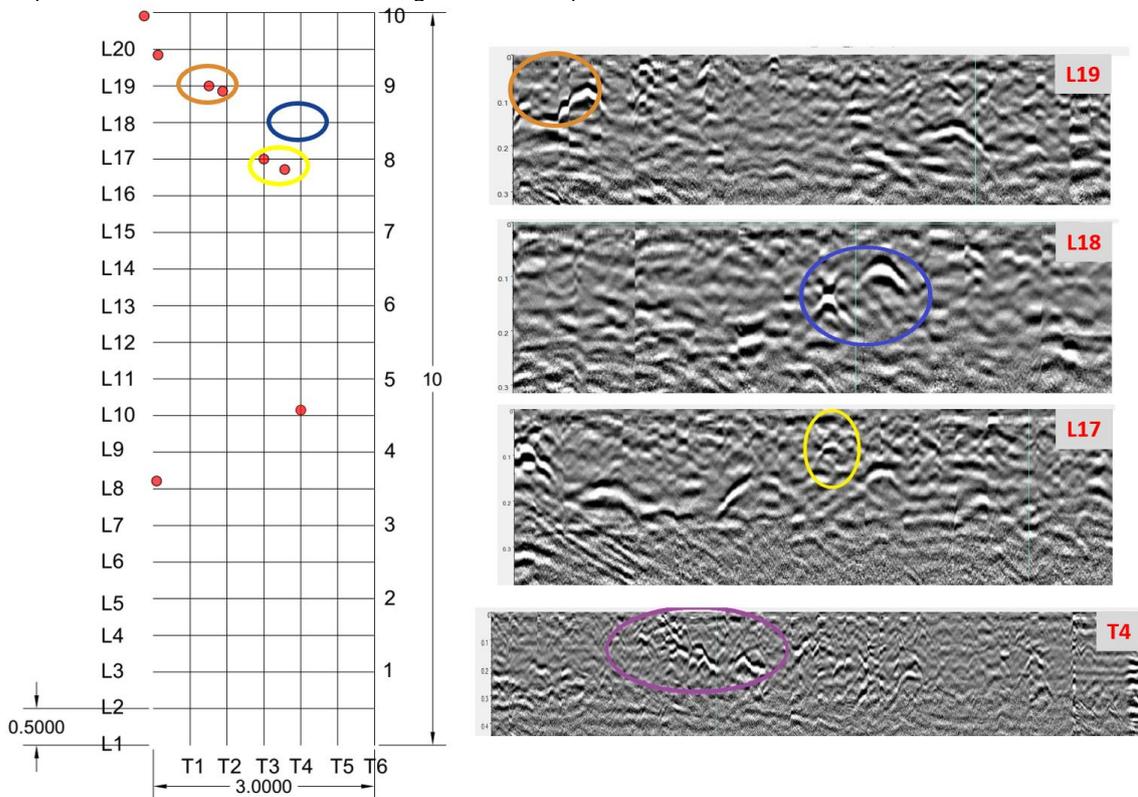
Figure 2.15. Comparison between visual inspections and GPR images.

After comparing between the 2D analysis of the data obtained by the 2G GPR and the visual inspections we can detect cavities in the upper surface near some of the discovered holes (see the yellow, blue and orange circle in transects L17, L18 and L19 respectively). This indicates the continuity of the discovered burrows underground. Around the rest of the burrows that were mapped on this location the GPR did not indicate any important cavity, which reduces their probability to be burrows of a larger network that leads to a den, or perhaps their dimensions are very narrow and cannot be detected. The 2D analysis of the GPR scans in this area shows many possible continued underground cavities (see e.g. the purple circle on transect T4), but no excavation was made in this area to verify if they are indeed a tunnel by a burrowing animal on this spot. A more meticulous analysis in the future may provide more insights. More precise results of the 2GHz GPR could be obtained if the distance between the scanned transects is smaller. This was tried out in subsequent experimentations in the living lab (see also chapters 6 and 8).

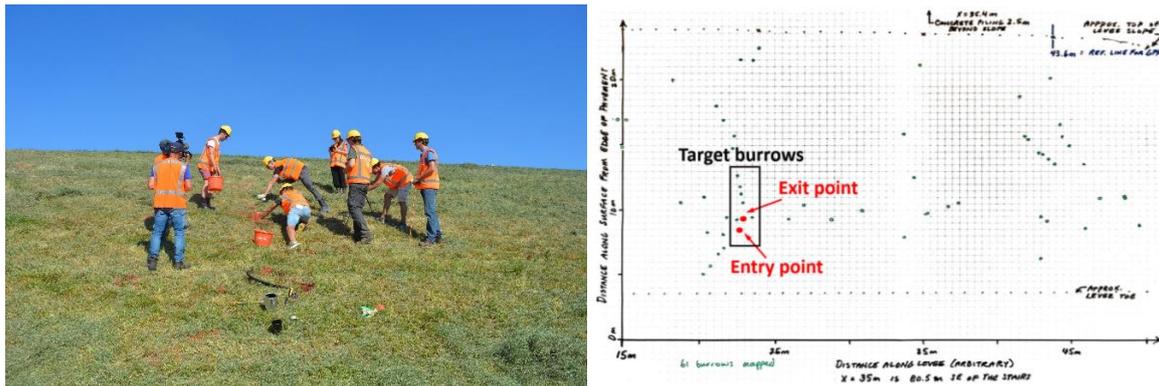
The smoke test was conducted when the mapping of burrows had been completed. Burrows that seemed to be part of a mole system were chosen for this. As an entry point the lowest burrow was selected. Within about 5 s after the team started injecting smoke, the smoke could be seen coming out from the closest burrow in the system (see also [Figure 4.52](#), right). Unfortunately the experiment had to be interrupted, because the experimental setup failed. In particular the hose that connected the barrel with the entry point on the ground was overheated and started melting. The team decided to improve the experimental setup and try out the experiment another day.

Figure 4.52. Left: Preparation of section for the smoke test. Right: Target area for the smoke test with indication of the entry point, i.e. where smoke was injected, and the exit point, i.e. smoke came out, before failure of the experimental setup.

3. The smoke test indicated interconnectedness between two burrows, but the setup failed during the experiment. The plastic hose was overheated and it started melting. This probably happened because the can that was used to retain the smoke and channel it to the burrow system was too small. This increased its temperature to a level that exceeded the melting point of the hose material.

In the end the smoke experiment was also executed with an improved set-up. In relation to the previous set-up, two key improvements were made (see also [Figure 6.65](#)); 1) The plastic hose was replaced by a rubber hose, and 2) the aluminium can was replaced by a larger metal barrel. The purpose of these improvements was prevent failure of the hose due to overheating, which was the case in the first trial of this experiment.

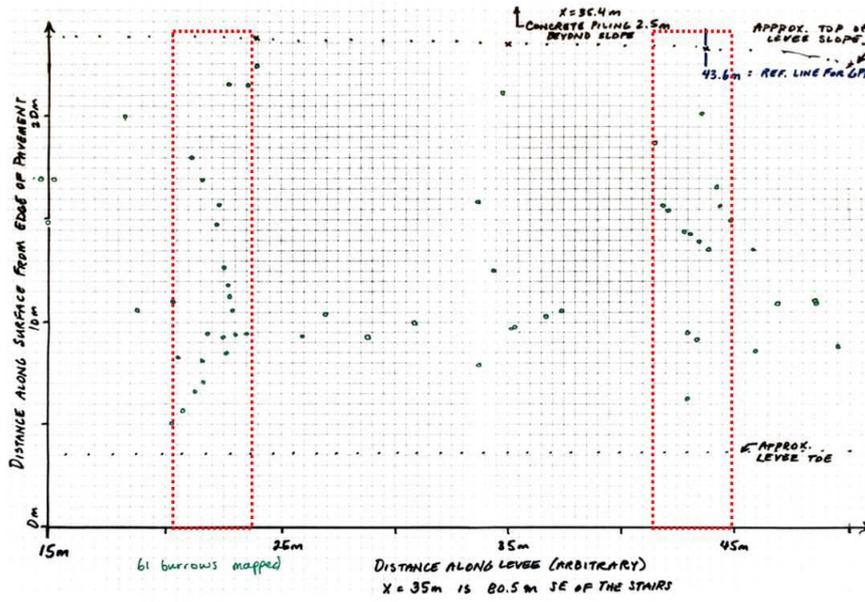
Two sections with high concentrations of burrows were selected as candidates for execution of overflow tests on burrows, which are indicated in [Figure 4.53](#). In both sections it was assumed that there were mole burrow systems, which are expected to be extensive in length and probably interconnected. In the upper half of the right-hand side section GPR scans were also made. The team agreed to come back to these spots and make a new trial of the smoke test and more GPR measurements. This would allow a more extensive analysis of the results of overflow tests in this location (see also chapters 6 and 8).

Figure 4.53. Indication of selected sections for the execution of overflow tests on burrows.

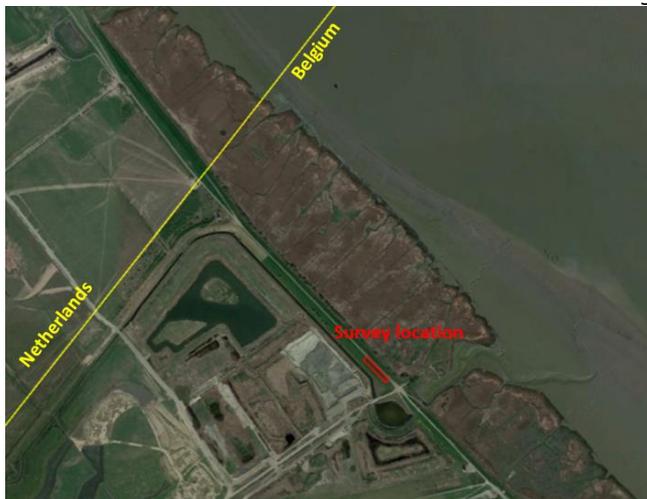
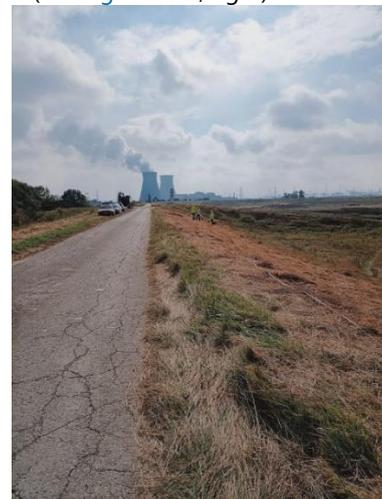
Figure 5.54. Left: Map indicating the location of the animal burrows survey on 24th September 2021. Right: Picture of the surveyed levee from the crest.

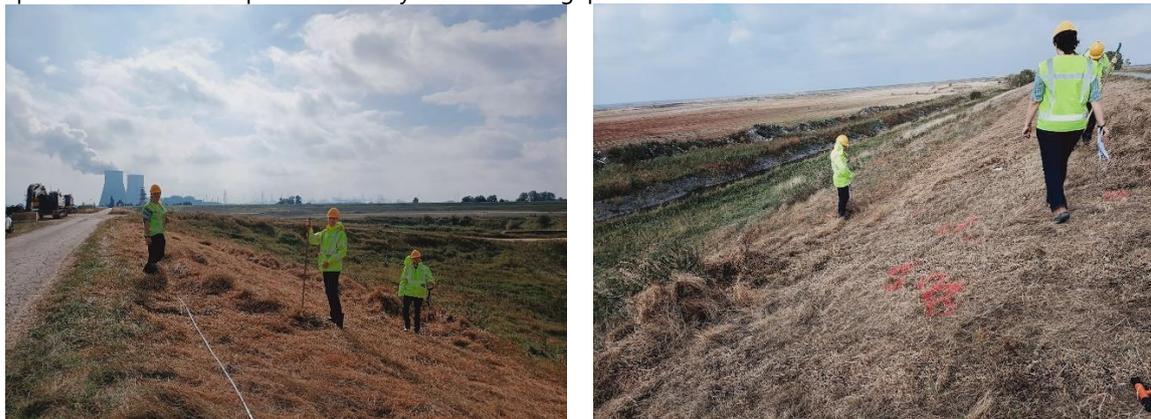
[Figure 5.59](#). Impression of the surveyed levee segment before (left) and after (right) removal of mowed grass. Regarding the geometry of burrows, their diameters ranged between 2 and 7 cm while their depths between 2 and 30 cm, which are comparable to the dimensions measured on the Hedwigepolder levee. Yet a qualitative difference was observed this time; the clay on the top layer was much more dry and brittle than the clay layer on the Dutch levee, and loose clay could be seen lying around several detected burrows ([Figure 5.60](#)).

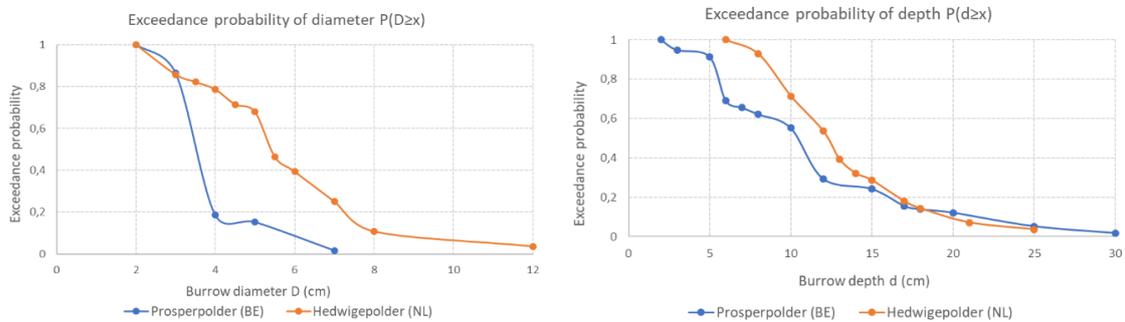
Comparing to the values collected in the survey of the Dutch levee, the most prominent difference is that in the Prosperpolder levee a burrow was detected with sand spread around it, which is evidence that the burrow reached the sand core of the structure (see also Figure 5.60, left). The maximum depth measured in the Prosperpolder levee is also slightly larger than that in the Hedwigepolder levee. For a more detailed comparison, the frequency of encountering burrows of a certain size needs to be considered. This is illustrated in Figure 5.61, where the exceedance frequencies of given diameters and depths of burrows on the Hedwigepolder levee and the Prosperpolder levee are contrasted. For the Hedwigepolder levee only burrows from stretch 2 are presented in the plot, because in stretch 1 detailed information on diameters and depths was not collected. The graphs show that burrows of the Dutch levee had in general larger diameters and depths.

Figure 5.61. Contrast of exceedance probabilities of burrow diameters (left) and burrow depths (right) in the Hedwigepolder and the Prosperpolder levee.

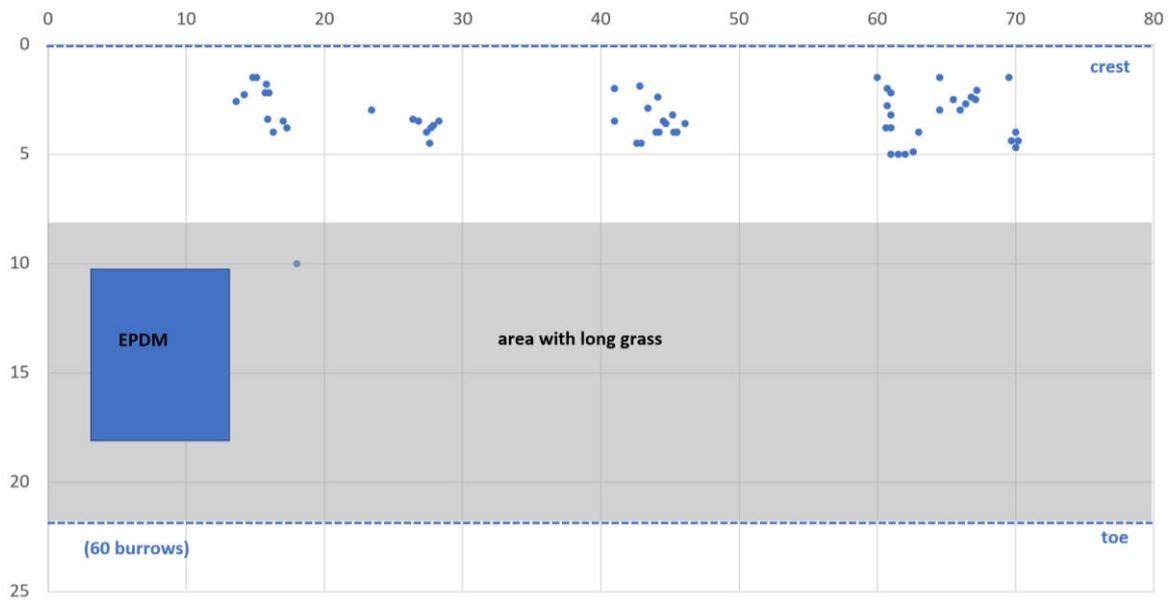
Figure 5.62. Spatial distribution of burrows in the surveyed levee segment.

Clusters of burrows, similar to those identified in the Hedwigepolder levee, can be clearly discerned there. Unlike the Hedwigepolder levee, linear patterns that characterise mole systems are not present. The burrow shown in the grey area was the only one detected in the unmowed part of the slope. The team looked at that area because much loose clay was spread around the cluster of burrows above that point, which could be attributed to an extensive burrow system under the surface; hence the team tried to see if there were any traces of a linear pattern. Although it would normally be unlikely to detect a small burrow in an area with long grass, the burrow was probably detected because there was loose sand around it, whose light colour was easier to see among the vegetation, as visible in Figure 5.63.

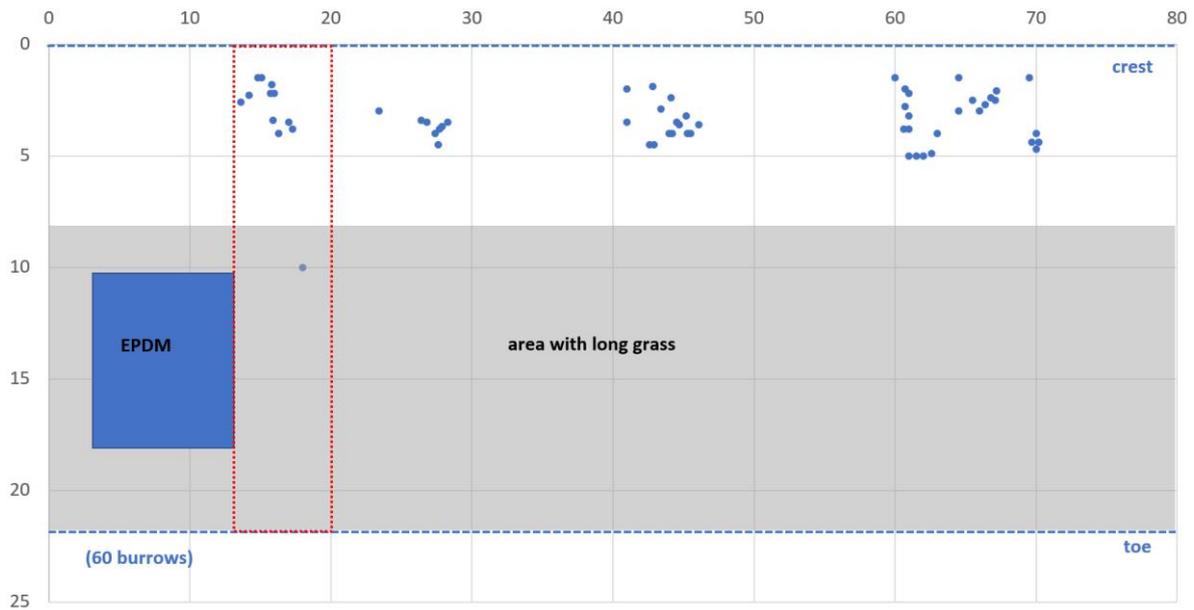
Based on the outcome of this survey, a 6-8 m wide section adjacent to the EPDM cover on the SE side was selected for further investigation (Figure 5.64). This is the section that contains the burrow with sand at its periphery, which makes it clear that the local burrow system reaches the sand core of the levee.

Figure 5.64. Red rectangle: area selected for further investigation.

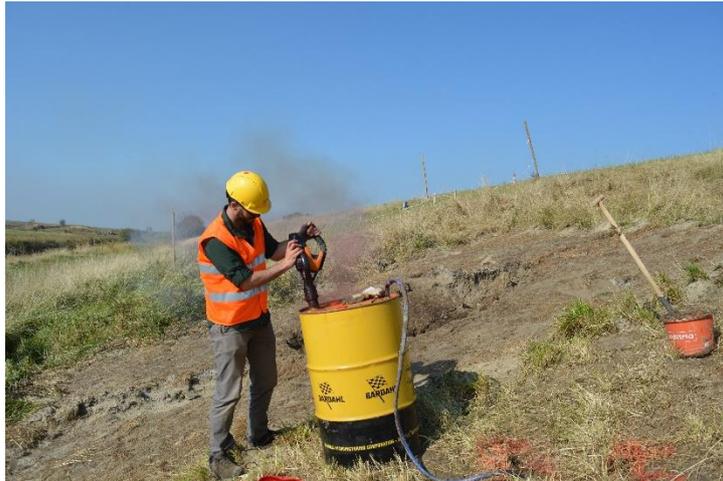
Figure 6.65. Improved setup for the smoke experiment.

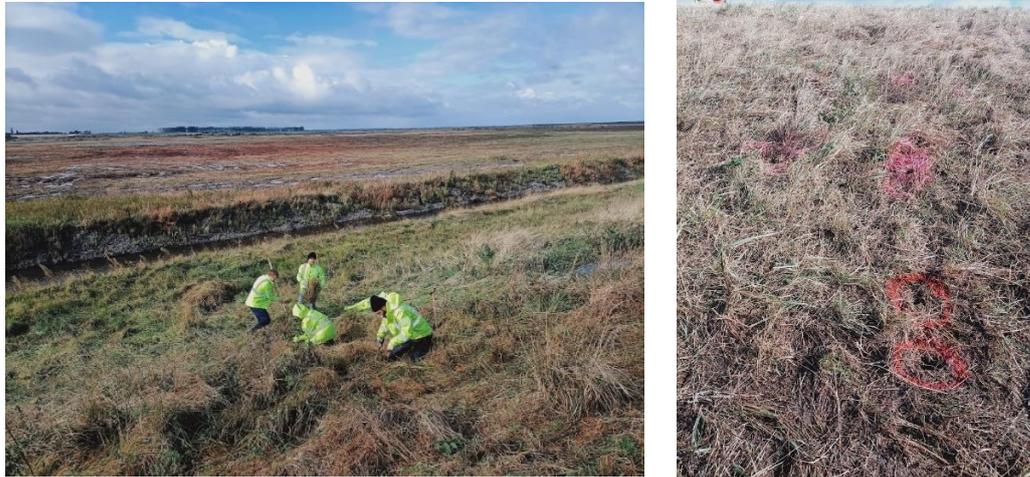
Figure 6.66. Left: The visual inspection team mowing and removing long grass before detection of burrows. Right: Detected burrows marked with fluorescent spray.

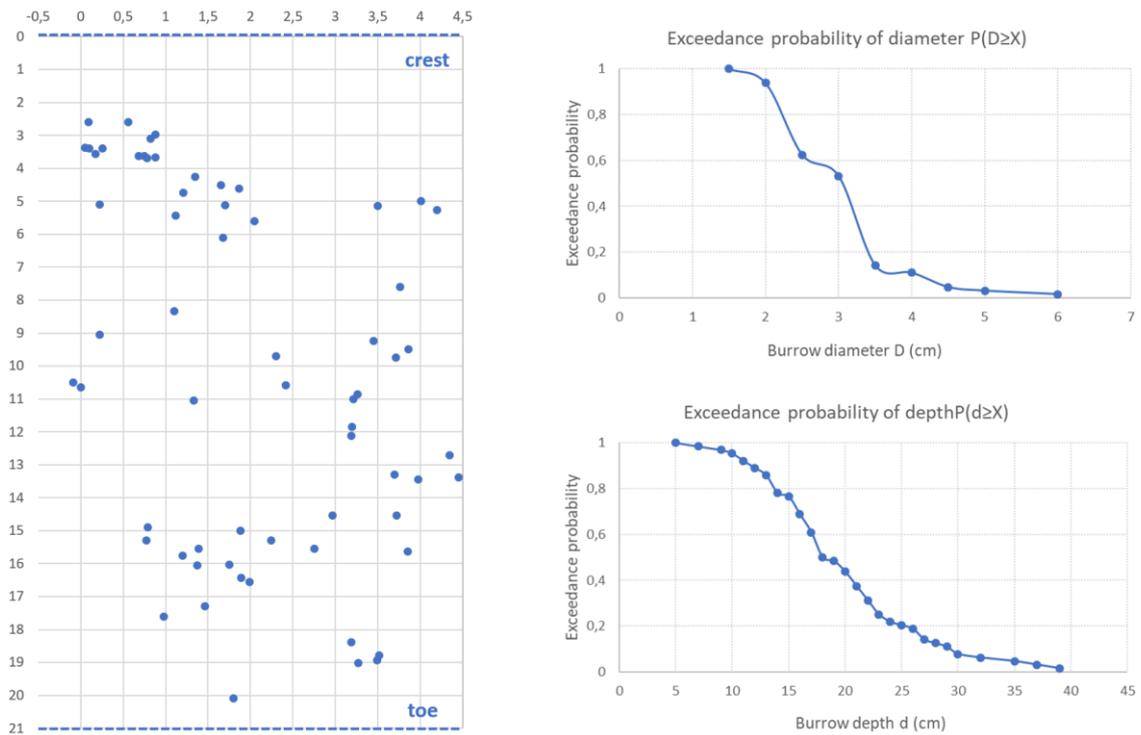
The exceedance probabilities of diameter and depth occurrences are presented in Figure 6.67 (right). On the left hand side of the same figure, the spatial distribution of detected burrows is illustrated. It is clear in this illustration that burrows appear in clusters. Some areas on the grid seem to be densely populated by burrows, while other areas are clean. Regarding the linear patterns that were detected during the survey in the Hedwigepolder levee, it is difficult to identify them on the grid because of the high density of burrows. The linearity in the underground systems could only be verified with the grouting experiments that were performed later on the same section (see forthcoming relevant chapters).

Figure 6.67. Left: Spatial distribution of detected burrows. Right: Exceedance probability of measured burrow diameters (top) and depths (bottom).

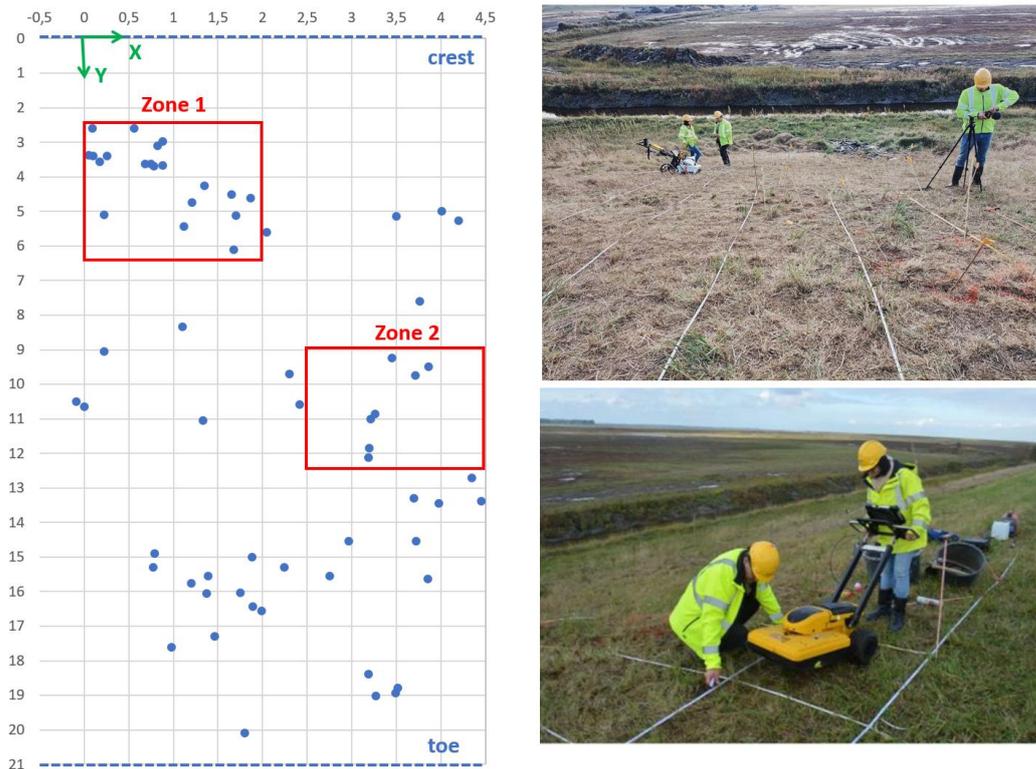
Figure 6.68. Left: Image indicating the reference point of the GPR grid (0,0) and the areas that were scanned in high frequency (i.e. Zone 1 and Zone 2). Right: Data collection with Ground Penetrating Radar.
