# Management of harmful animal activities on levees: Fact finding fieldwork in the Living Lab Hedwige-Prosperpolder

Adaptation  
to climate  
change

Vana Tsimopoulou, André Koelewijn

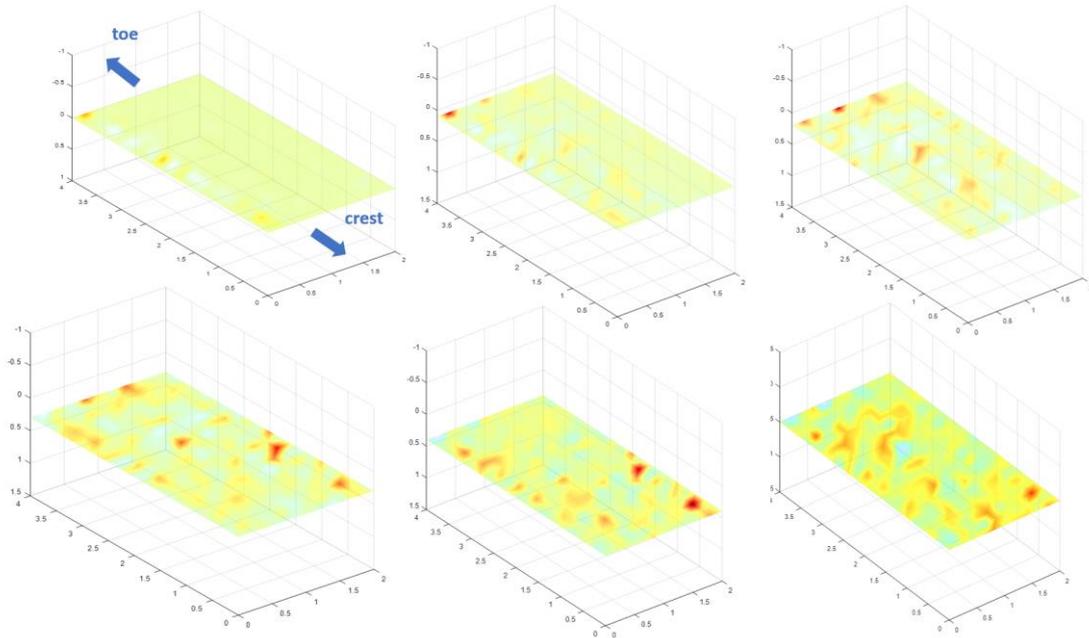
For the zones that were scanned in high frequency, vertical transects were extracted in the X- and Y-direction with a distance of 10 cm from each other. Horizontal transects were extracted up to a depth of 50 cm from the surface, see Figure 6.69. These transects reveal the occurrence of cavities whose presence appears to be more prominent in the depth zone of 30-50 cm below the surface, illustrated at the three bottom transects of Figure 6.5. The depths of the burrows that were detected at this area by means of visual inspections were all in the range of 10-30 cm, which shows that similarly to the previous GPR survey on the Hedwigepolder levee (described in chapter 4), the depths that were measured with probes during the visual inspection were smaller than the ones detected with GPR.

Figure 6.69. Horizontal transects in Zone 1 presented individually, starting from the level of the surface (Z=0, top left transect) to a level of 0.5 m depth (Z=0.5, bottom right transect).

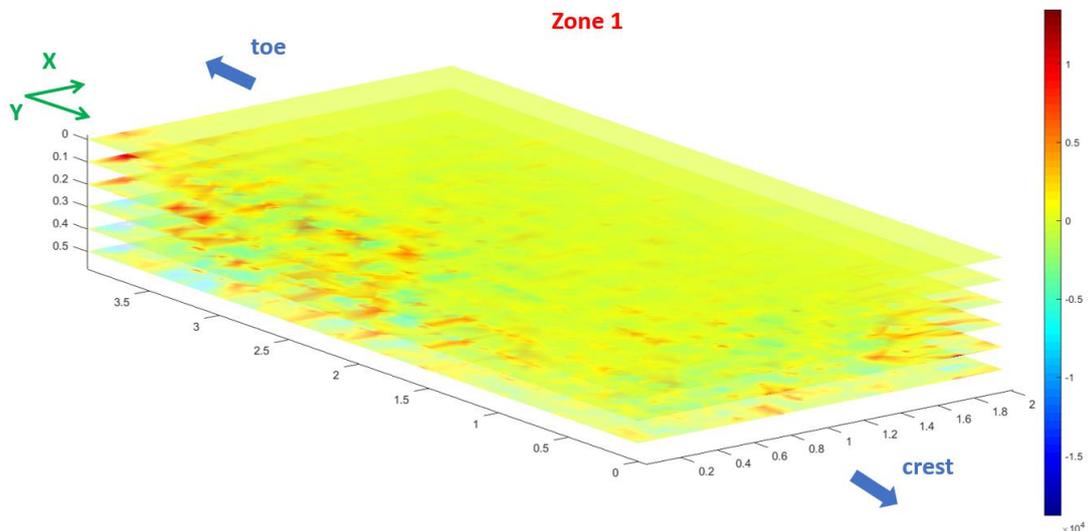
After completion of the activity, a 3D image of the first 50 cm of the levee subsoil was created, by interpolating this dense network of images (Figure 6.70 - Figure 6.72). The red lines indicate areas occupied by air, which are discontinuities that could be attributed to animal activity. A casual observation of the cavities illustrated in red colour in the figures below and the density of burrows detected in zone 1 (see figure 6.4, left) make it clear that a dense system of cavities is located under an area where a cluster of small burrows was visible in the surface.

Figure 6.70. Composition of horizontal transects in Zone 1.

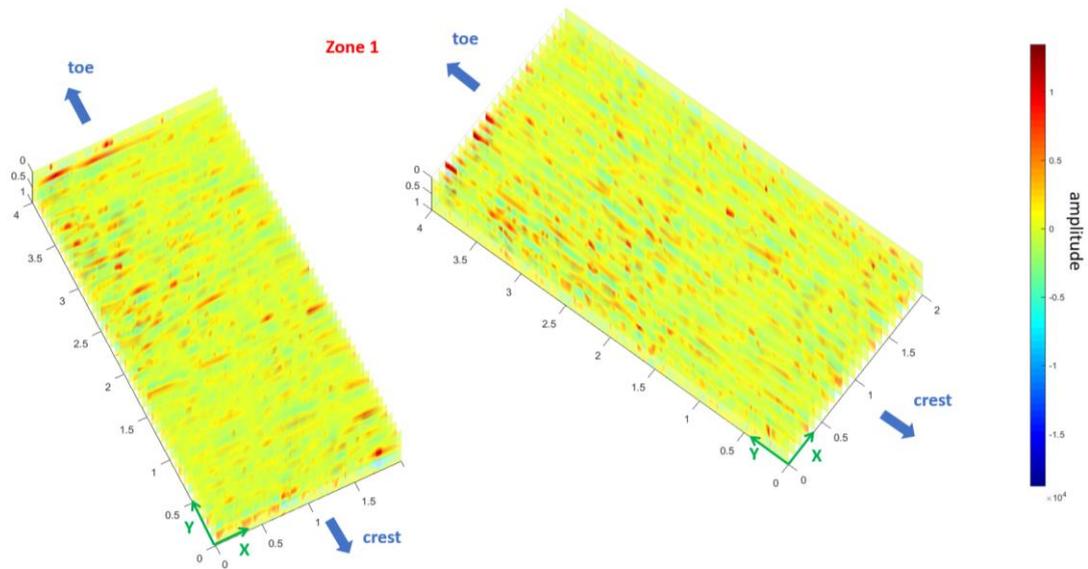
Figure 6.71. Composition of vertical transects in Zone 1 in X-direction (left) and Y-direction (right).

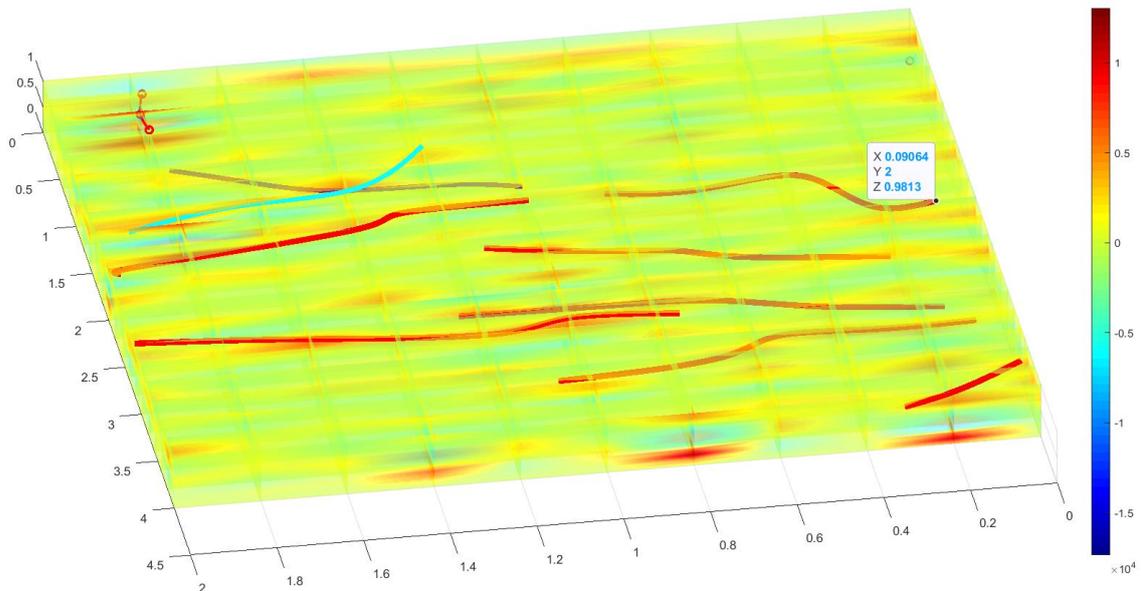
Figure 6.72. 3D image of the first 50 cm of levee subsoil, created by interpolation of horizontal and vertical transects in Zone 1.

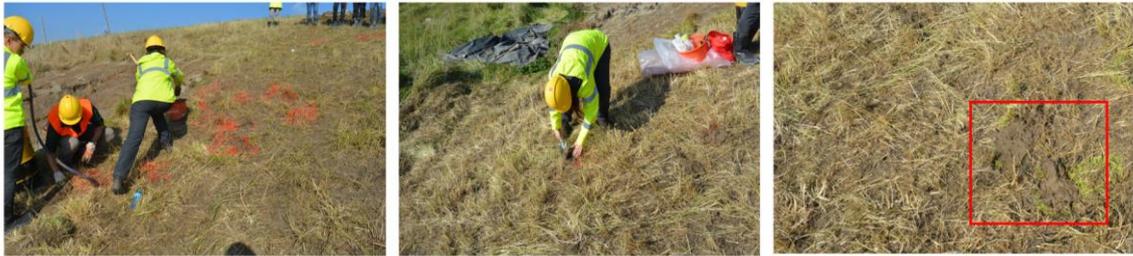
The smoke test was first attempted at the cluster of burrows in zone 1 (Figure 6.68, left) without success. The injected smoke did not appear to be exiting the ground from other burrows. A second attempt was made at the cluster of burrows that was the closest to the toe (Y=14-18 m), with a successful result. Smoke was injected in one of the lowest burrows in the cluster (X=0.98 m, Y=17.6 m). Every time that smoke appeared coming out from a burrow, the burrow was covered with wet clay to block the exit and redirect smoke to other exit points in the system (Figure 6.73).

Figure 6.73. Left and middle: Application of wet clay on burrows where smoke was witnessed. Right: Two burrows covered with wet clay.

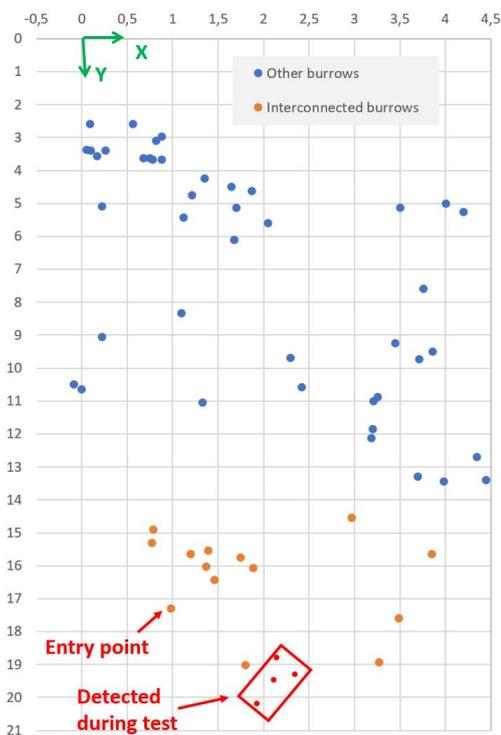
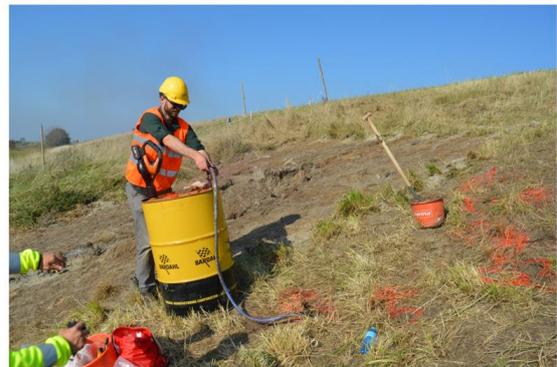
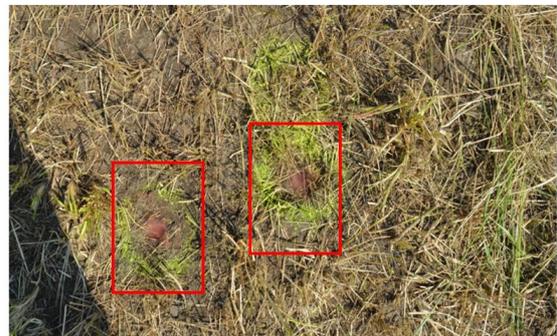
Smoke was witnessed exiting from 17 neighbouring burrows in total (see Figure 6.74). It is characteristic that in this trial of the smoke test, a number of burrows were spotted that had not been detected during the visual inspection. Apart from this, all newly detected burrows as well as a small number of exit points were located lower on the section than the entry point. This contradicts the initial expectation that burrows at higher points

Figure 6.74. Left: Image indicating which burrows proved to be interconnected based on the outcome of the smoke test. Right: Execution of the smoke test (top) and evidence of red smoke exiting the burrows in the red rectangles (bottom).

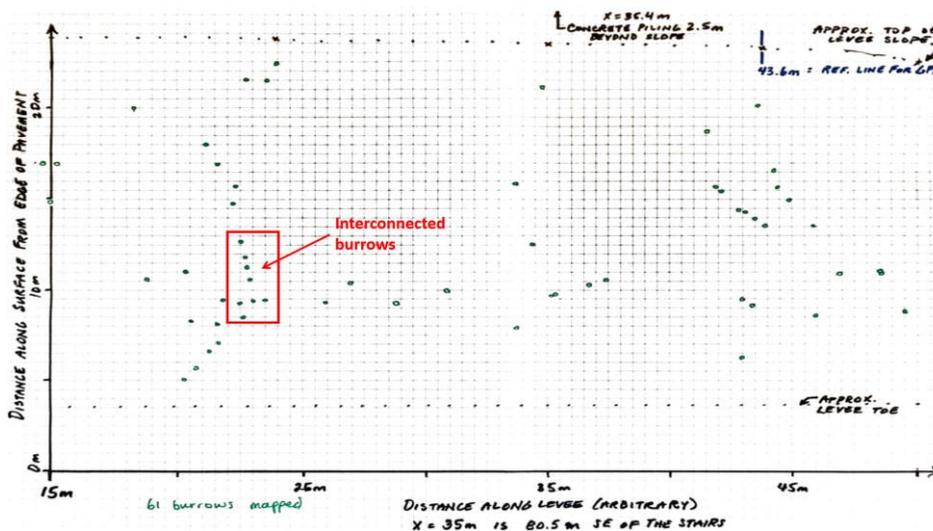
Afterwards the team moved to the Dutch side of the living lab to repeat the smoke test on the section that had been selected for an overflow experiment with burrows, at the area where an animal burrows survey was executed on the 8th of September 2021. This was the left-hand side section of [Figure 4.53](#) (see also Depreiter, D. 2021). The smoke test indicated 8 interconnected burrows at this location ([Figure 6.75](#)).

Figure 6.75. Smoke test result on the section where overflow testing with burrows had been planned to take place in November 2021.

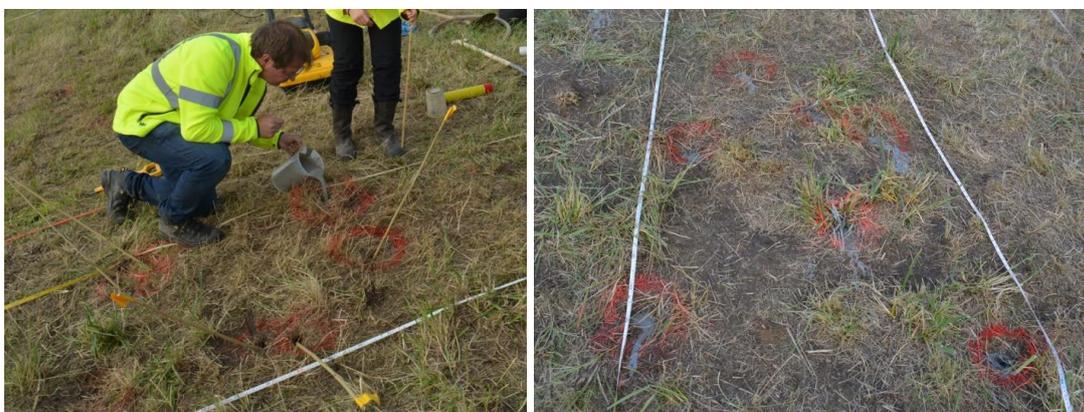
The burrow holes that were previously marked and identified on the same coordinate grid as used to make the GPR scans, were filled with a total of 20 liters of grout, spread over the 63 burrow holes that were found on this 4 meter wide stretch of the levee. Figure 7.77, left, shows the process of filling a burrow hole with the grout mixture and Figure 7.77, right, indicates the final result, after all burrow holes have been filled up.

Figure 7.77. Left: Filling a burrow hole with grout. Right: Numerous grout-filled burrow holes on the coordinate grid.

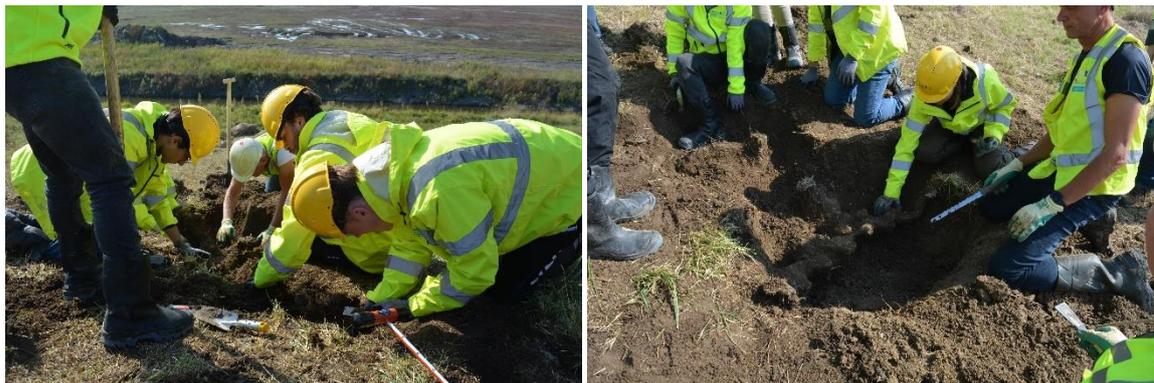
During a small session of the winter school on October 9<sup>th</sup>, where students of the HZ University of Applied Sciences could get familiar with the living lab and participate in activities on the effect of animal burrows on the erosion resistance of levees, a few of the grouted burrow holes were excavated (Figure 7.78). The groups used garden tools to dig in the vicinity of the marked burrow holes to aim and follow the grouted system as accurate as possible. Excavations took place close to the levee crest, and specifically at Zone 1 of the GPR scan that was performed the day before (see also figure 6.4., No GPS measurements were taken to allow the extraction of detailed information about the exact shape and orientation of the excavated burrow system. However casual measurements of the depth in which concrete was found showed that the concrete was found in the of range of 25-50 cm depth from the surface. This is very much aligned with the depths where cavities could be seen in the results of the GPR measurements at the same location, which was in the depth zone of 30-50 cm from the surface (see figure 6.5). Most of the concrete appeared to be shaping one piece, which shows that most burrows in this zone were interconnected and were probably leading to the same den. Unlike the grout that was excavated at the location of the rock bags installation in June 2021 (see also figure 1.2b), the grout at this location did not have a linear shape, but rather an indented shape, which shows that a different type of animal created this burrow system. While the one excavated in June was attributed to a mole, this one was attributed to mice. Comparing this irregular shape of the grout and the coloured shapes that illustrate cavities in the GPR transect at a depth of 45 cm in figure 6.5, it is clear that irregularities of the cavity shape is captured well by the GPR scan.

Figure 7.78. Excavations during the winter school session on October 9<sup>th</sup> 2021

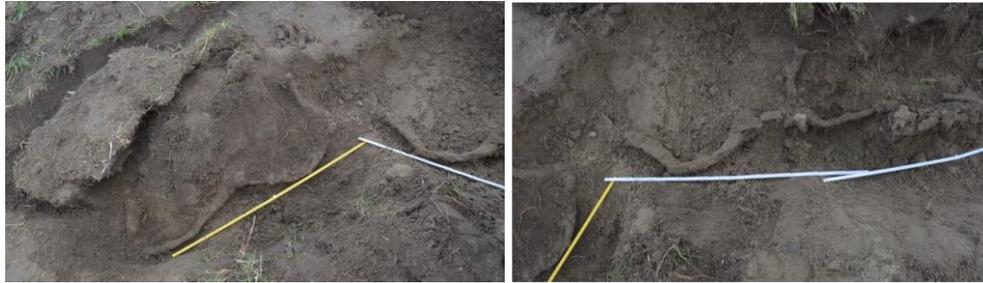
few centimetres, characteristically made by moles. Images of this burrow system can be seen in Figure 7.79. The excavated burrows that are visible in the left-hand side image are connected to those visible in right hand side image of the same figure. It is important to note that in this excavation it was clear that the grout had reached the sand core of the levee.

Figure 7.79. Part of the excavated mole burrows.

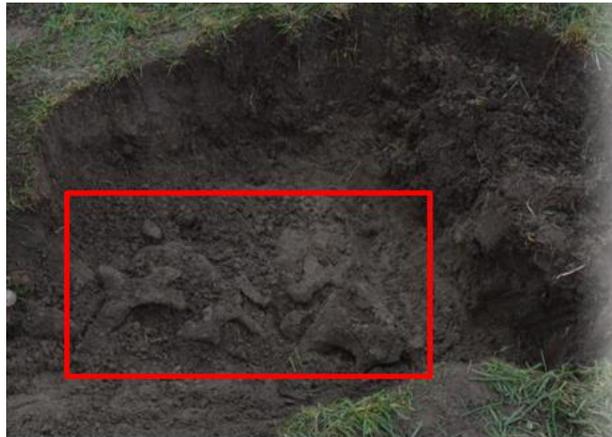
Further up the slope, towards the crest, a small system of dense tunnels was found, assumed to be connected by small chambers which is characteristically made by mice (Figure 7.80). The mole burrow system was later scanned by the LiDAR and the location of interesting points on the grouted system was measured using RTK-GPS scanning.

Figure 7.80. Excavated mice burrow system.

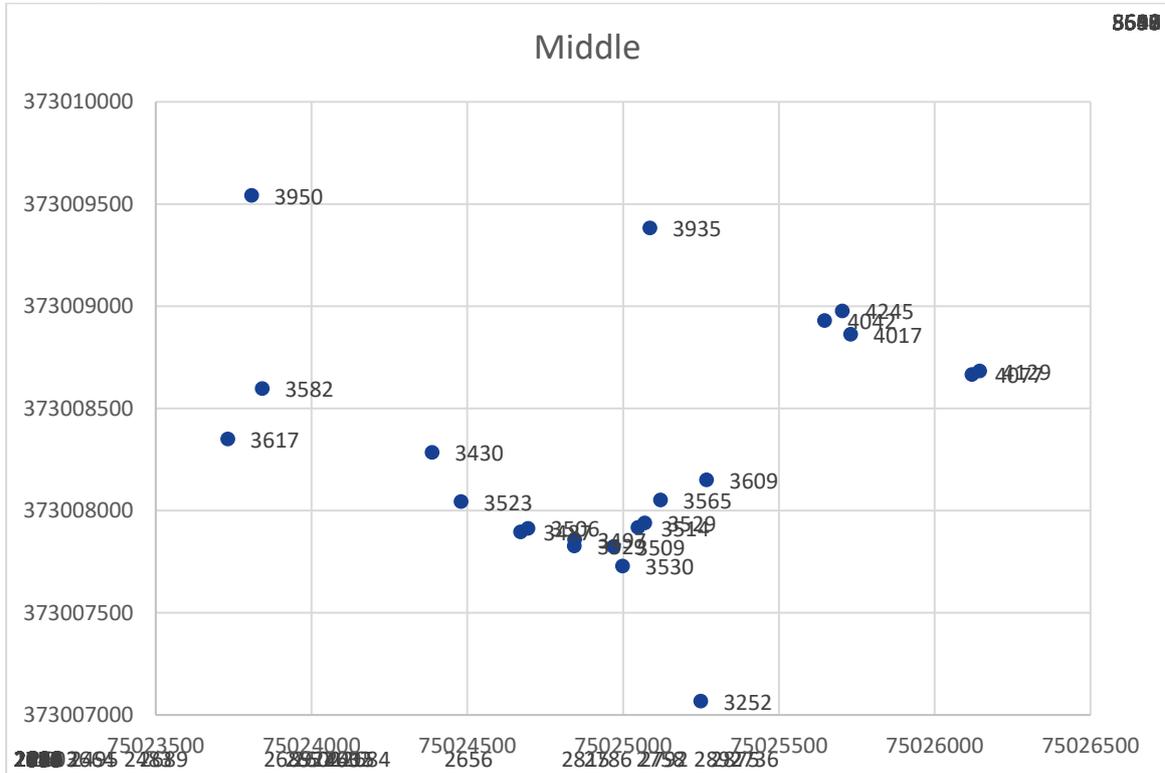
Figure 7.82 shows a zoomed plot of the points in the middle of the previous figure. The label '4245', rather on the right of this figure, refers to the main point of entry of the animal burrow that consumed a lot of grout while pouring the grout. The two points close to this point have been measured after excavation and these are over 20 cm lower.

Figure 7.82 RTK measurements in the middle of the excavated area.

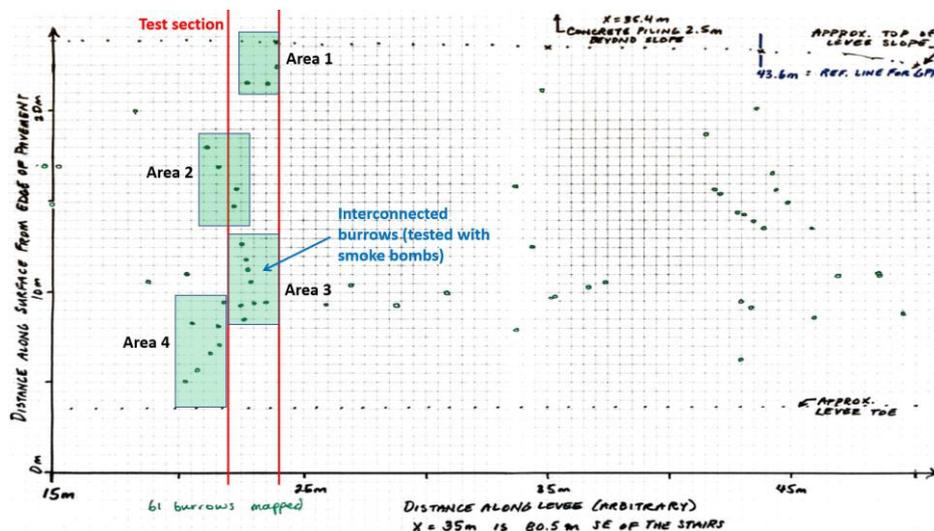
- Area 1: Cluster of burrows that seems to be disconnected from burrows in areas 2 and 3.
- Area 2: Burrows that seem to be part of the mole pathway. The smoke test that was performed here did not prove interconnectedness with the rest of the burrows in area.
- Area 3: Cluster of interconnected burrows. Their interconnectedness was proven with the smoke test.
- Area 4: Burrows outside the test section that seem to be part of the mole pathway.

Figure 8.3. Top: Borders of test section N-OF09 and areas of interest that were defined in the process of positioning the test section.

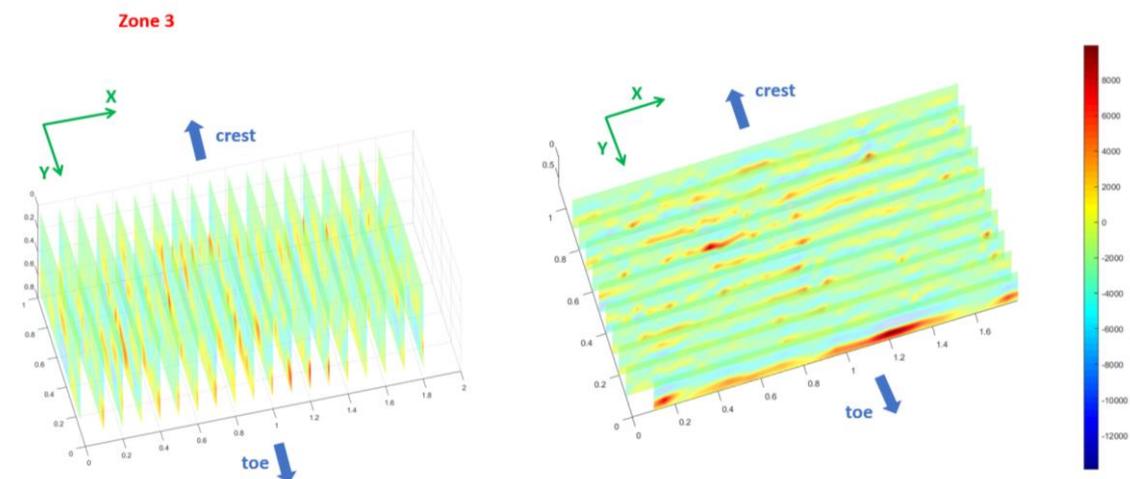
Figure 8.7. Left: Vertical transects in zone Z3 in Y-direction. Right: Horizontal transects in zone Z3.

The transects show clearly the presence of discontinuities, which are illustrated with red colour. In the figures below it can be seen that some of those discontinuities are matching well the presence of burrows on the surface. For example in the lowest horizontal transect of zone Z3 (figure 8.7, right), a red line is visible that extends almost in the entire width of the test section, in a depth of about 0.5m. Along this line three burrows had been detected (see also figure 8.4) that the smoke test showed that they are interconnected. This means that the red area in the transect probably illustrates the existence of a mole tunnel in a depth of about 0.5 m. However there are also discontinuities in the GPR results that cannot be correlated to the detected burrows. See for example the vertical transects in Y-direction of zone Z1 (figure 8.5, left). In those transects various red areas can be observed, while in that location only one burrow was detected that was interconnected with a burrows lower in the levee. It is unclear if such discontinuities are related to the subsurface burrow system. In the final assessment of the GPR results it should be taken into account that on the day of the measurements the weather and soil conditions were not ideal for GPR. It was a rainy day and the soil was not dry. Possible errors stemming from the weather and soil conditions need to be factored in. The accuracy of the GPR results depends on scan conditions, soil characteristics, properties of devices and analysis techniques. A more detailed analysis of the results will probably provide interesting insights. GPR use for the detection of burrows in levees is not really widely used, which means that its usability can be improved via a study like this.

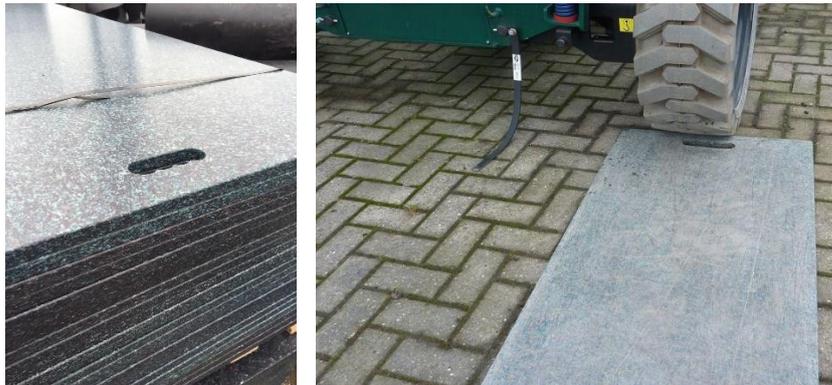
Before commencement of the overflow experiment a temporary protection of the interconnected mole burrows of area 3 and the additional burrows of area 2 was installed. Road plates (figure 8.16) combined with metal pins (figure 8.17) and bicycle inner tubes were used to create a low-cost assembly of a temporary barrier for the protection of levee sections with mole burrows, in anticipation of high water and overflow.

Figure 8.16: Synthetic road plates that were used for the assembly of the temporary protection of the mole burrows.

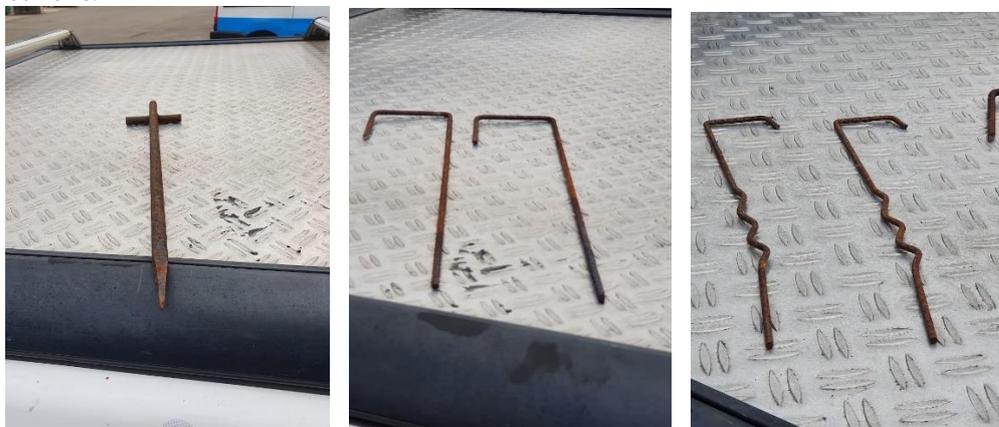
Figure 8.17: Metal pin types that were combined to attach the road plates on the soil

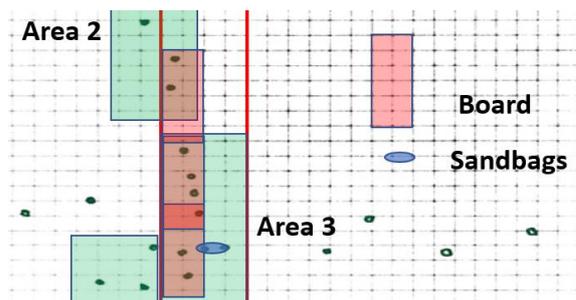
Three road plates of (3x1) m were placed in the flume in a linear set-up adjacent to the flume wall. The plates were installed in such a way that most detected burrows within the flume were covered by them. In order to minimize the passage of water under the plates, metal pins were used at their periphery to attach them to the ground. Furthermore, the plates were placed so that they overlapped with each other by about 50 cm, with the lowest plate being fully attached to the ground, the second overlapping with the first, and the third overlapping with the second. At the overlapping areas, the elastic tubes were placed on the top and pinned on the ground to provide additional resistance to the uplifting forces of the water. At the edges of the overlapping areas and at the upper edge of the assembly, synthetic sandbags were placed and pinned on the ground to provide extra protection against water passage under the plates.

Figure 8.18. Top view layout of the solution.

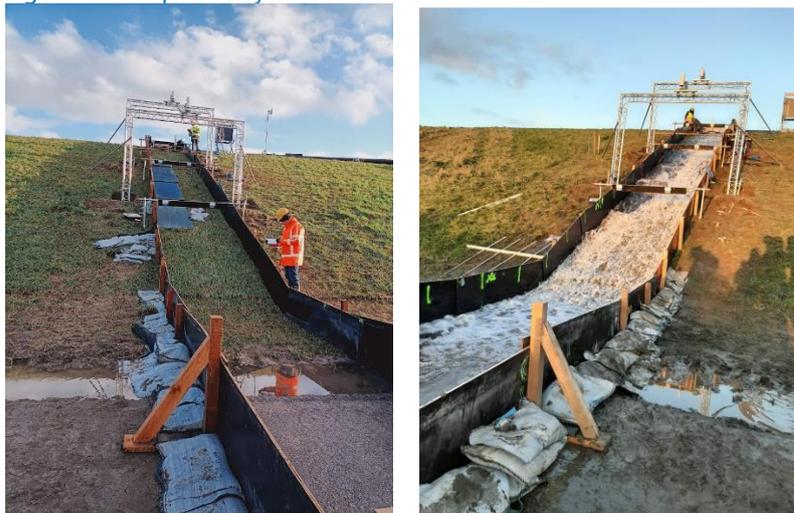
Figure 8.19: Temporary protection with road plates before commencement and during the overflow test.

The installation was completed in 15 min by a team of 3 people. This makes it a very practical solution for emergency interventions, especially when compared to other interventions tested in the living lab (see e.g. EPDM or levee challenge repairs). The installation appears to have worked well, as no erosion was detected after completion of the experiment on the covered area. Yet the sandbags did not provide any essential protection as they were washed away by the water flow very early in the experiment. The pins and bicycle tubes remained intact. The same plates and pins were also used in several other overflow experiments to protect scour holes at the transition between grass and asphalt at the toe, and their performance there was always satisfactory. This provides confidence about the suitability of this method to protect larger burrows and other discontinuities too.

Apart from the ERT monitoring system a temporary protection of the mole burrows was applied with a composition of road plates, pins and bicycle inner tubes. The installation performed well in this test but further testing in different conditions is recommended.

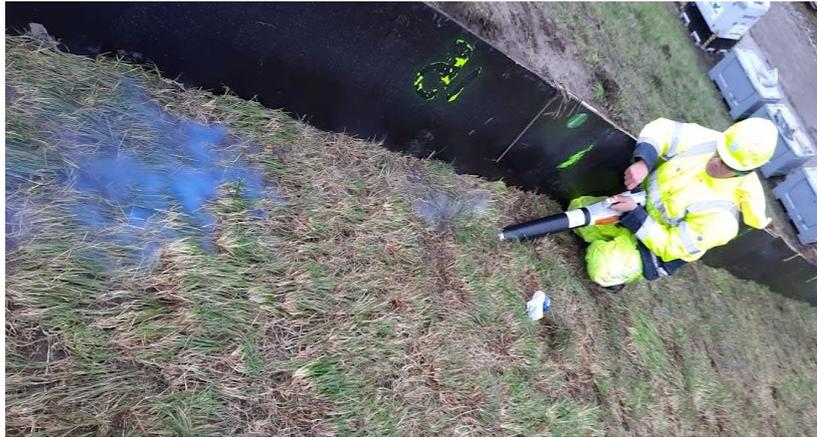
After completion of the overflow experiment and removal of the road plates, the smoke test was performed on burrows of this section once again in an improved version. This time only a smoke bomb and leafblower was used, but the leafblower was larger than the one in the previous trial. The smoke bomb was placed directly at the entrance of the burrow and the smoke was blown inwards with the leafblower. With a larger leafblower the pressure of the air was increased, which led to instant passage of air from the subsurface cavities. Air started exiting from a number of burrows almost instantly (figure 8.20).

Figure 8.20: Application of the smoke test on mole burrows in section N-OF09.

The only disadvantage this time was that there was no provision made to seal the exit points of the smoke, which would have possibly allowed to identify more exit points. Wet clay that was also used in the previous trials of the smoke test could be a solution. An improved alternative could be the use of glass tiles instead of clay. This solution was tried in May 2022 by Karsten de Pauw during his graduation internship at Hoogheemraadschap van Rijnland and it worked well. (see also [relevant video](#)).
